Lenovo ThinkCentre A70z Backlight Cable Replacement

The ThinkCentre A70z Monitor lamp turns off so can't see display without a light to verify LCD screen is working.

Written By: James Finch

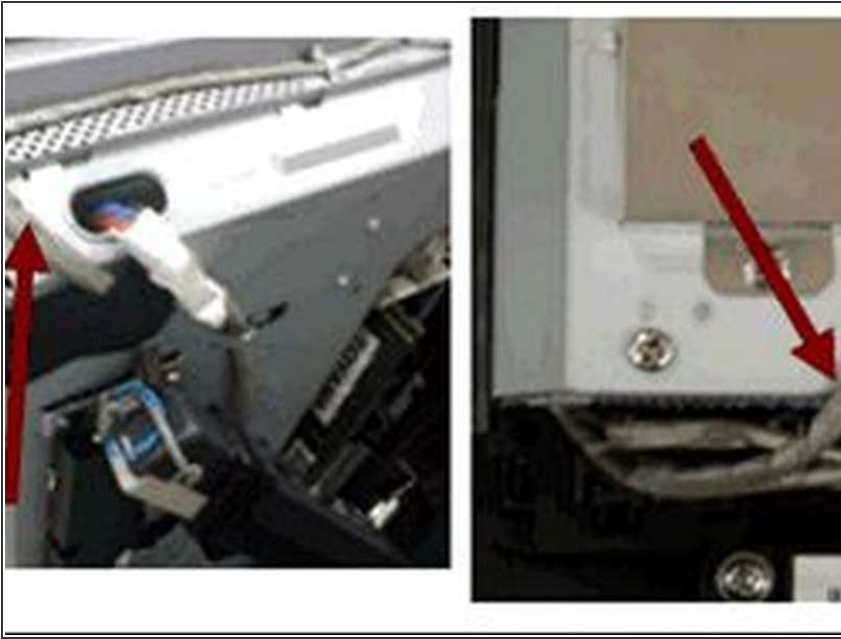
Step 1 — Remove Conductive Tape from Backlight Cable

The issue is caused by the conductive tape wrapped around the backlight cable as seen below.

The issue has a low failure rate with the woven type of conductive tape. However, has a high failure rate with an aluminum foil type of conductive tape.

LG panel mentioned, "do not attach a conducting tape to lamp connecting wire directly. If the lamp connecting wire attach to a conducting tape. LCD module will have a risk for low luminance.

- Remove conductive tape wrapped around the backlight cable as below seen below.
- The issue has a low failure rate with the woven type of conductive tape. However, has a high failure rate with an aluminum foil type of conductive tape.

I removed the conductive tape wrapped around the backlight as noted and now the computer is working great again other than a login issue that will be corrected with a Windows 10 reset or I'm thinking a fresh install of a Linux OS for a multiboot system.
