# Philips Wake-Up HF3520 Power supply repair

Flashing or flickering light when using radio can be caused by a malfunctioning switchmode power supply IC.

Written By: Thomas Widmaier

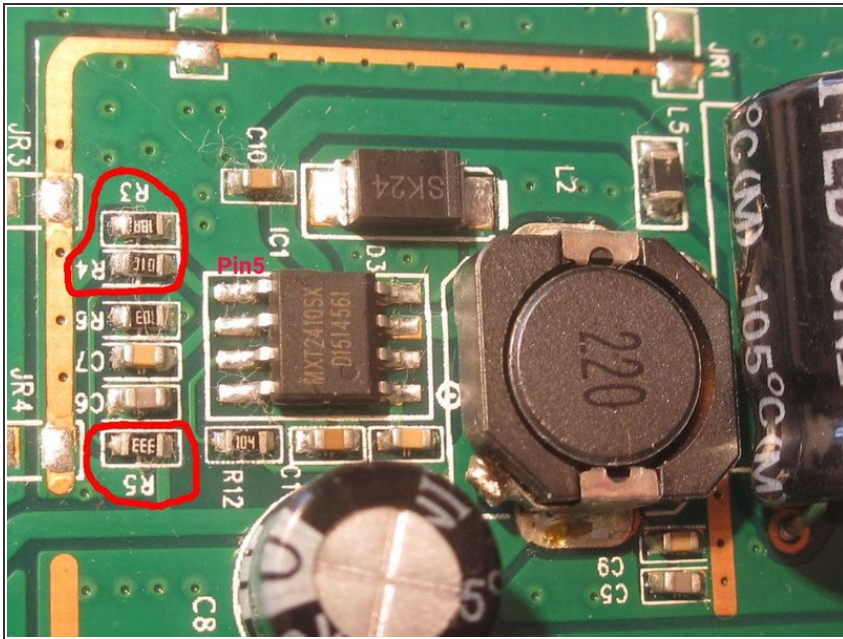
## Step 2 — Replace IC

The IC (chip) inside the lamp seems to die slowly resulting in flickering/flashng lamp operation when using the radio. Also the buttons may become unresponsive.

The problem occurs specifically when the device is cold and/or humid. Heating up the IC makes it work again.

- On the main PCB with the power-jack, replace the MXT2410 switchmode regulator IC (SO-8 Package).
- There is a pin-compatible device from Quorvo (ACT4060ASH-T) which has a different internal voltage reference but otherwise works fine. Only a resistor must be changed for this to work.
- Feedback Voltage for MXT2410 is 1.222V, for ACT4060 is 1.293V, so voltage divider on Pin5 must be changed accordingly.
- One can best adjust R4+R3 (series). Remove R4, measure R3 and R4, and increase. It should measure about 10.67kOhm (R3 plus R4), and it can be slightly increased to 11.51kOhm. So basically add 1kOhm to R3+R4.
