iPhone 7 - U3101 Audio IC Replacement

Fix audio problems that affect the iPhones 7 and 7 Plus with this method! Requires soldering.

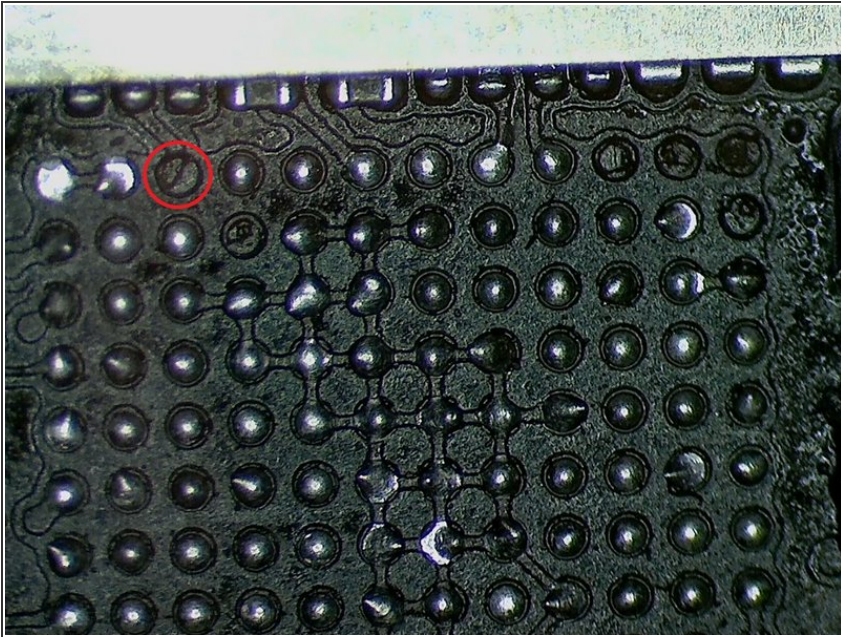
Step 1 — Remove U3101

It is disconnected from the logic board. The iPhone 7's logic board may be slightly twisted and often results in a broken track.

- Remove the chip cleanly, with hot air. On my Quick 861DE rework station, I use as settings 400 °C and 100L/min. For you to decide which settings you prefer, you can find the Quick 861DW on the shop.
- Clean the tracks with a soldering iron, tin and flux. I use a tip about 1mm in diameter with my JBC Nase 2C, at 360 ° C.
- Clean the map.
- Inspect the card under the microscope. We can see on the picture below that a track is missing!
