# HP Pavilion x360 11-p110nr Hard Drive Replacement

If your HP Pavilion x360 11-p110nr laptop has a faulty Hard Drive, this guide will take you step-by-step in removing and replacing the original hard drive.

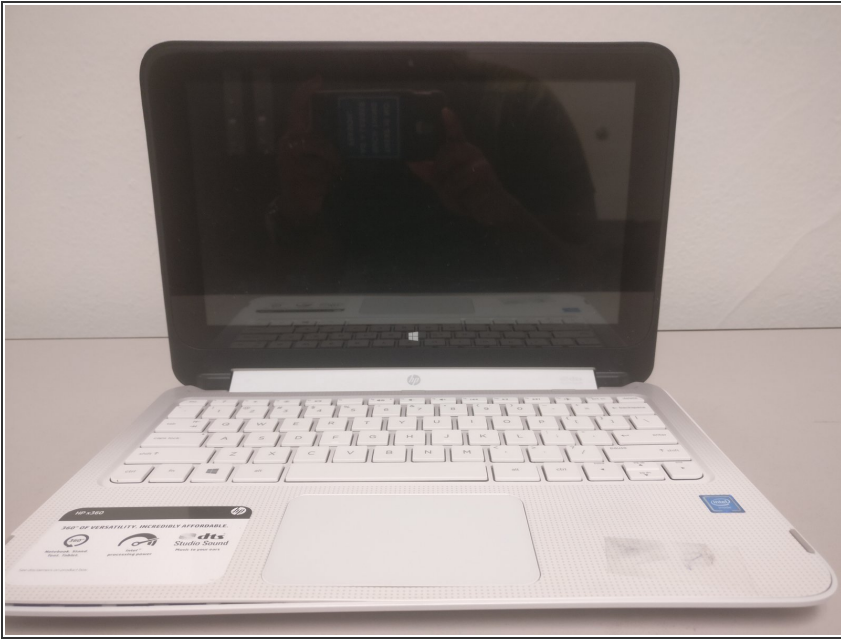
## Step 1 — Hard Drive

- Make sure the laptop is turned off, and the power cable is removed.
- ⚠ Leaving the laptop turned on can cause damage to the hardware and any stored data.

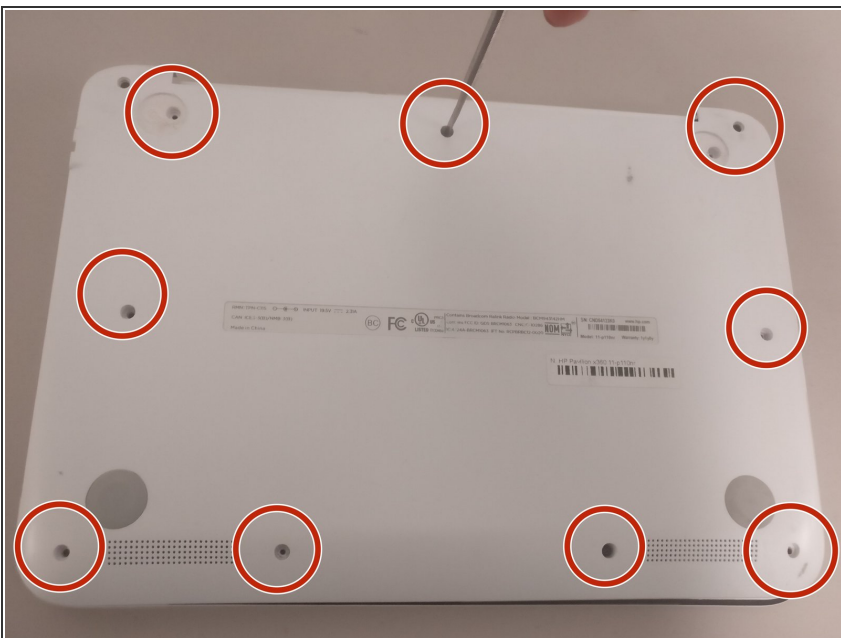
## Step 2

- Turn the laptop over to access the backside of the computer.
- Identify and confirm that the laptop is an HP Pavilion DV5T-1000.
- In order to remove the hard drive compartment cover, first remove the screws located on the panel, using a size 0 Phillips head screwdriver.

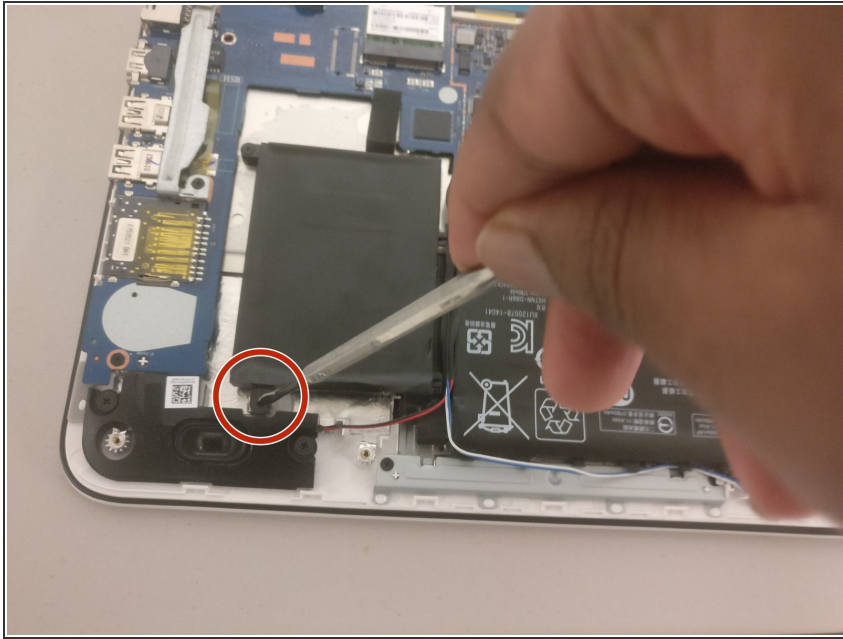
### Step 3

- Remove the 4 screws using a size 0 Phillips head screwdriver.
- Pull the hard drive up and out, to remove it from the compartment to replace it.

To reassemble your device, follow these instructions in reverse order.
