Microsoft Surface Book 2 Teardown

Microsoft Surface Book 2 teardown done on 11/17/2017.

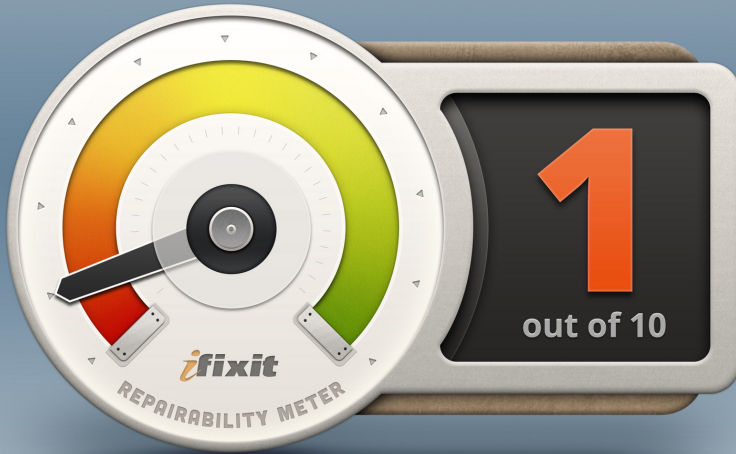
REPAIRABILITY SCORE:

- After the difficult opening procedure, the SSD can be replaced.
- The display assembly consists of a fused glass panel and LCD, and is difficult to remove and replace.
- The processor and RAM are soldered to the motherboard.
- Strong adhesive holds many components in place, including the display, base cover, and both batteries.
- Many components are on the backs of their respective boards, requiring motherboard removal to replace simple components.
