# Amazon Echo 2nd Generation AMP Board Replacement

How to replace the AMP Board in the Amazon Echo 2nd Generation.

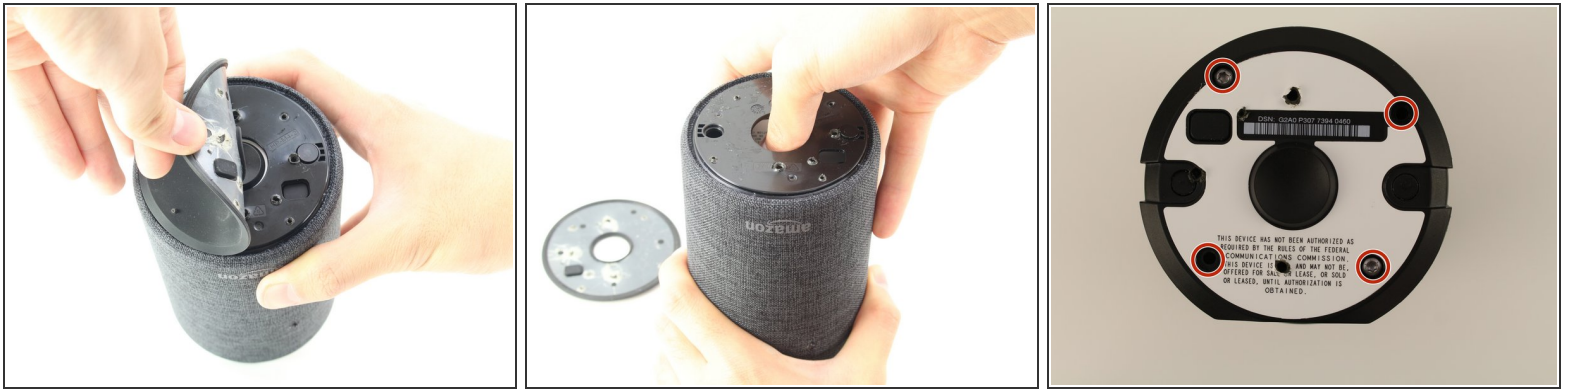
## Step 1 — AMP Board

- Remove the rubber layer beneath the device.
- Look for the crater beneath the rubber layer and place your thumb on it. Hold down and lift off the cover with your other hand.
- Remove the four 8.0 mm T8 Torx screws on the lid.
- Remove the lid from the device.

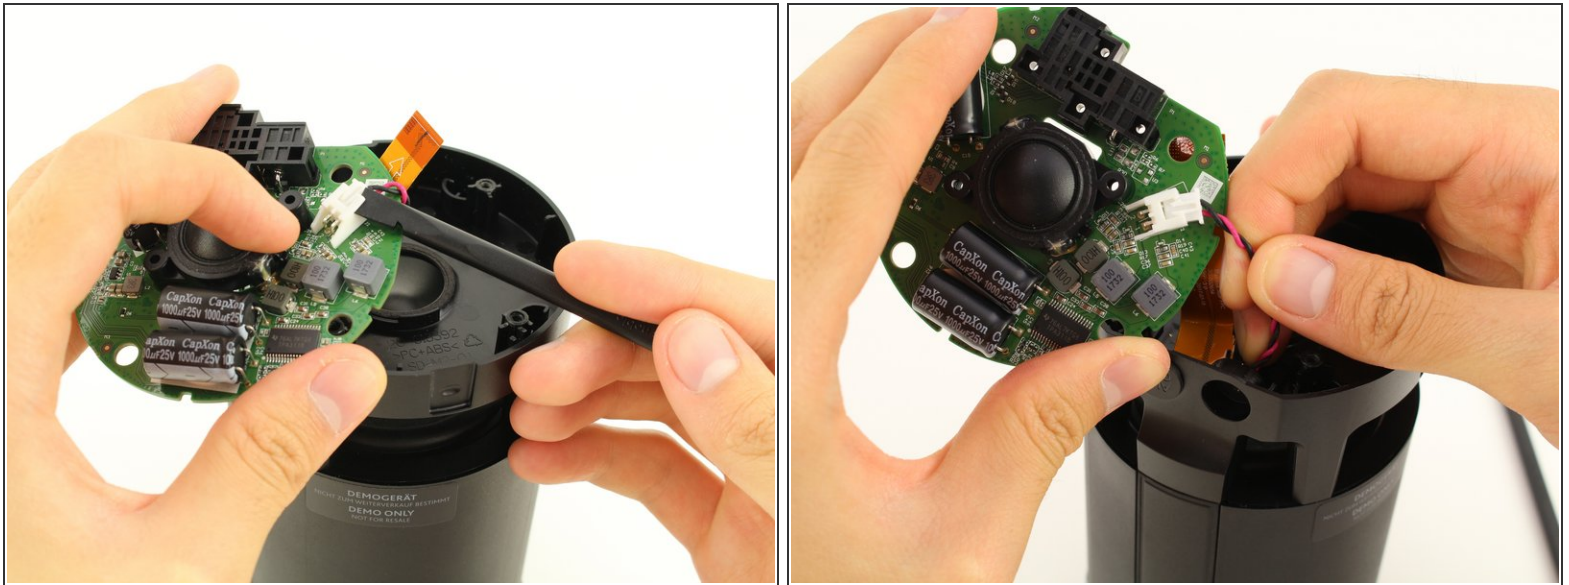
### Step 3

- Use a spudger to lift up one of the small flaps on only one side of the female connector.
- Pull on the wire toward the lifted side until the male connector is disconnected.
- Remove the AMP Board.
