# Amazon Echo 2nd Generation AMP Board Replacement

How to replace the AMP Board in the Amazon Echo 2nd Generation.

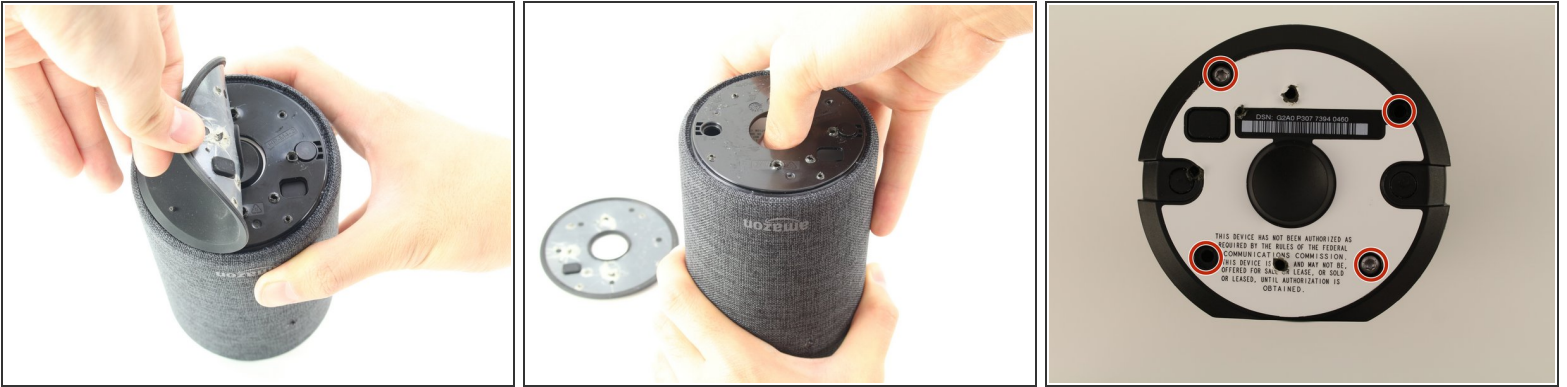
## Step 1 — AMP Board

- Remove the rubber layer beneath the device.
- Look for the crater beneath the rubber layer and place your thumb on it. Hold down and lift off the cover with your other hand.
- Remove the four 8.0 mm T8 Torx screws on the lid.
- Remove the lid from the device.

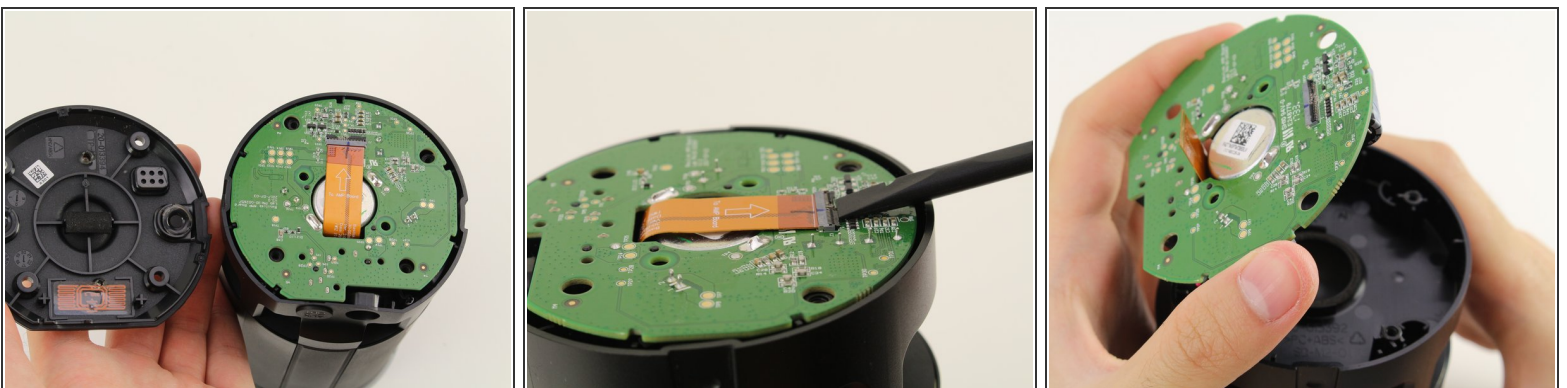
## Step 2

- Use a spudger to flip up the small flap on the ZIF connector.
- Gently pull the ribbon cable out of the ZIF connector.
- Lift the AMP Board gently while sliding the ribbon cable out through the center hole to reveal another set of wires underneath the board.

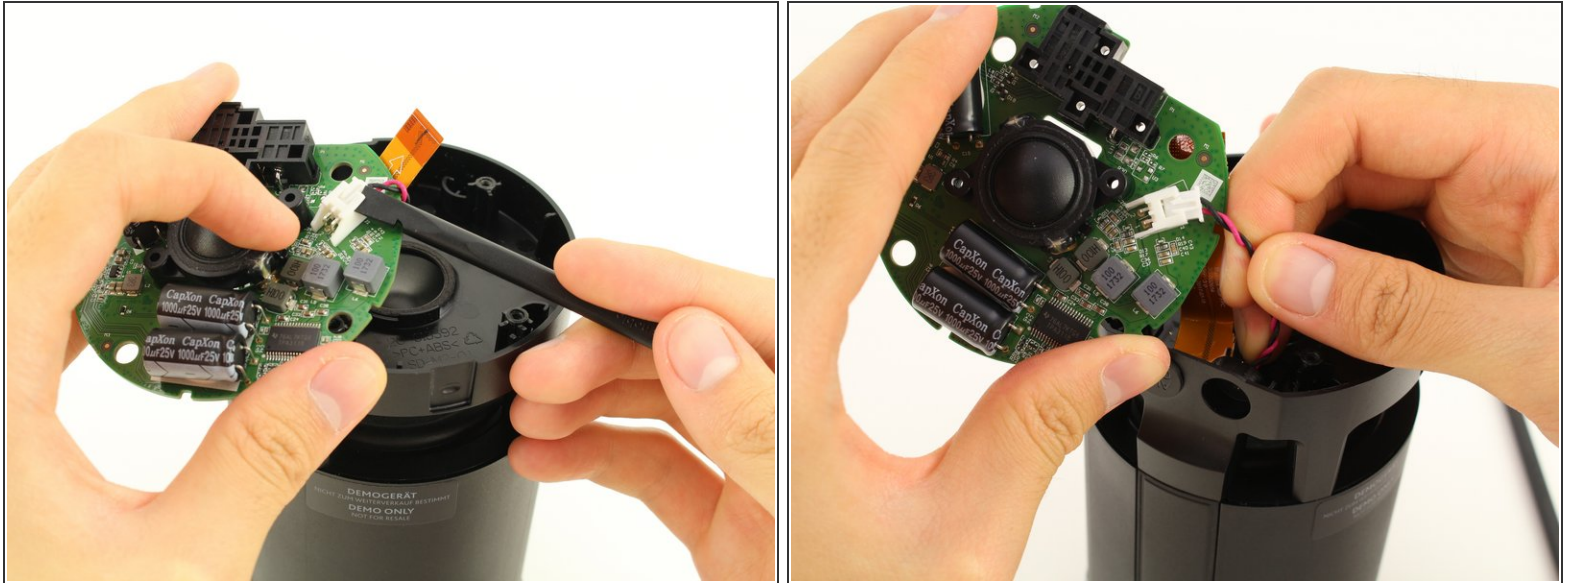
## Step 3

- Use a spudger to lift up one of the small flaps on only one side of the female connector.
- Pull on the wire toward the lifted side until the male connector is disconnected.
- Remove the AMP Board.
