How to Repair an Internal Leak in the Steam Wand of a Starbucks Barista

This guide will help you quickly fix an internal leak in the steam wand of the Saeco SN006 model.

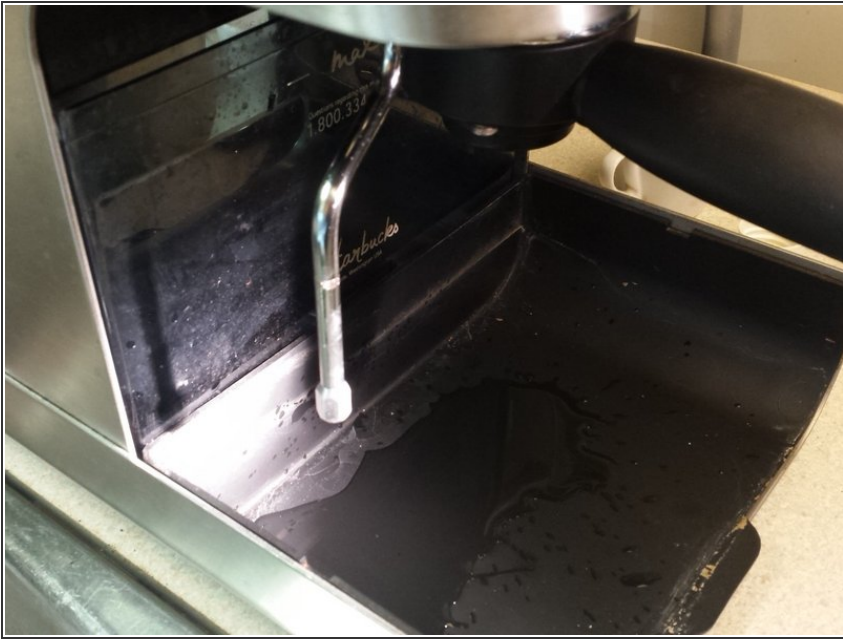
Step 1 — How to Repair an Internal Leak in the Steam Wand of a Starbucks Barista

- When there is water leakage from the steam valve, there are 2 sources, external and internal. External leaks are a matter of replacing bushings and shown elsewhere. This guide shows how to deal with internal leakage. First, descale the machine with a commercial product, like Dezcal. Unplug the machine from the power source then follow the steps:

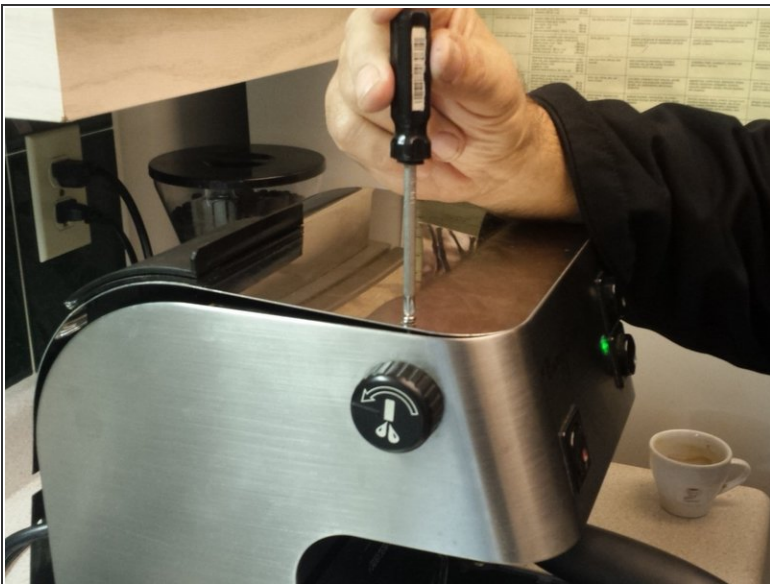
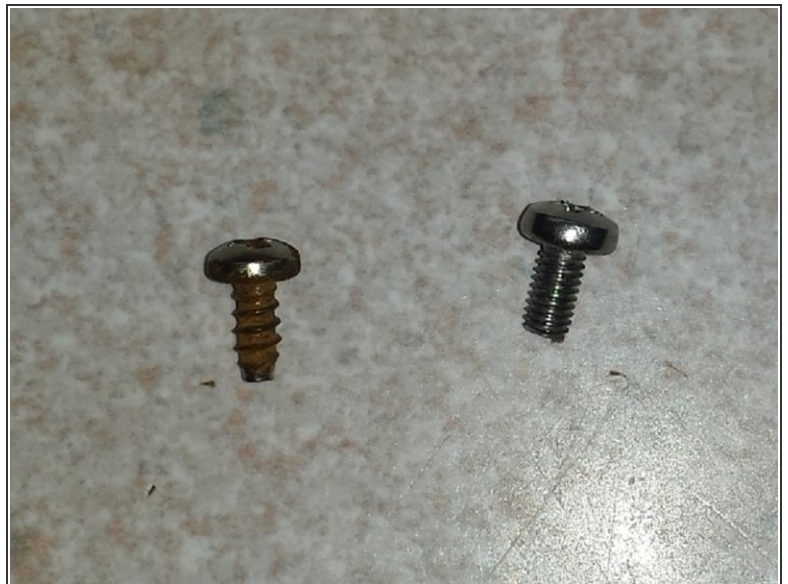
Step 2

- Remove the six screws holding down the cover. Note that the top screws have fine threads, while the four lower screws have coarse threads. Keep this in mind for later reassembly. Once the screws are off, remove the cover.

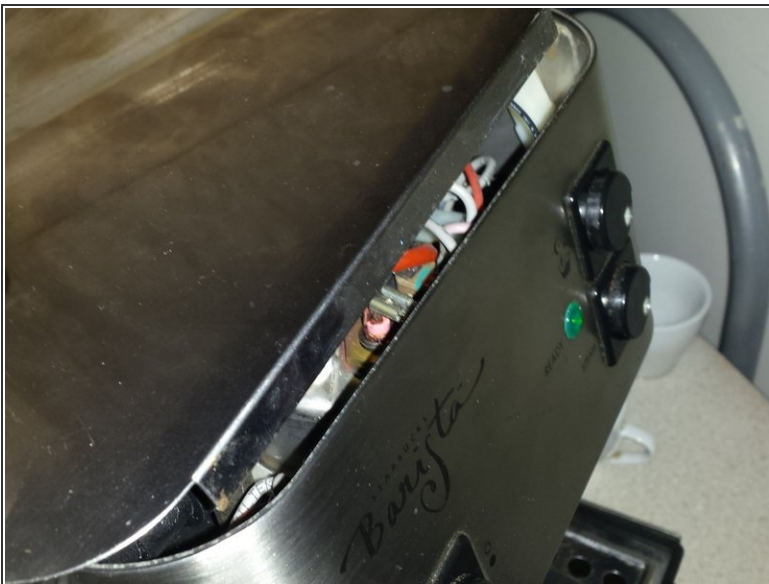
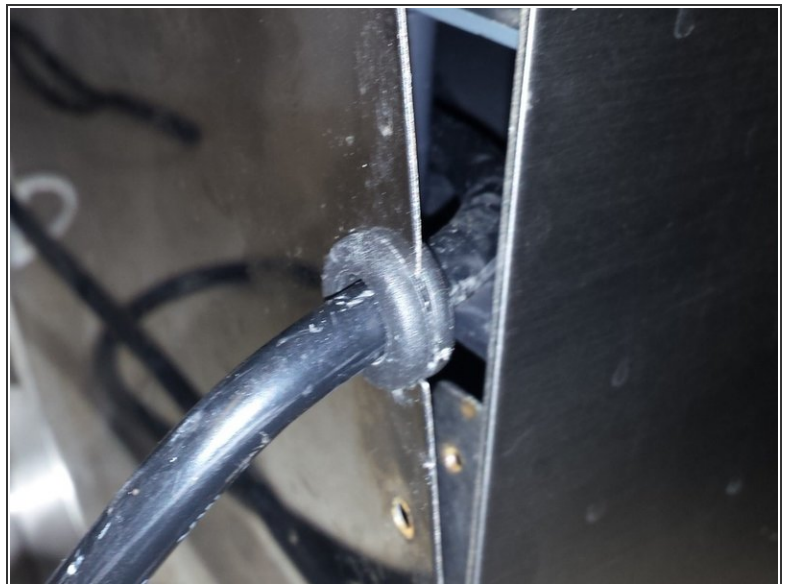
Step 6

- Replace the cover, making sure the steel lip at the front is in its slot, and that the black plastic bushing is in place at the back of the cover. Replace two of the six screws, to save time in case you have to repeat the process.

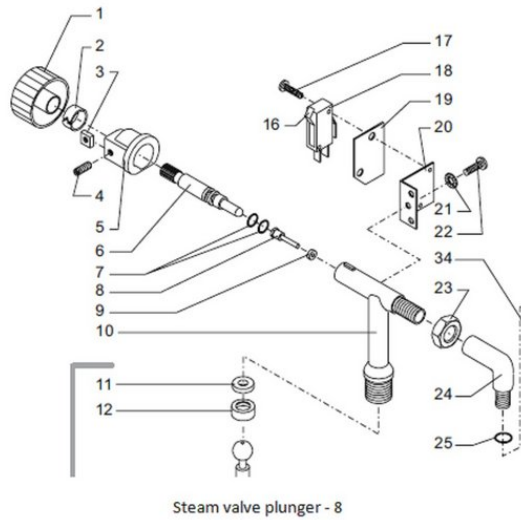
Step 8

- If the steam wand is still leaking after a second try, then the steam valve plunger needs to be replaced. This is part number 8 on the schematic. Overhaul kits can be acquired from sources like espressocare.com. You can follow the tear down instructions on this site, or some of the video sources on youtube.com.
