Pioneer FH-X730BS Deck Buttons Replacement

How to replace the Pioneer FH-X730BS buttons.

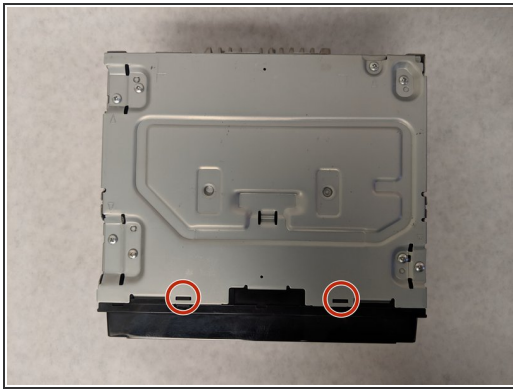
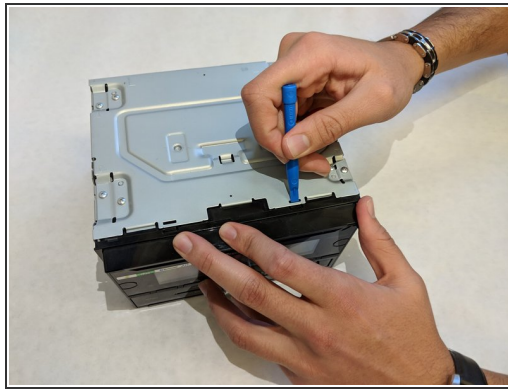
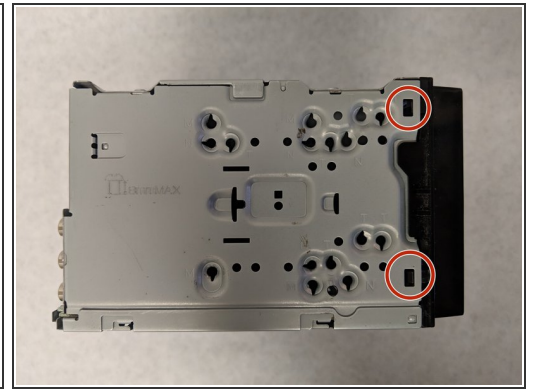
Step 1 — Deck Buttons

- Apply pressure to the tabs on each side using the plastic opening tool.
- You will need to pull the face away from the frame while unhooking the tabs.

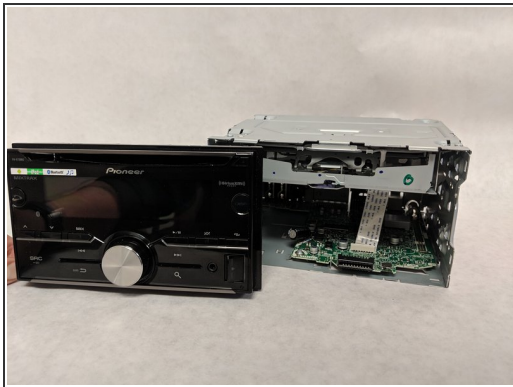
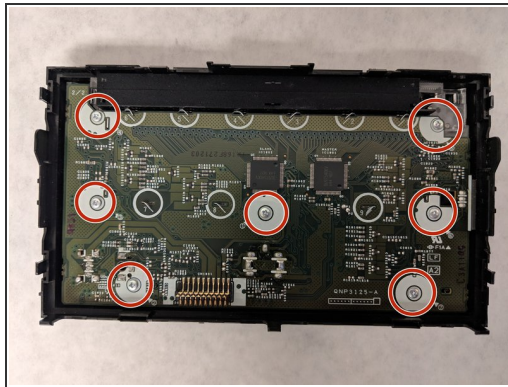
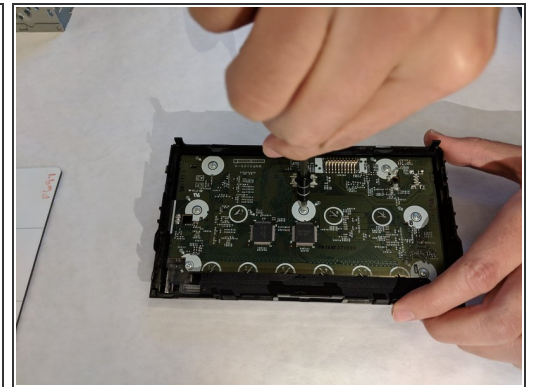
Step 2

- After removing the stereo face from the frame it should look similar to this.
- Remove the seven 11.2mm Phillips #1 screws on the rear side of the stereo face.

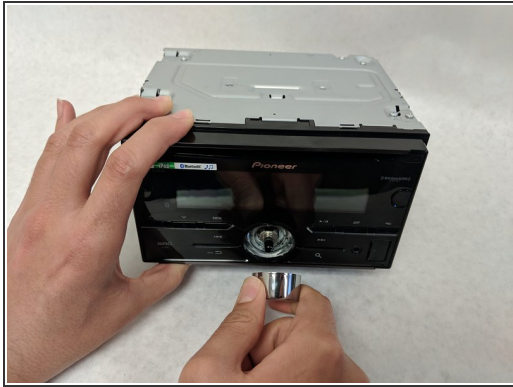
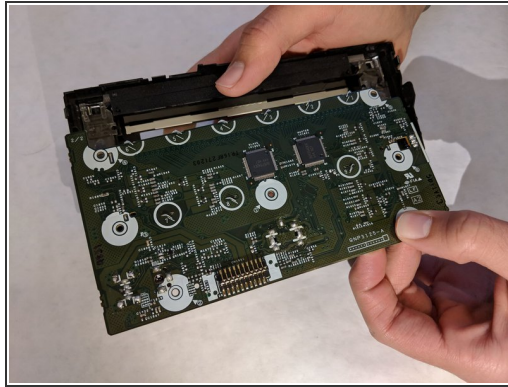
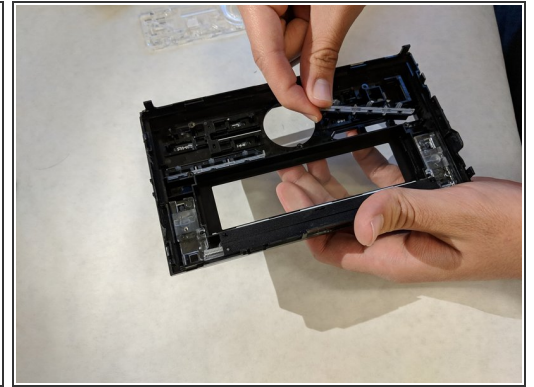
Step 3

- Remove the volume knob by pulling it towards you and pull the motherboard out of the face.
- The audio buttons can now be taken out. You can flip the face downwards and tap the audio buttons.
- You can now insert the replacement audio buttons into the face.
