Pioneer FH-X730BS Disk Drive Replacement

This guide shows you how to replace a Pioneer FH-X730BS disc drive.

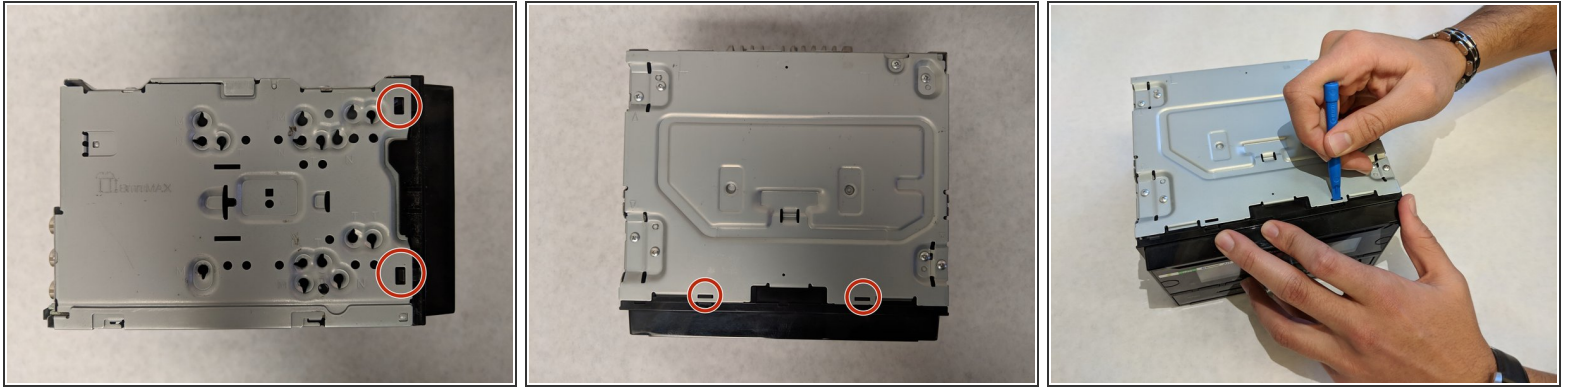
Step 1 — Disk Drive

- Apply pressure to the tabs on each side using the plastic opening tool.
- You will need to pull the face away from the frame while unhooking the tabs.

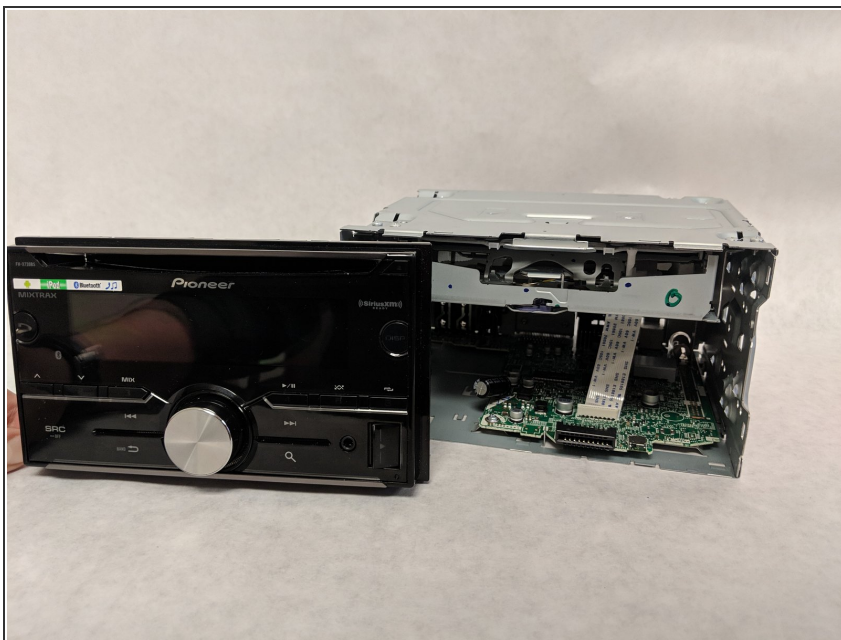
Step 2

- After removing the stereo face from the frame, it should look similar to this.

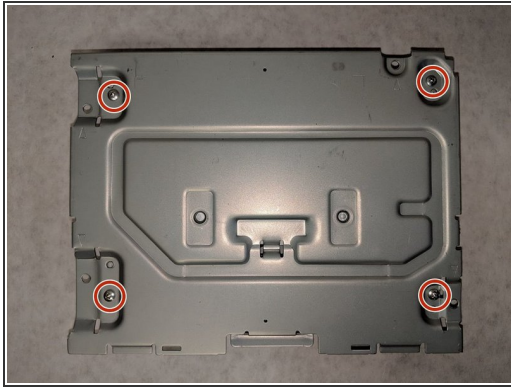
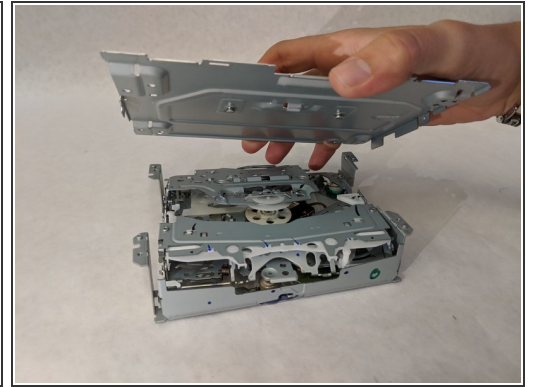
Step 5

- Unscrew the four inner screws that are 7.3 mm long using a Phillips #1 head screw driver to remove the disk drive from the top face plate.
- Replace the old disk drive with a new one.
