# Pioneer FH-X730BS Disk Drive Replacement

This guide shows you how to replace a Pioneer FH-X730BS disc drive.

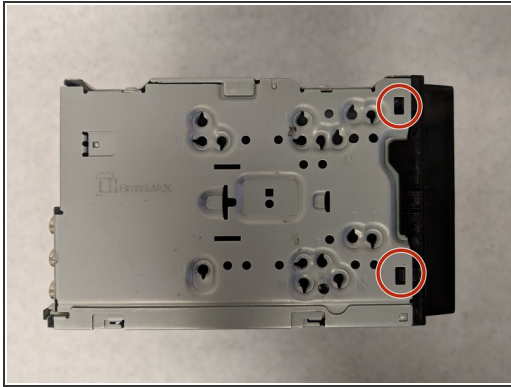
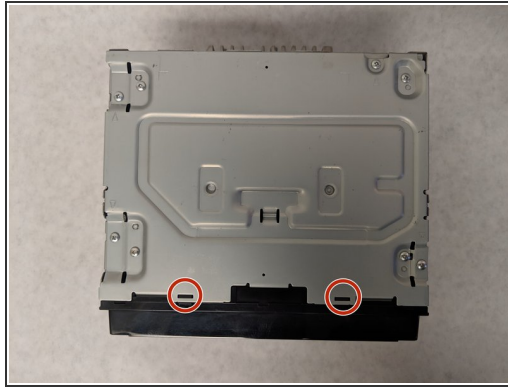
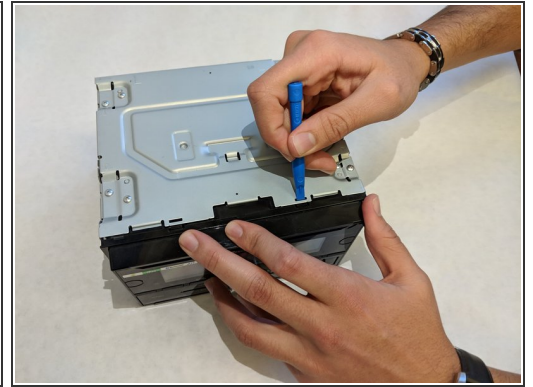
## Step 1 — Disk Drive

- Apply pressure to the tabs on each side using the plastic opening tool.
- You will need to pull the face away from the frame while unhooking the tabs.

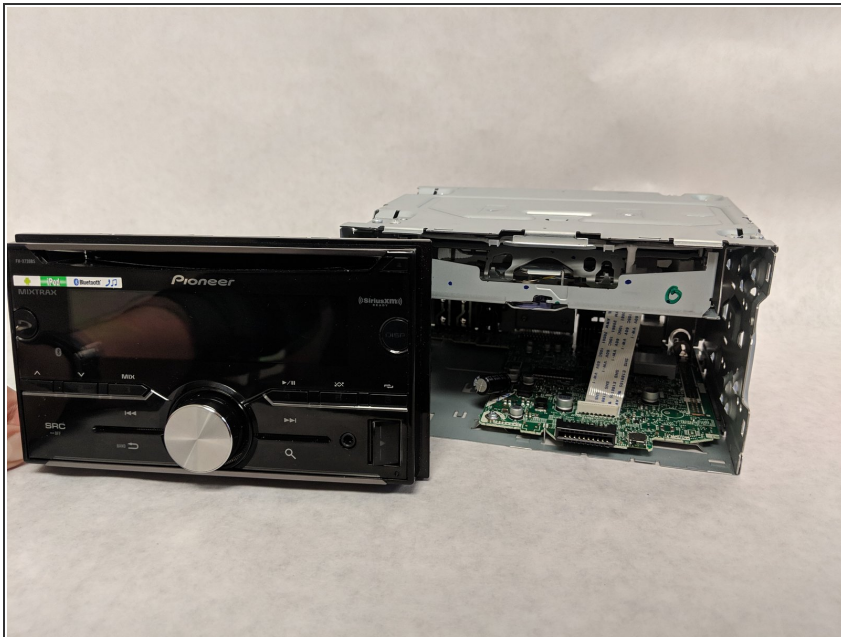
## Step 2

- After removing the stereo face from the frame, it should look similar to this.

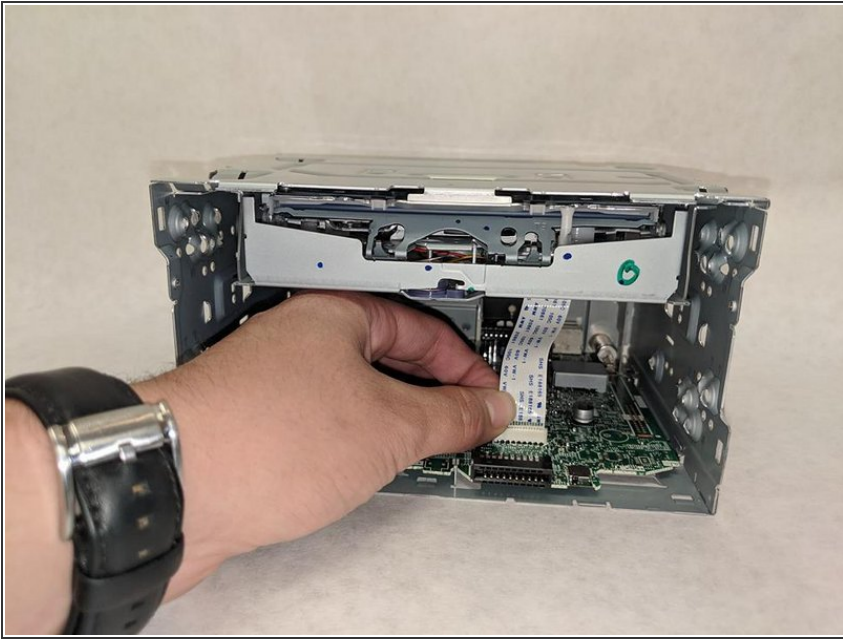
### Step 3

- Remove the ribbon wire from where it is being held in place. This can be done by applying force upwards.

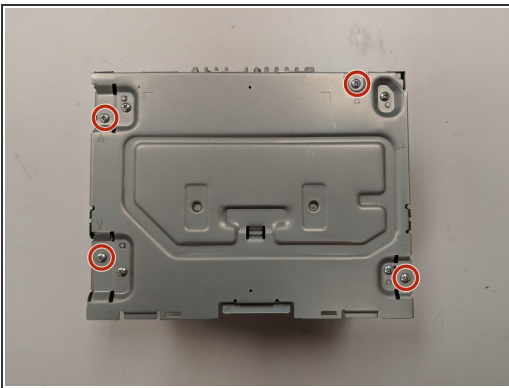
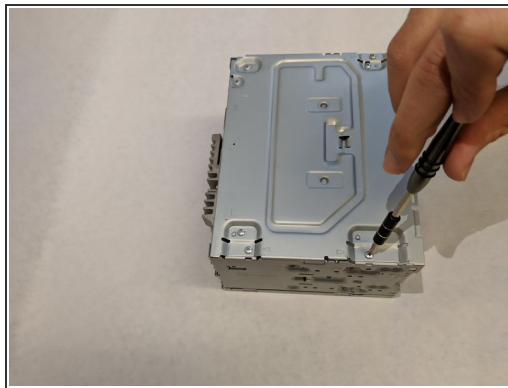
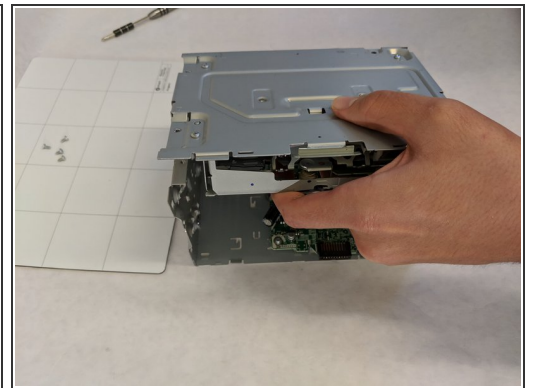
### Step 4

- Unscrew the four 7.3 mm outer screws on the top to remove the top face from the rest of the frame.

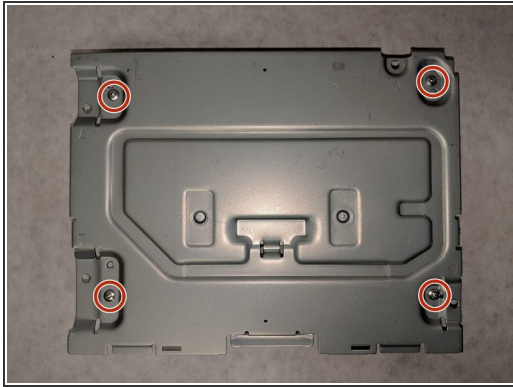
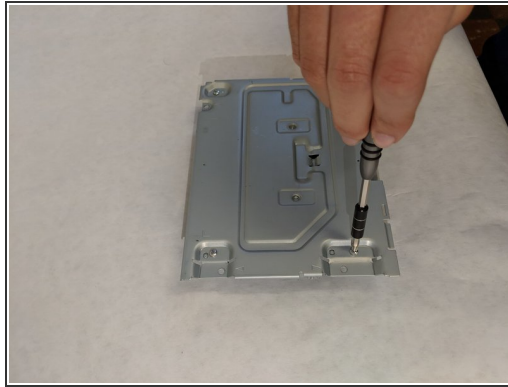
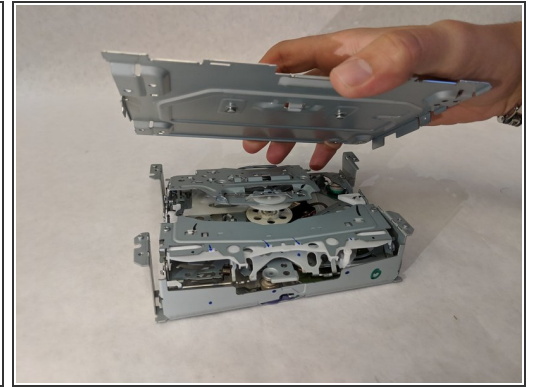
## Step 5

- Unscrew the four inner screws that are 7.3 mm long using a Phillips #1 head screw driver to remove the disk drive from the top face plate.
- Replace the old disk drive with a new one.
