Lenovo Thinkpad Tablet 1838 Camera Replacement

In this guide we will replace the camera and ribbon cable.

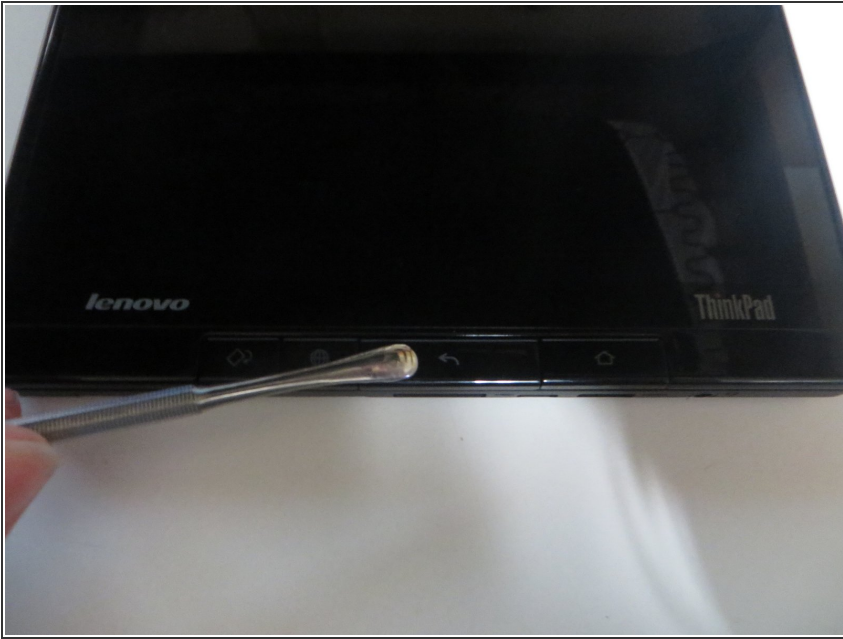
Step 1 — Camera

- Start by removing the button covers by prying them off.

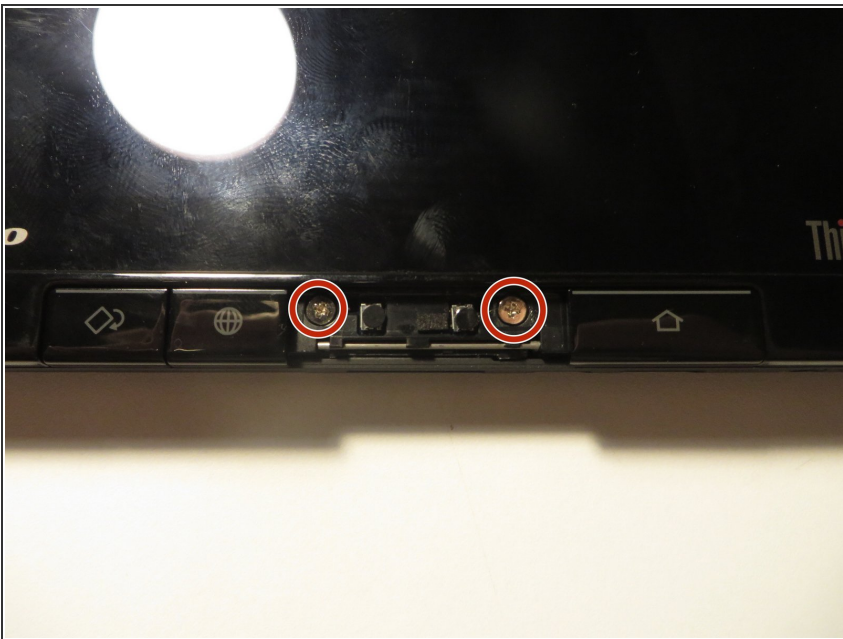
Step 2

- Next Remove the two screw found under the buttons.

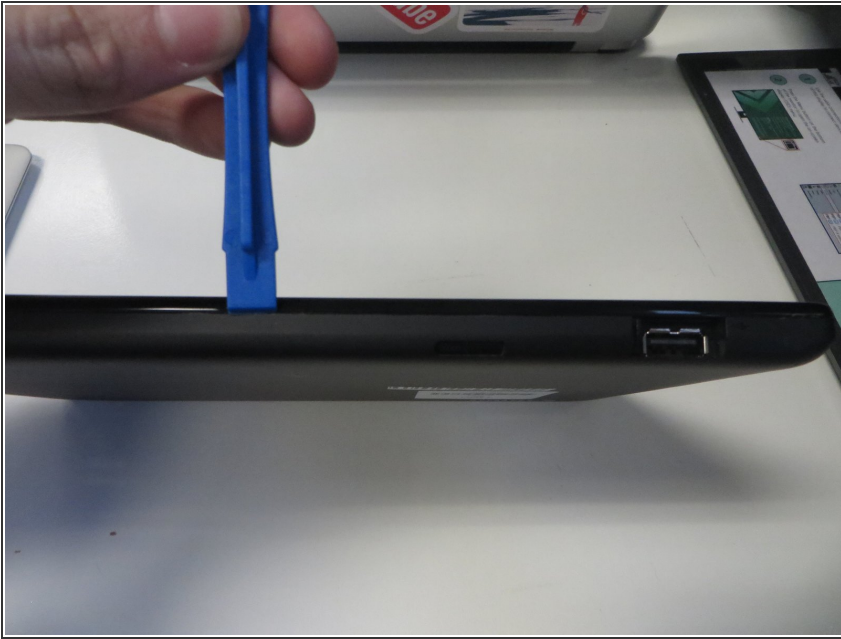
Step 3

- Using a plastic opening tool carefully pry open the the outer perimeter of the tablet.

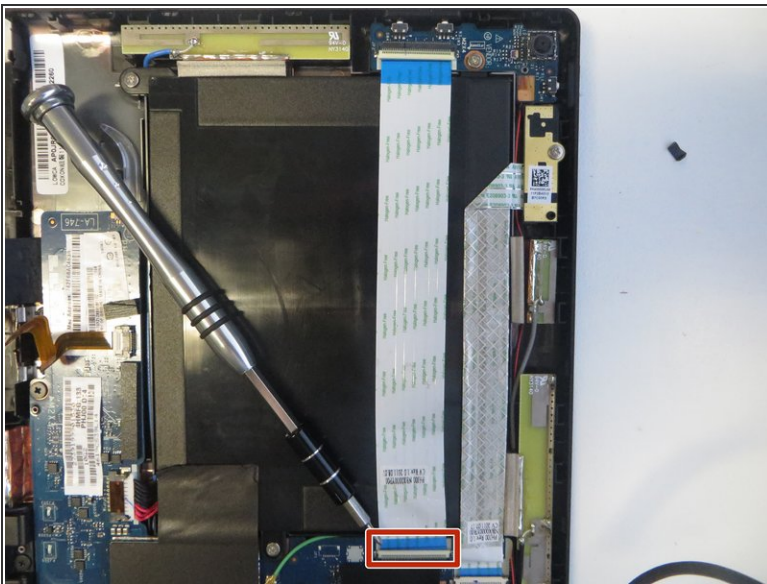
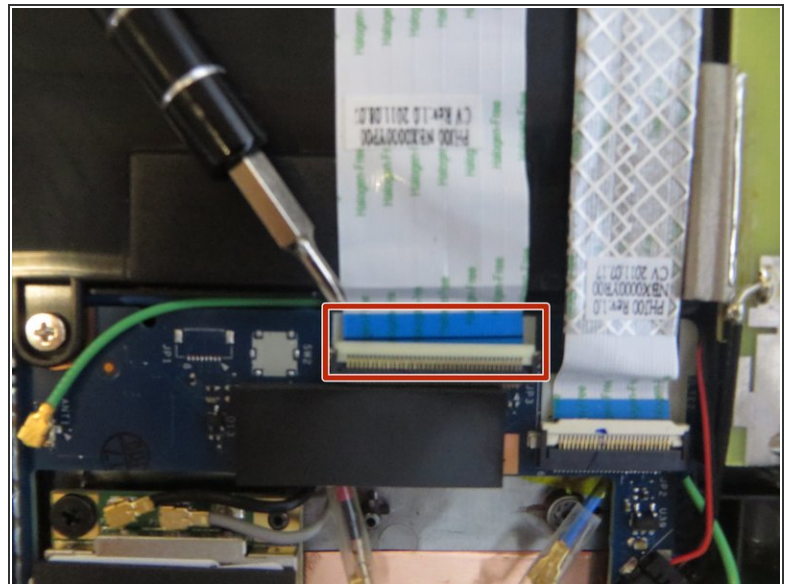
Step 4

- Next remove the ribbon cable lift up the tab on the back end and slide it out.
- ⓘ Only the back side of the cable has been removed—the other can remain connected.

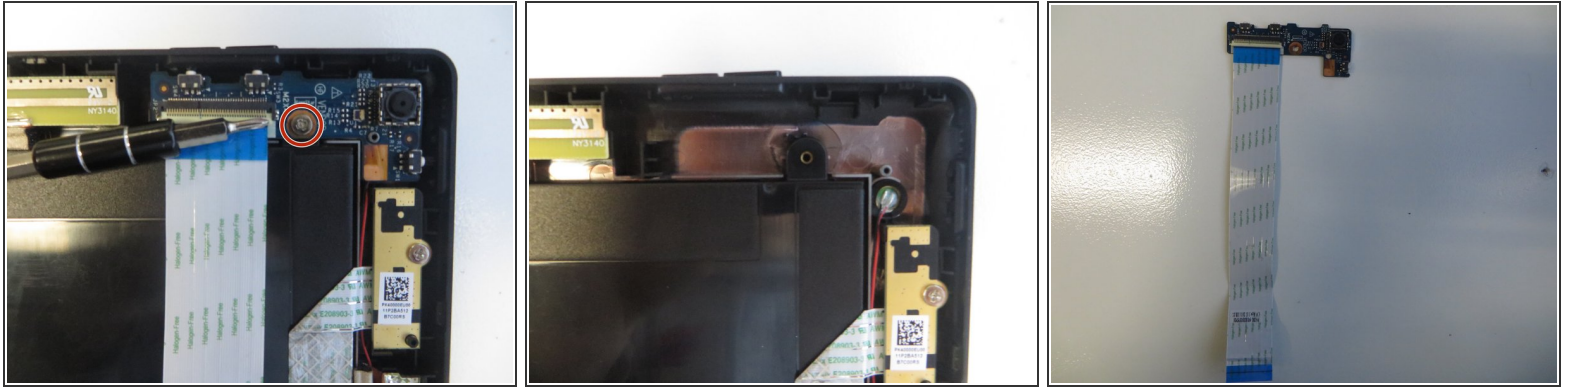
Step 5

- Remove this screw and lift out the whole assembly.
