Asus Vivobook Q301LA-BHI5T02 Hard Drive Replacement

How to replace a Asus Vivobook Q301LA-BHI5T02 hard drive.

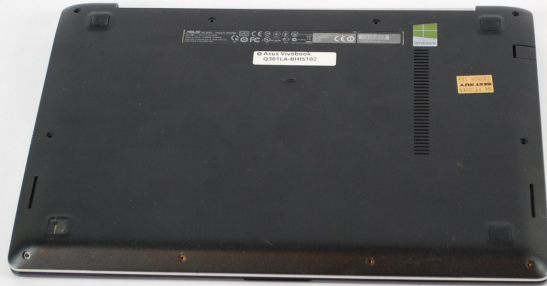
Step 1 — Back Cover

- ⓘ Make sure the computer is turned off.
- Flip the device over so that the back cover is facing you.

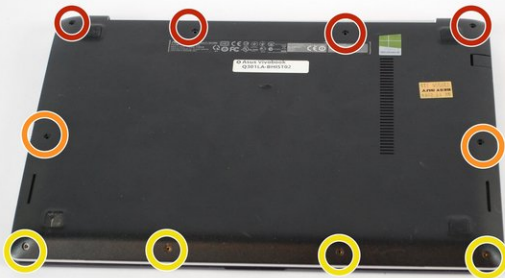
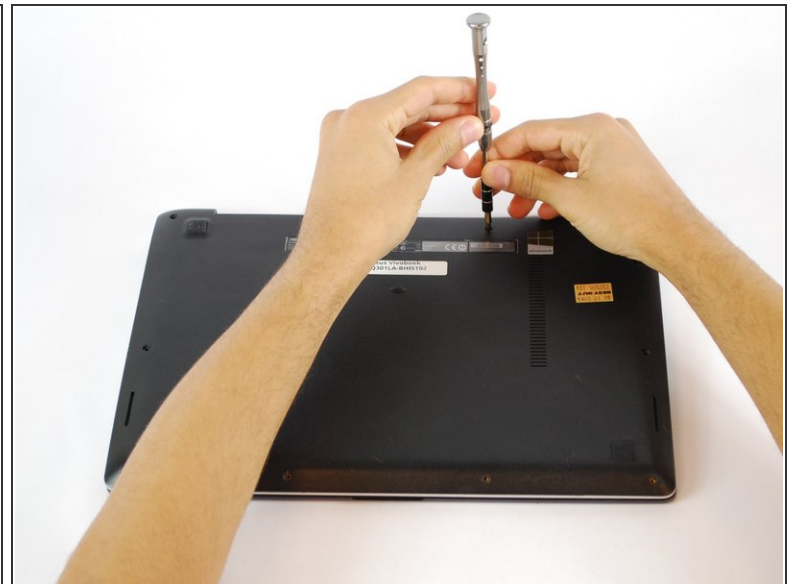
Step 2

- Remove the four 5mm Phillips #1 screws from the top of the laptop.
- Remove the two 6mm Phillips #1 screws from the sides of the laptop.
- Remove the four 2mm Phillips #1 screws from the bottom of the laptop.

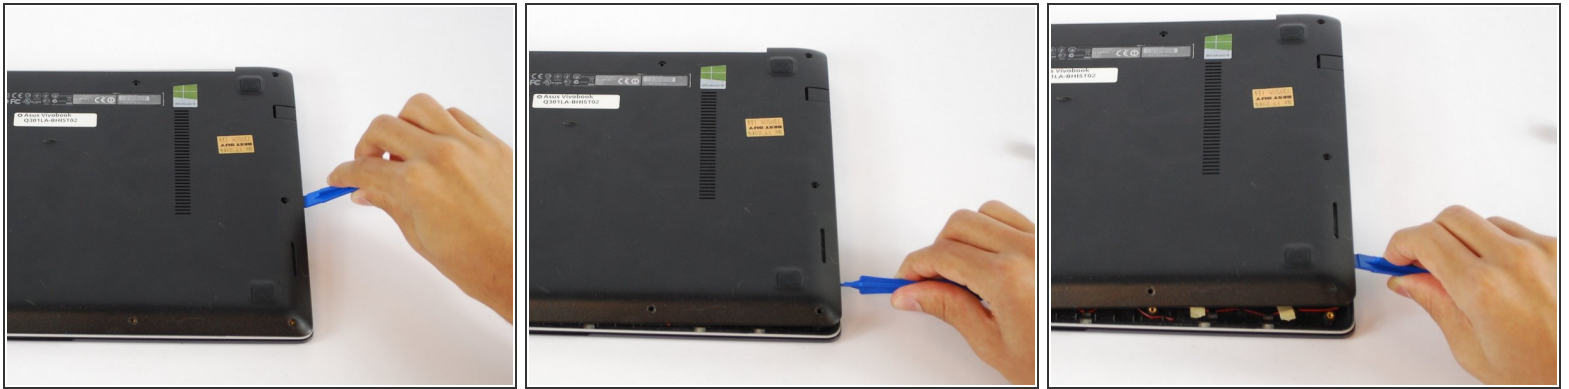
Step 3

- Use a plastic opening tool to gently pry the bottom of the laptop up. Slowly slide it along the edges, twisting it every so often to pop the bottom of the laptop out of the clips holding it in place.

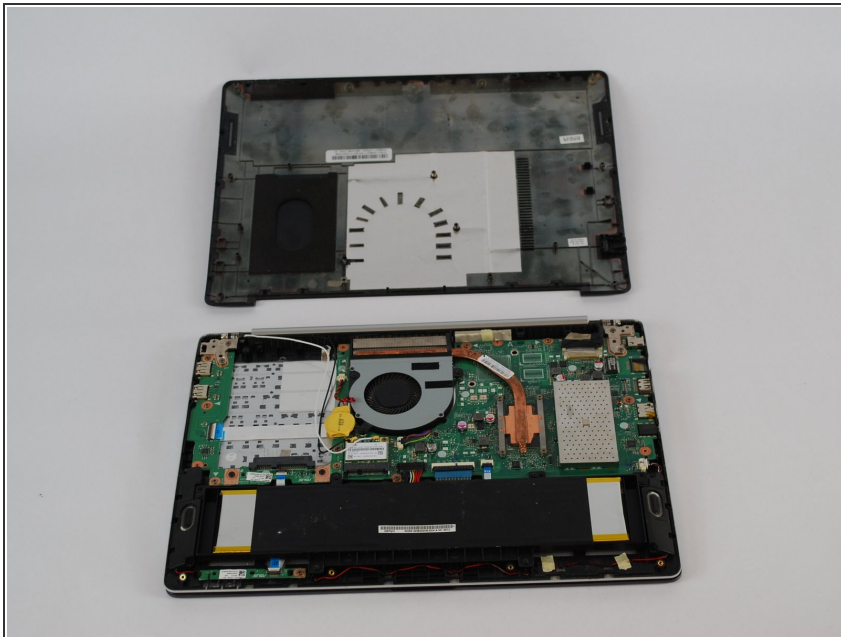
Step 4

- Lift off the cover and remove the back cover from the device.

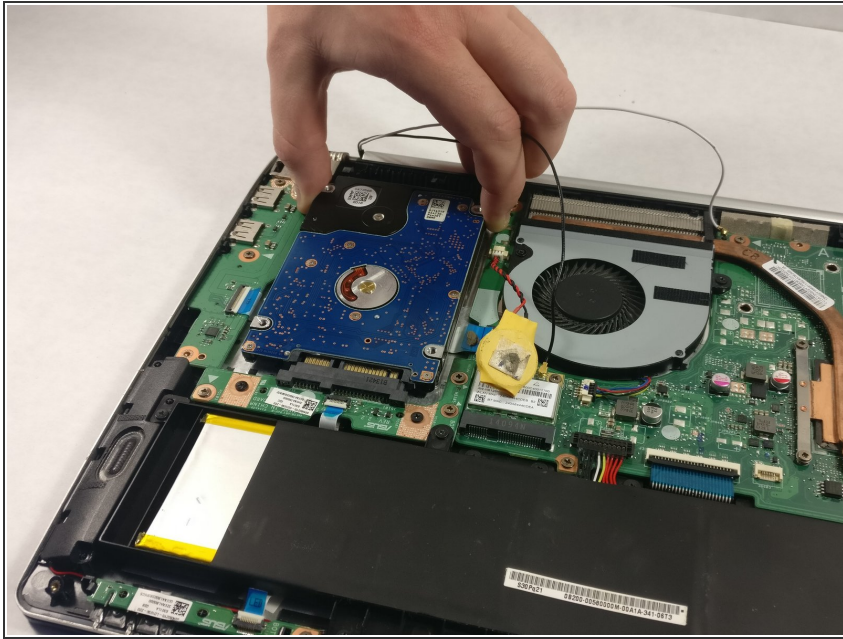
Step 5 — Hard Drive

- Slide the hard drive out of the SATA port and remove it from the device.

To reassemble your device, follow these instructions in reverse order.
