Asus Vivobook Q301LA-BHI5T02 Hard Drive Replacement

How to replace a Asus Vivobook Q301LA-BHI5T02 hard drive.

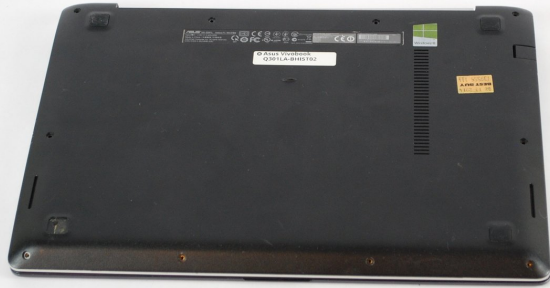
Step 1 — Back Cover

- ❗ Make sure the computer is turned off.
- Flip the device over so that the back cover is facing you.

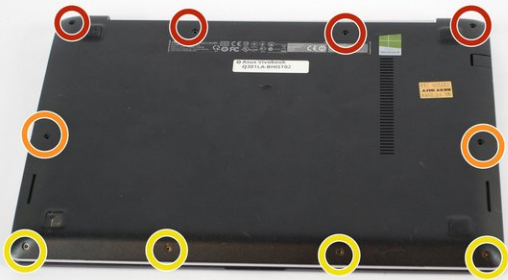
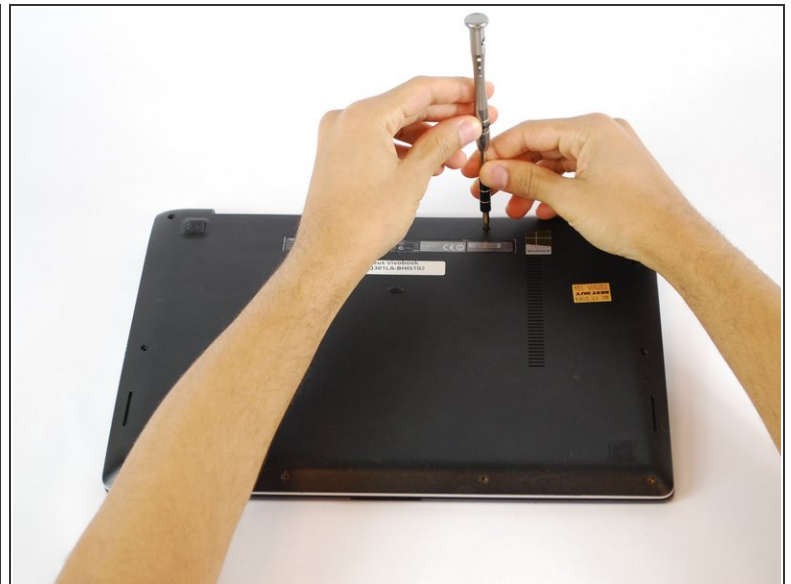
Step 2

- Remove the four 5mm Phillips #1 screws from the top of the laptop.
- Remove the two 6mm Phillips #1 screws from the sides of the laptop.
- Remove the four 2mm Phillips #1 screws from the bottom of the laptop.

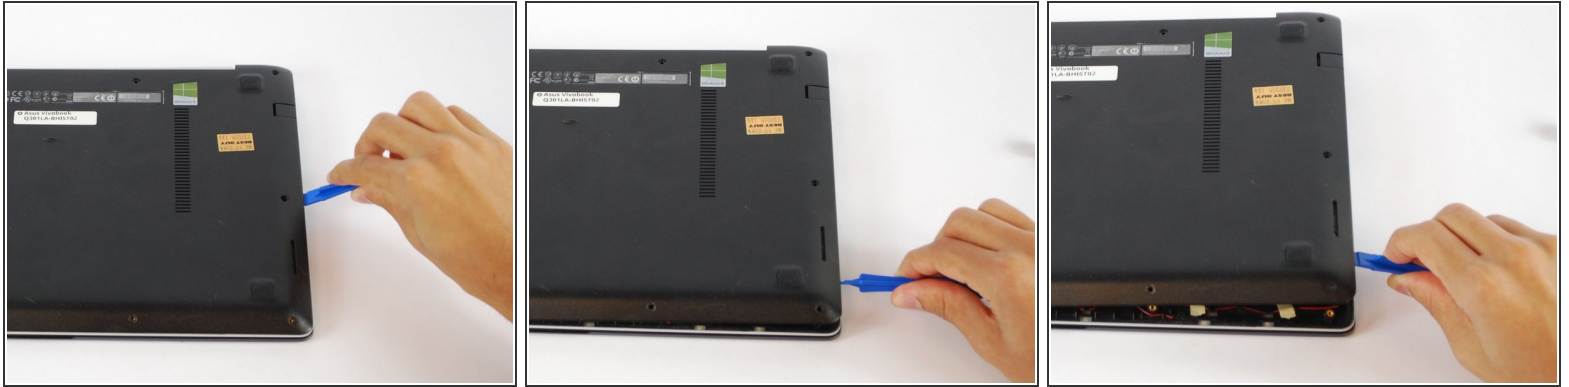
Step 3

- Use a plastic opening tool to gently pry the bottom of the laptop up. Slowly slide it along the edges, twisting it every so often to pop the bottom of the laptop out of the clips holding it in place.

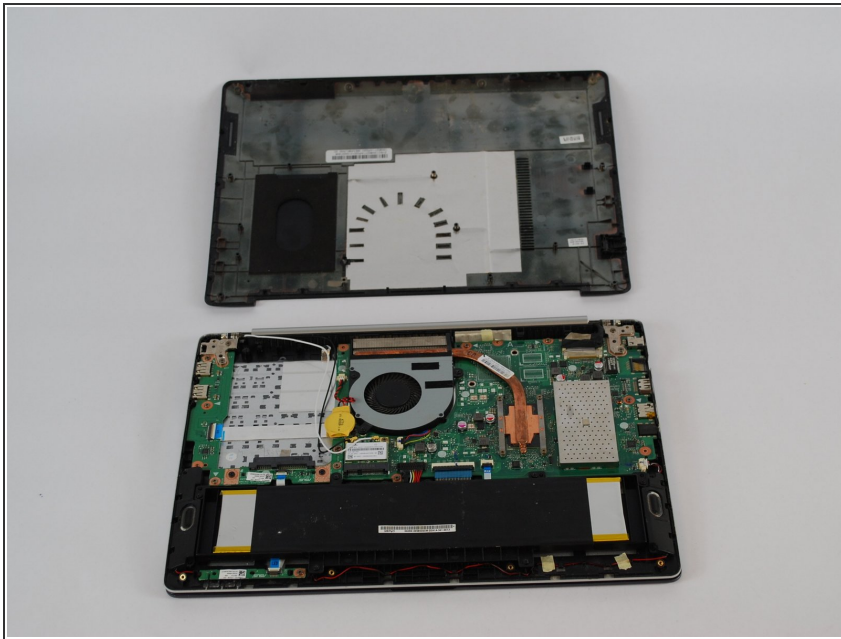
Step 4

- Lift off the cover and remove the back cover from the device.

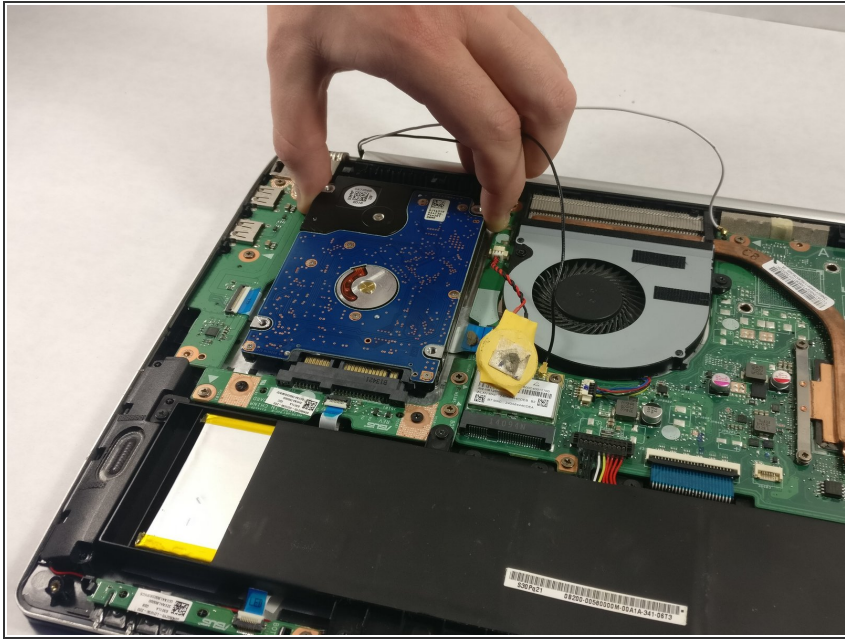
Step 5 — Hard Drive

- Slide the hard drive out of the SATA port and remove it from the device.

To reassemble your device, follow these instructions in reverse order.
