iPhone 11 Pro Back Glass Replacement

iPhone 11 Pro Back Glass Replacement/Repair

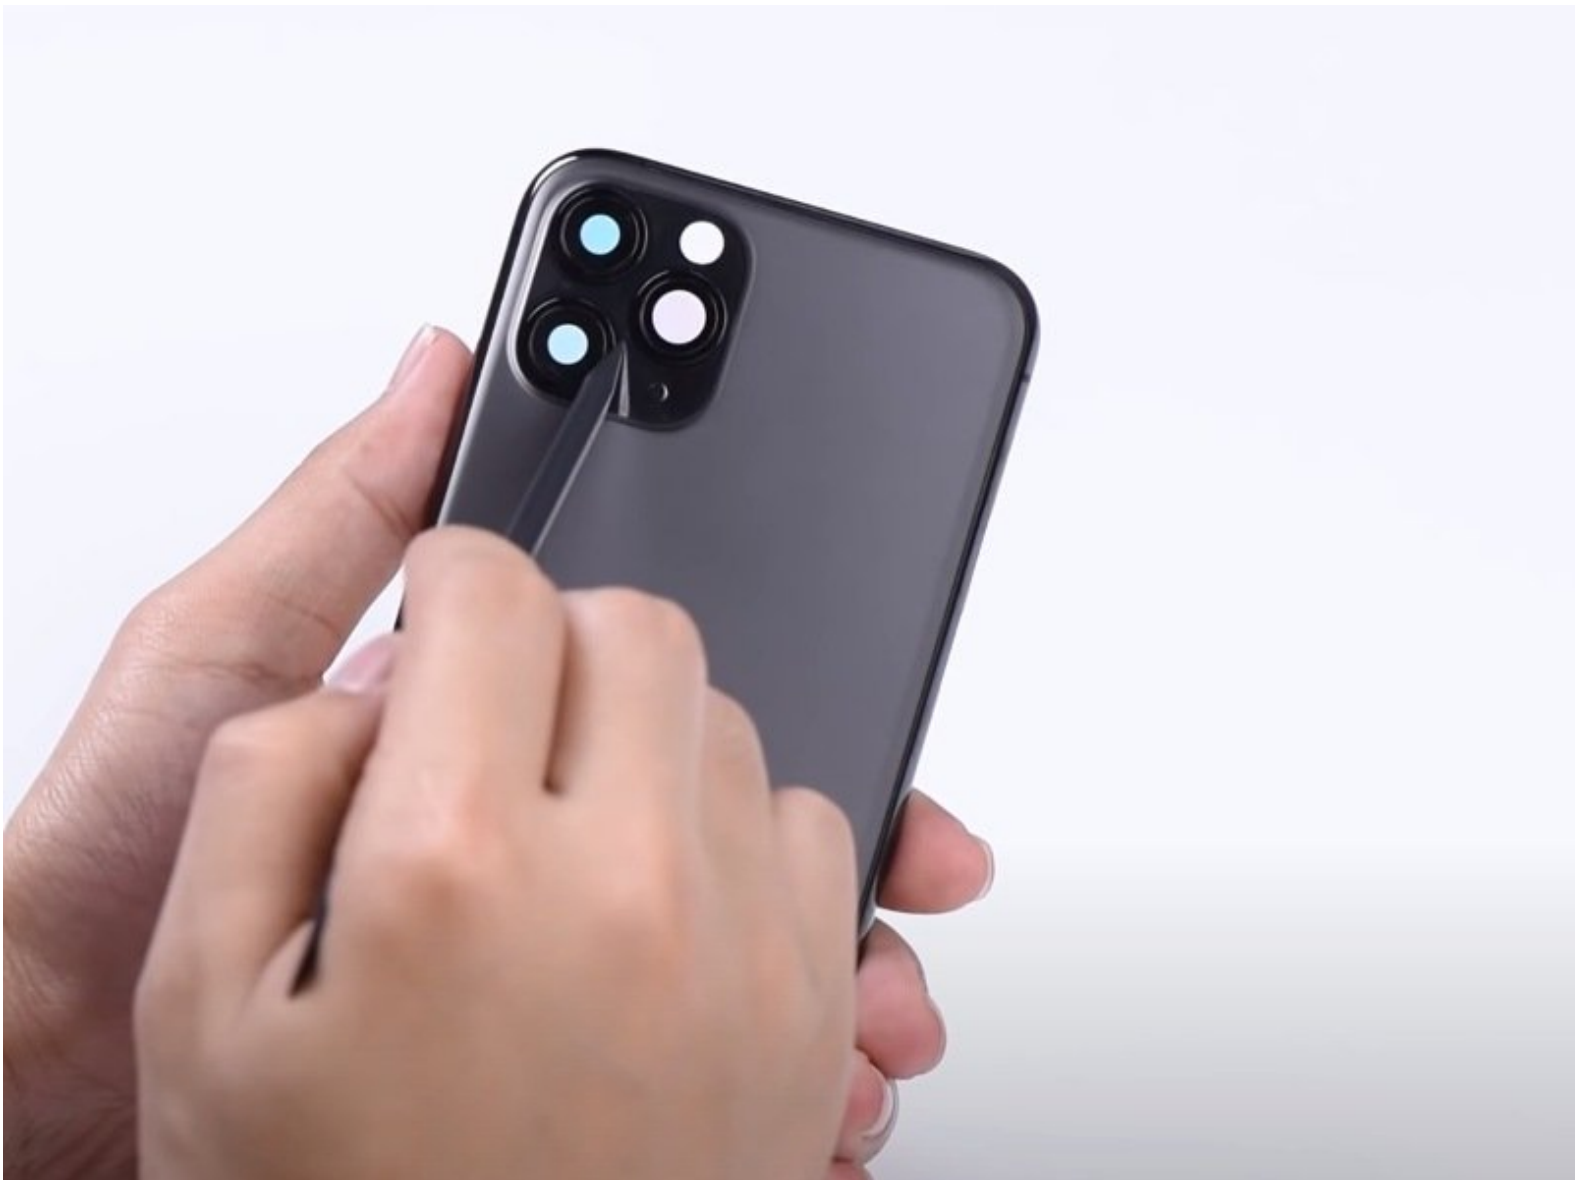
iPhone 11 Pro is made of a surgical grade stainless steel, and on its back is a single piece of machine glass with an optical PVD coating, adding to the difficulty of repair. What's more, the arrangement of rear cameras of iPhone 11 Pro also greatly increases the difficulty of back glass repair. A full housing replacement is often more practical, especially as a DIY—but if you have the proper equipment, the technique shown here can work too.

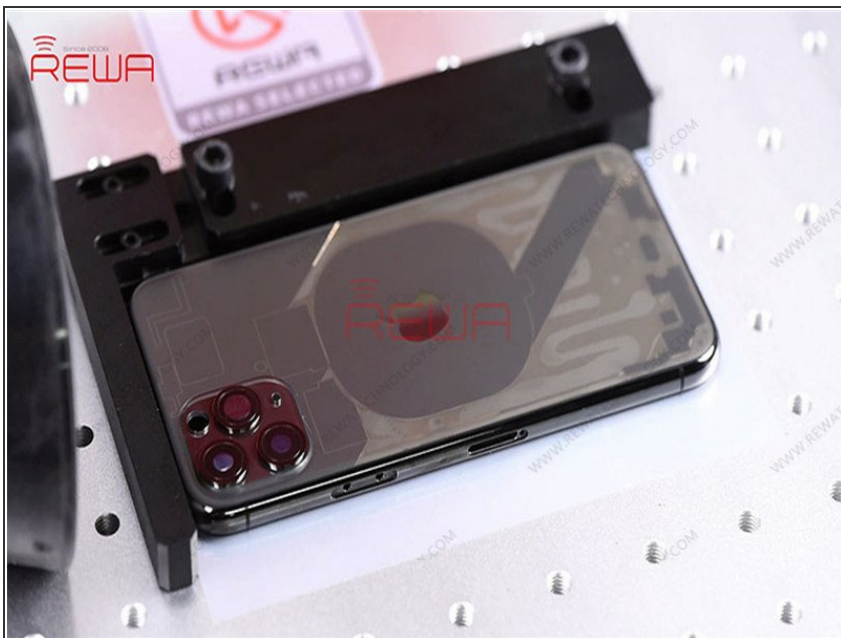
Step 2 — Scan The Back Glass With Laser

- Adjust the laser light scanning area on the back glass.
- Once finished, get the parameter set and click 'Mark' to scan the back glass with the laser light.

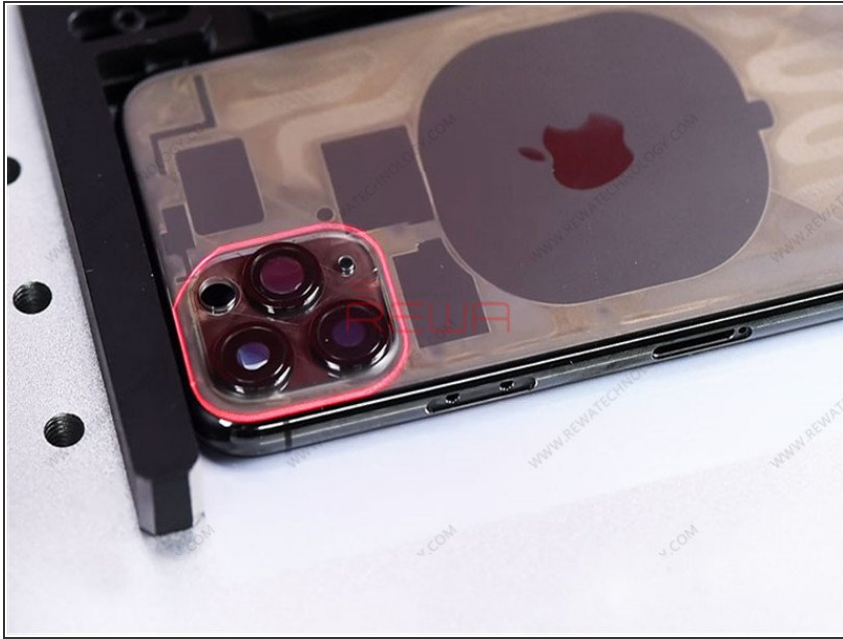
Step 3 — Scan The Glass Around The Triple-lens Camera With Laser

- The laser light scanning didn't work well with the triple-lens camera area here.
- After several attempts and experiments, REWA LAB successfully completed a specialized drawing for the triple-lens camera area.
- Scan the triple-lens camera area again with the laser with the help of the drawing.

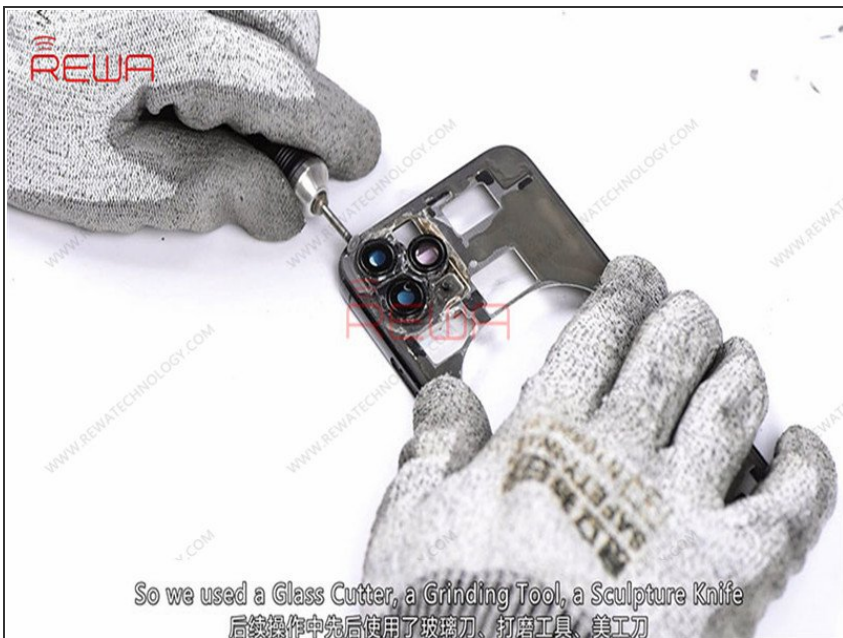
Step 4 — Separate The Back Glass From The Mid-frame

- The scanned back glass can be separated easily. However, the glass around the triple-lens camera needs further operation.
- Our commonly used tools failed to remove the glass here, so we used a glass cutter, a grinding tool, a Sculpture Knife and a Cutting Nipper to remove the glass around the triple-lens camera.
- Once completed, remove residual black adhesive with the Laser Machine.

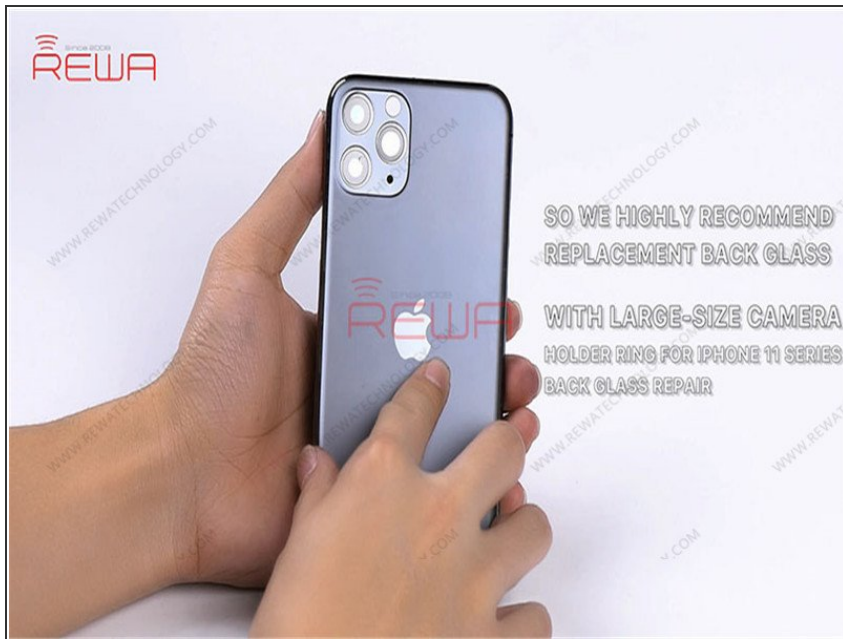
Step 5 — Big Hole Back Glass

- The camera holder ring of iPhone 11 series is harder and comes with thick inside walls, adding to the difficulty of polishing. Meanwhile, the camera lens can also be easily damaged during polishing.
- So we highly recommend replacement back glass with a big camera hole for iPhone 11 series back glass repair.

Due to the special arrangement of the three cameras of iPhone 11 Pro, the space between the three cameras is also narrow, adding to the difficulty of back glass separating. Therefore, the Laser Machine may be the safest and most efficient solution for iPhone 11 Pro back glass repair.
