SteelSeries Arctis Pro Headset Mute Button Cap Replacement

If the mute button is stuck or has stopped...

Written By: Matthew Hockey

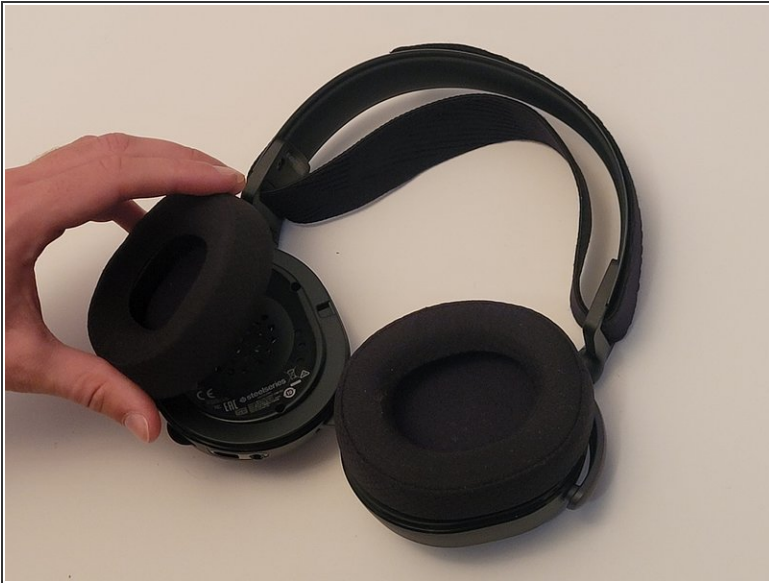
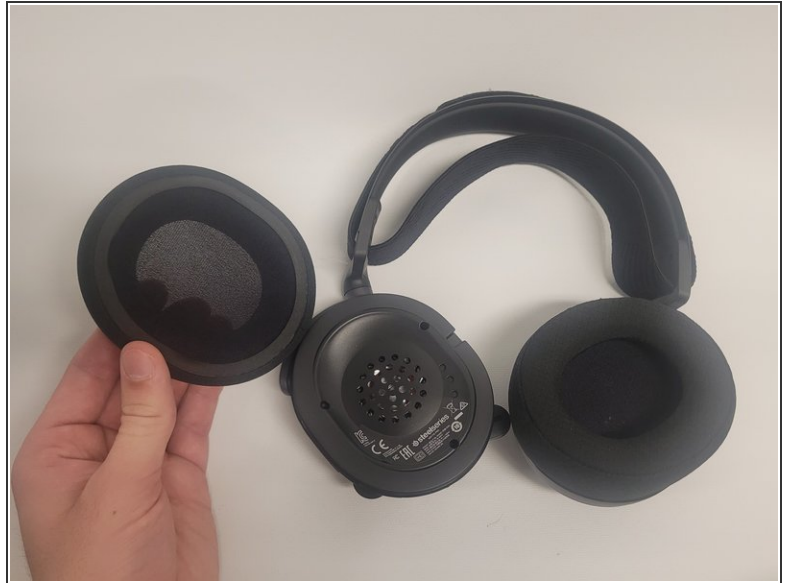
Step 1 — Headset Mute Button Cap

- Remove the ear cushion by pulling the edge up and towards yourself
- Repeat this motion all the way around the ear cushion until it comes free

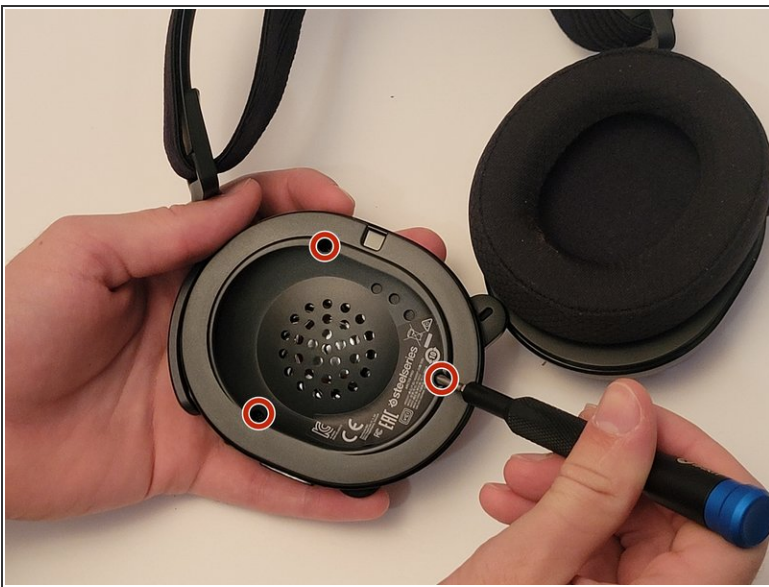
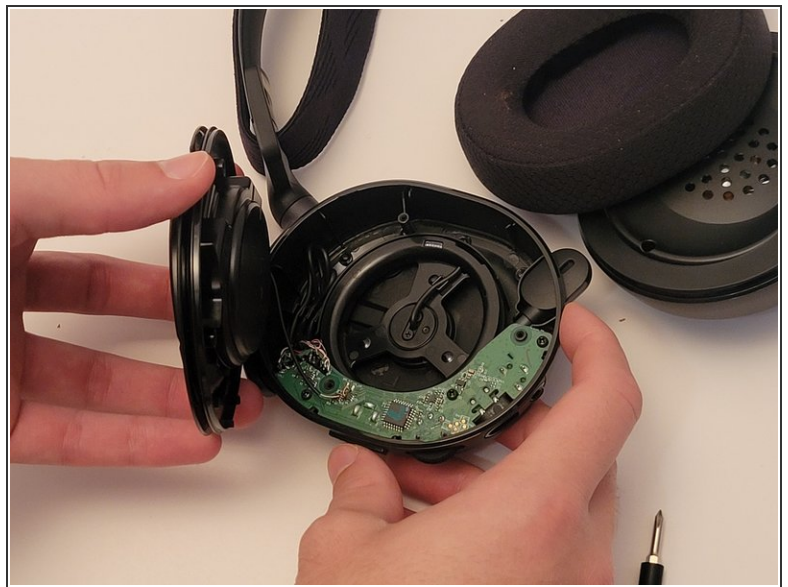
Step 2

- Use a Phillips #0 screwdriver to remove the 3 case screws.
- Remove the driver assembly from the rest of the housing

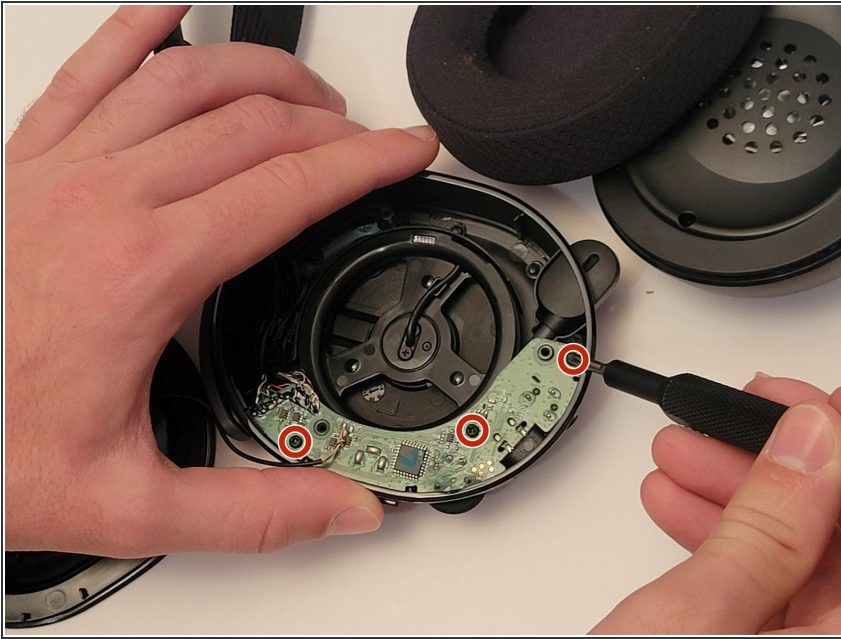
Step 3

- Use a Phillips #0 screwdriver to remove the three 5 mm screws.

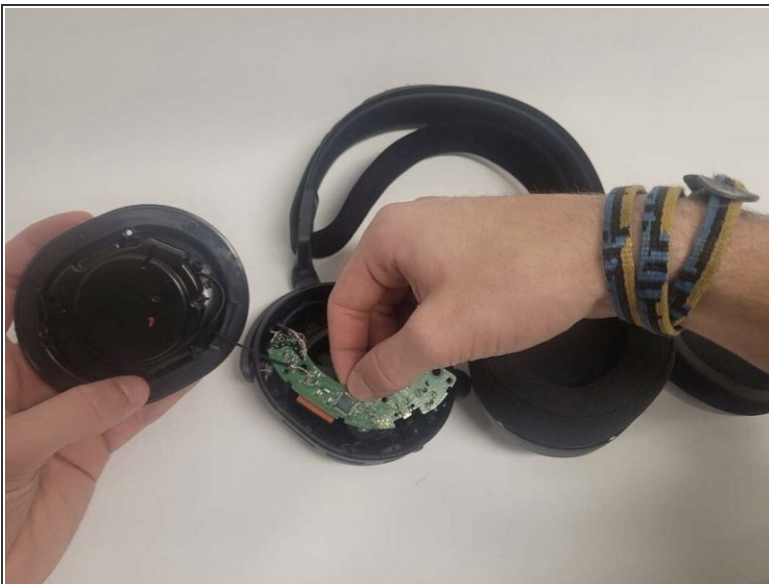
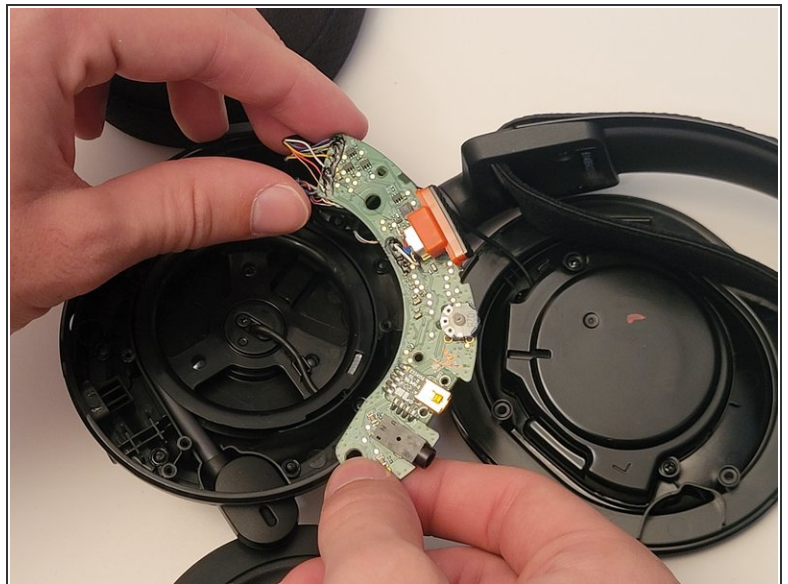
Step 4

- Remove the circuit board by pushing the scroll wheel out of the board and pulling it from the other side.

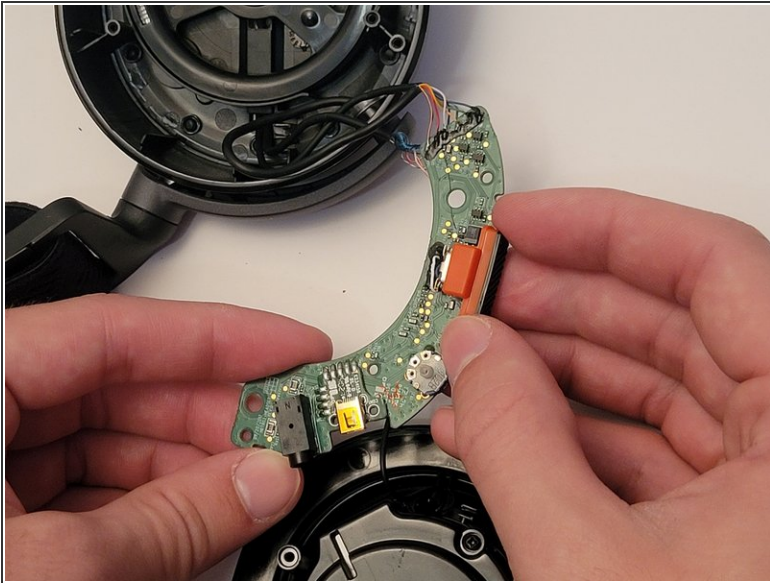
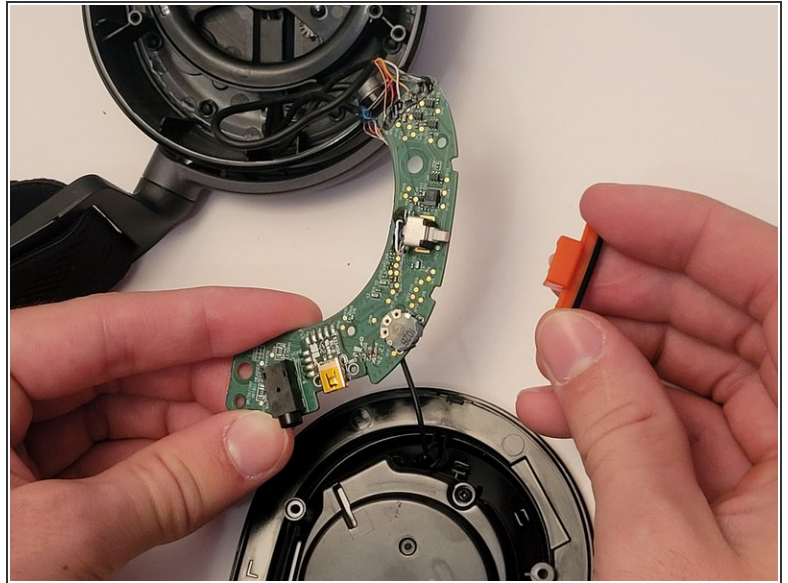
Step 5

- Grab the keycap and pull outwards till it comes free

To reassemble your device, follow these instructions in reverse order.
