Mercedes W123 Sway Bar Link Replacement

The rear sway bar is connected to the hub assembly by what is called a sway bar link. Over the years the boots that protect the joints split, allowing in dirt and moisture, eventually ruining the joint. This can create a lot of noise from the rear.

Written By: Nicolas Siemsen

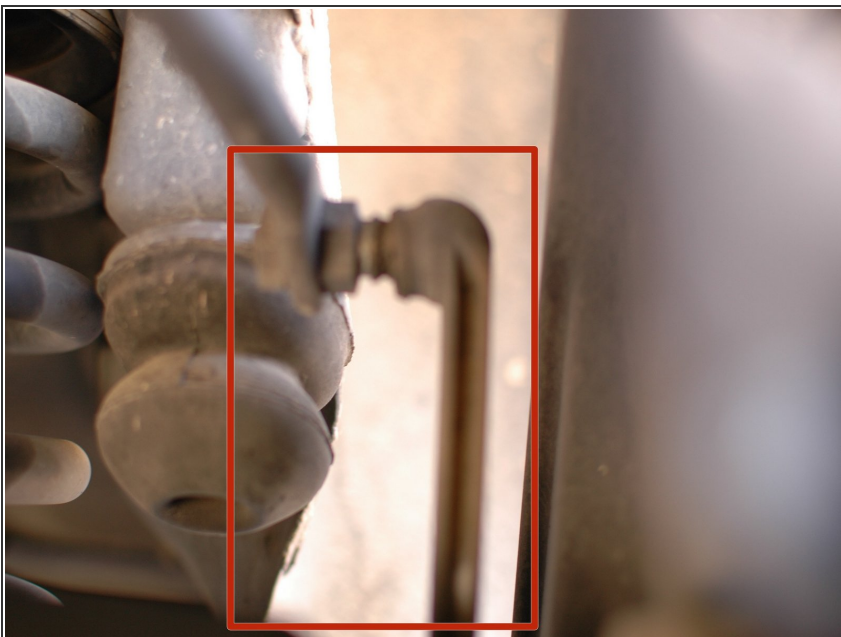
Step 2

- You can see here the sway bar link where it attaches to the sway bar. It's hidden partially behind the brake shield. It's tricky to take a good picture of...
- The threaded portion of the link goes through a hole in the sway bar end and is held in place by a nut.

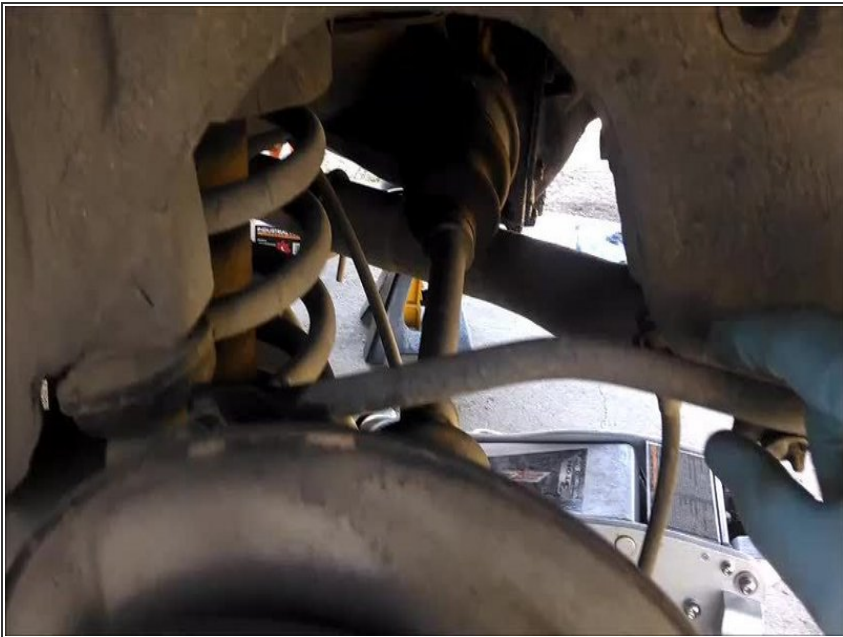
Step 4

- View this video to hear what a bad sway bar link sounds like when you move the sway bar around. If yours sounds like this is definitely time to replace it.

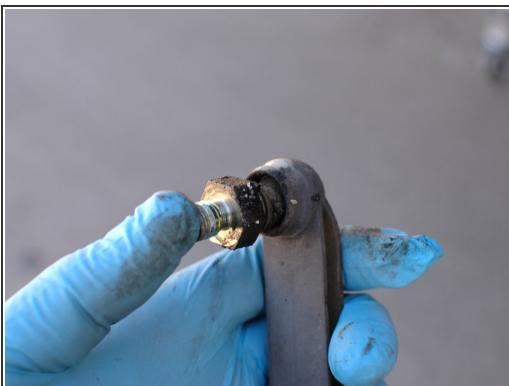
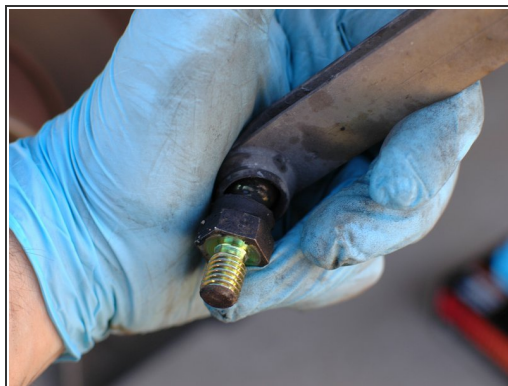
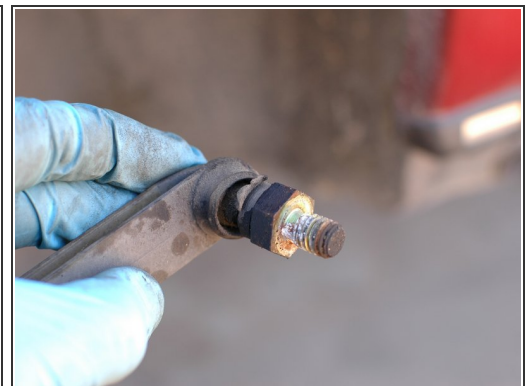
Step 6

- Pictured are example of the joints on the two sway bar links that were removed from this 1985 300D. Each one is split or even missing.
- You can see how this exposes the joint to moisture, dust, and road debris; this quickly ruins the joint.

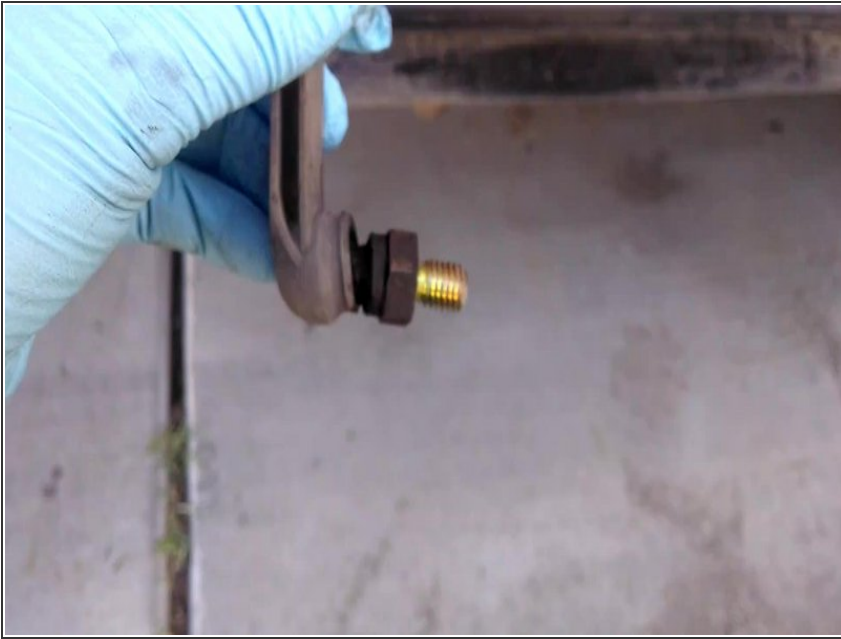
Step 7

- Watch this video to see how loose the bottom joint on this sway bar link was. It was half of the culprit for the clunking. The other side was just as bad.
