Mercedes W123 Sway Bar Link Replacement

The rear sway bar is connected to the hub assembly by what is called a sway bar link. Over the years the boots that protect the joints split, allowing in dirt and moisture, eventually ruining the joint. This can create a lot of noise from the rear.

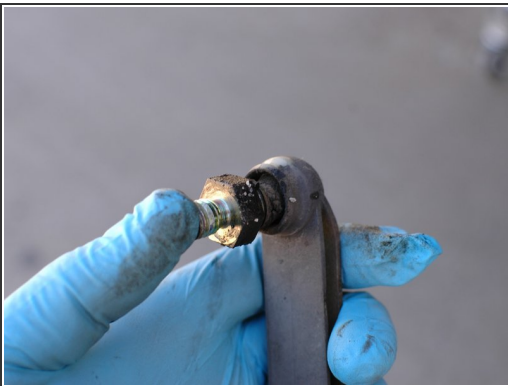
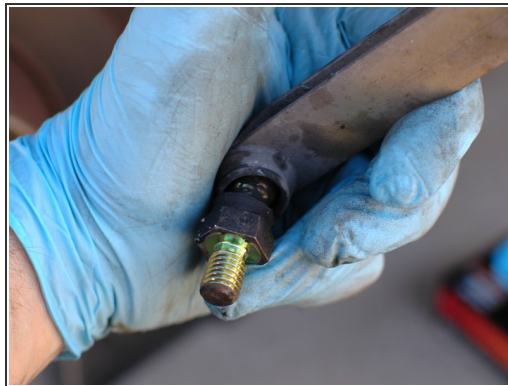
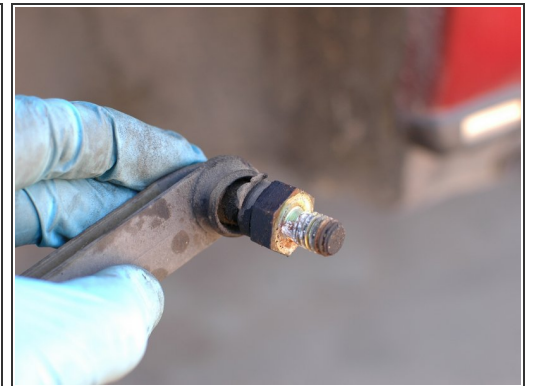
Step 6

- Pictured are example of the joints on the two sway bar links that were removed from this 1985 300D. Each one is split or even missing.
- You can see how this exposes the joint to moisture, dust, and road debris; this quickly ruins the joint.

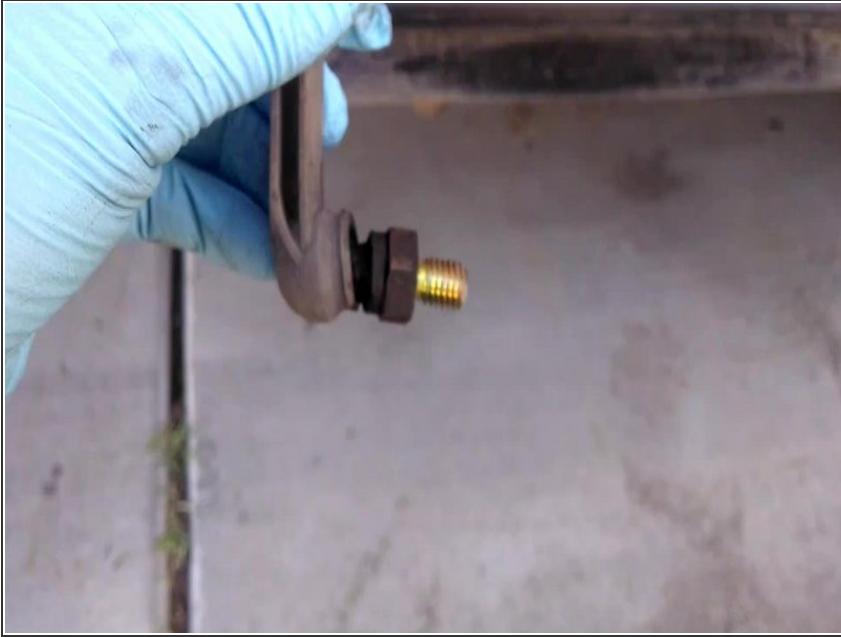
Step 7

- Watch this video to see how loose the bottom joint on this sway bar link was. It was half of the culprit for the clunking. The other side was just as bad.
