Durofix RV332 Control Button Replacement

This guide will demonstrate how to properly replace a defective control button on a Durofix RV332 Cordless Li-ion Screwdriver.

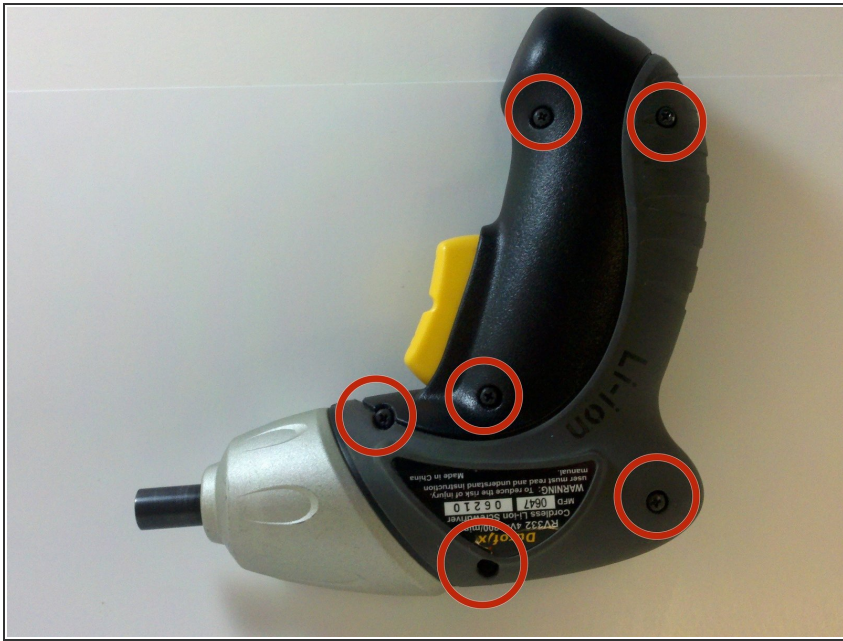
Step 1 — Control Button

- Remove the six 13 mm casing screws with a #0 Phillips screwdriver.

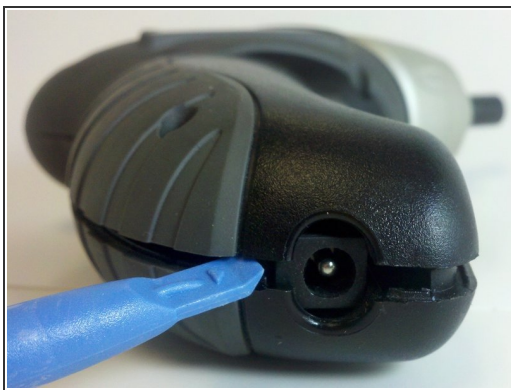
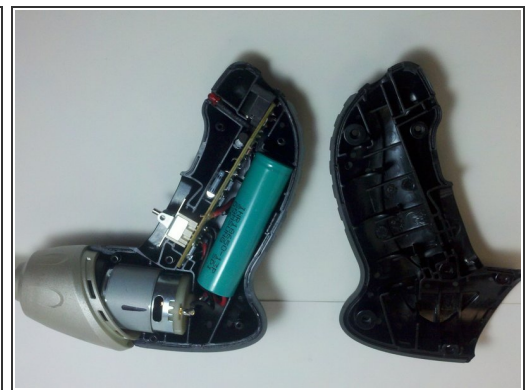
Step 2

- Separate screwdriver casing halves with a plastic opening tool.

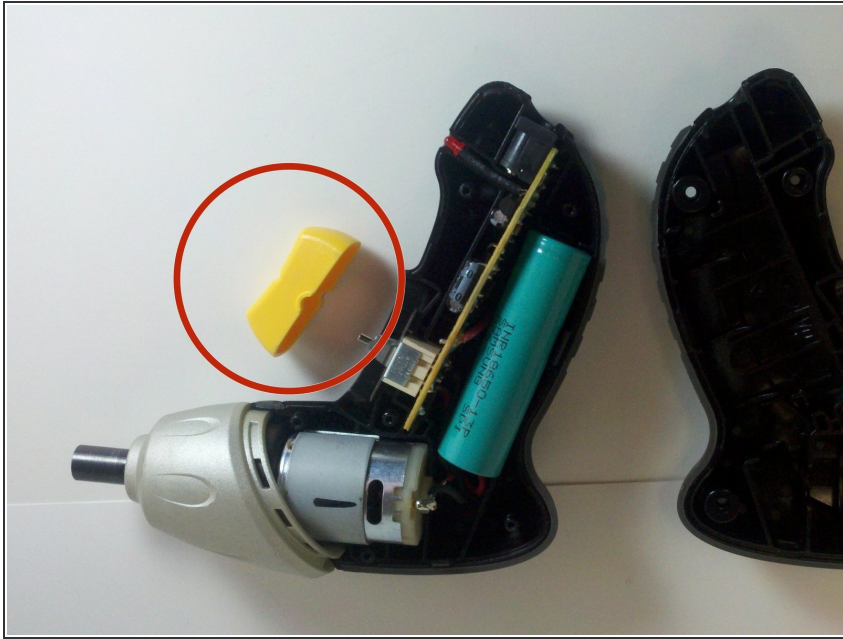
Step 3

- Remove the yellow plastic control button from the screwdriver casing.
- With the defective button removed, replace with a new control button.

To reassemble your device, follow these instructions in reverse order.
