Repairing a Panasonic SA-HT810V with the H02/H07 error

This guide describes how to fix the H02/H07 error that is common with Panasonic DVD/VCR players.

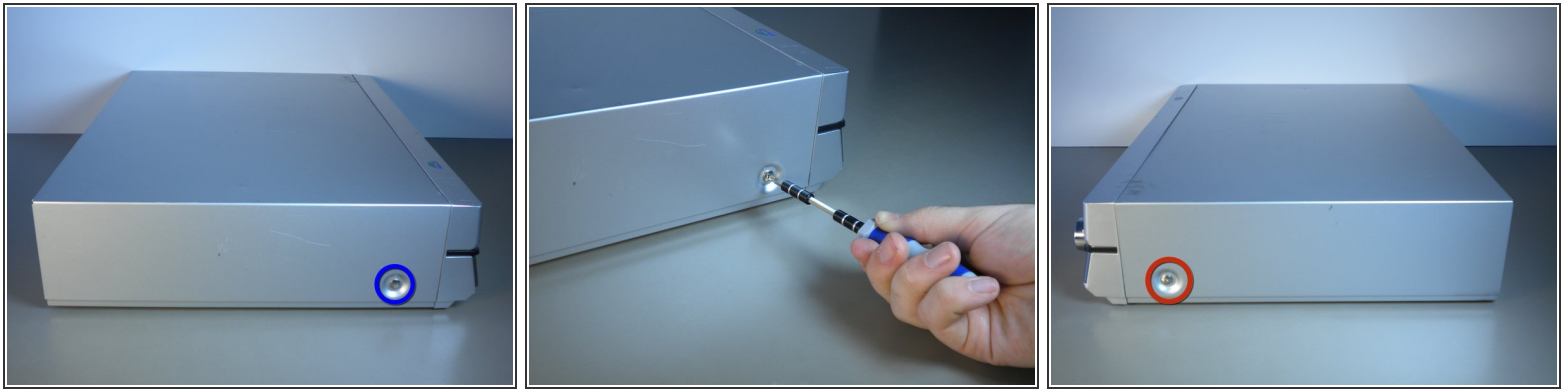
Step 1 — Repairing a Panasonic SA-HT810V with the H02/H07 error

- With the front display of the device facing you, rotate the device 90 degrees counter clockwise.
- Remove the screw that is on the right side of the panel facing you.
- Now rotate the device 180 degrees and remove the second screw.
 - Remove all screws with a phillips head screwdriver.

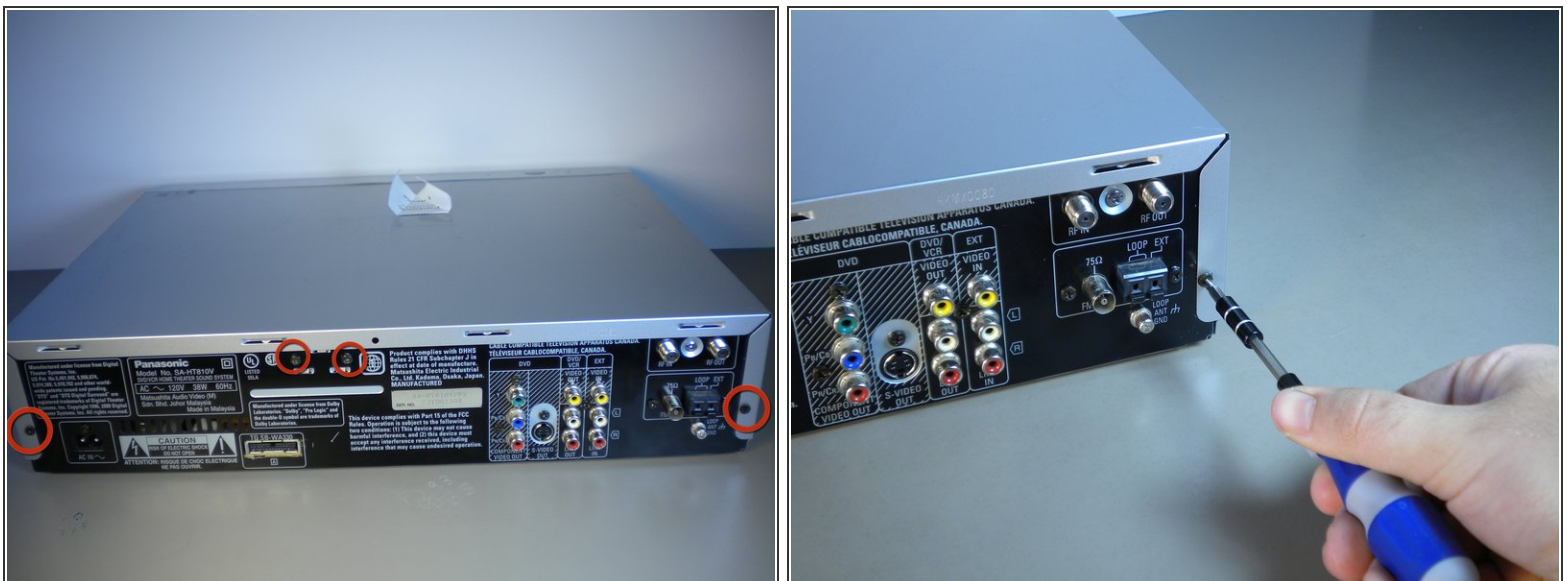
Step 2

- Rotate the device so that the back faces you.
- With a phillips head screwdriver, locate and remove the two screws highlighted by the red circles in image one.

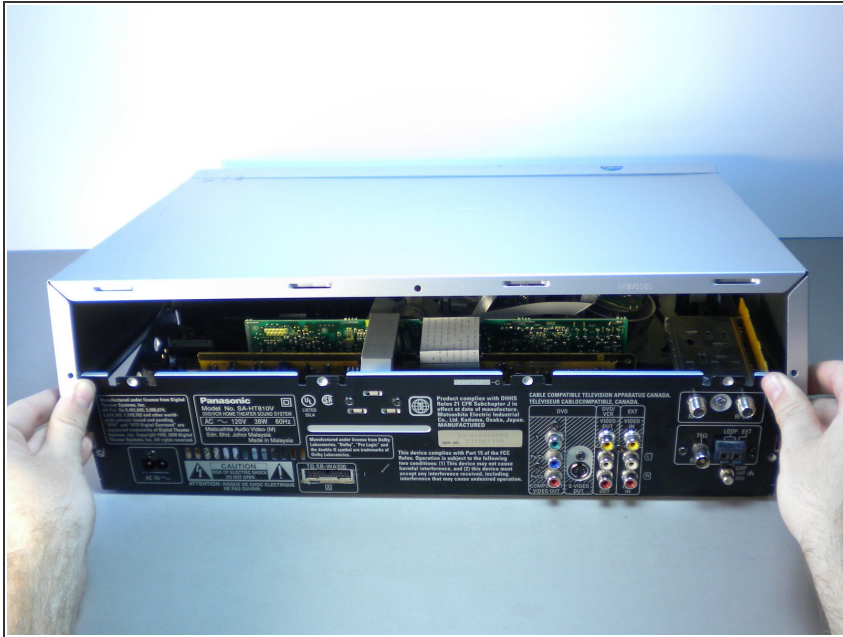
Step 3

- Before removing top cover make sure that the back of the device is facing you.
- Remove the top cover by bending out on the sides, and pulling the cover towards you while applying upward pressure.

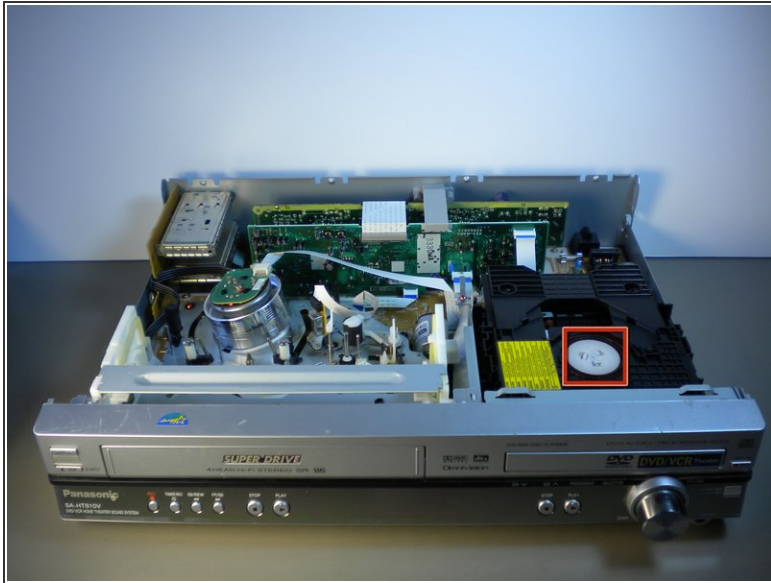
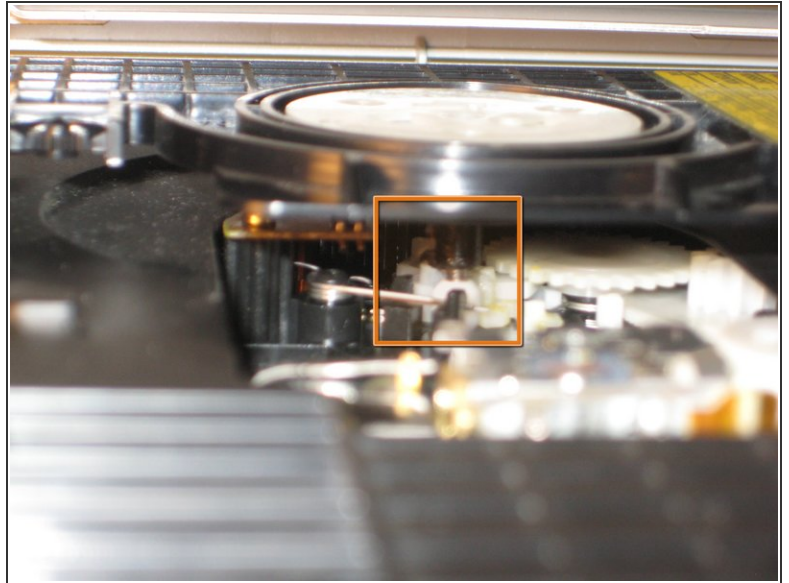
Step 4

- i** Note that the spindle you will be lubing is located underneath the white disk device highlighted in figure one
- Tilt the device on its front side until you can see underneath the white circular component mentioned in the note above.
 - Locate the spindle circled in figure two and apply one or two drops of 3 in 1 lubricating oil to the spindle.
