# Repairing NEC VT700 Lamp Cover

How to repair a "Lamp cover error or lamp housing error" due to a missing part of the lamp cover.

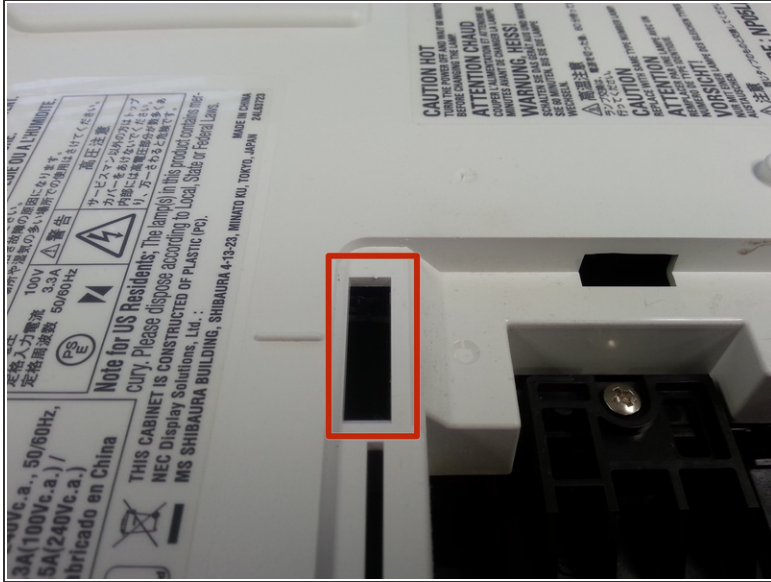
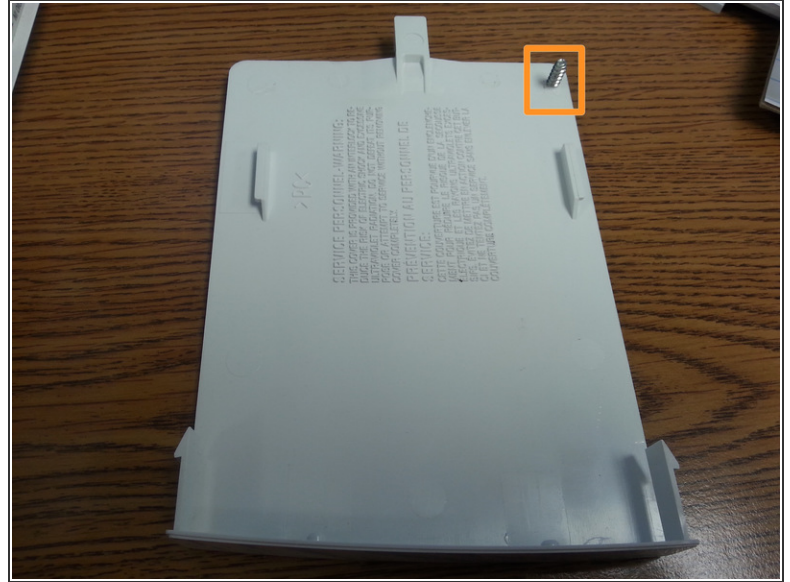
## Step 1 — The Root of the Problem

This projector might stop working for no apparent reason and the status light will flash red, 0.5 sec on, 2.5 sec off sequence. This indicates a "Lamp cover error or lamp housing error" according to the manual. This error can be caused by a plastic part breaking off of the lamp cover. I was able to repair this easily and place the projector back into service.

- This is the bottom of the projector with the lamp cover removed. The long rectangle shaped slot in the center of the photo has a micro switch located at the far end that would indicate the cover being in place.
- This is the inside of the lamp cover. At the marked location (sorry the repair is already in place) there should be a plastic "L" shaped extension from the cover. This would extend into the slot in the first photo and actuate the switch indicating the cover is in place. This was broken off of the cover.

- Carefully locating the hole with the marking of the missing piece, drill a hole suitable for a screw of about 3 mm diameter. The screw needs to extend about 10 mm from the surface of the lamp cover to actuate the switch, but it should not extend much beyond this.
- The screw goes through the cover, from the outside of the lamp cover and must extend into the slot mentioned in step 1.
- All better! The projector now works as intended.
