# Nintendo Entertainment System Springs Not Properly Mounted on Cartridge Tray Replacement

The springs are not properly mounted to the cartridge tray so the game does not eject.

Written By: nicholasweiser

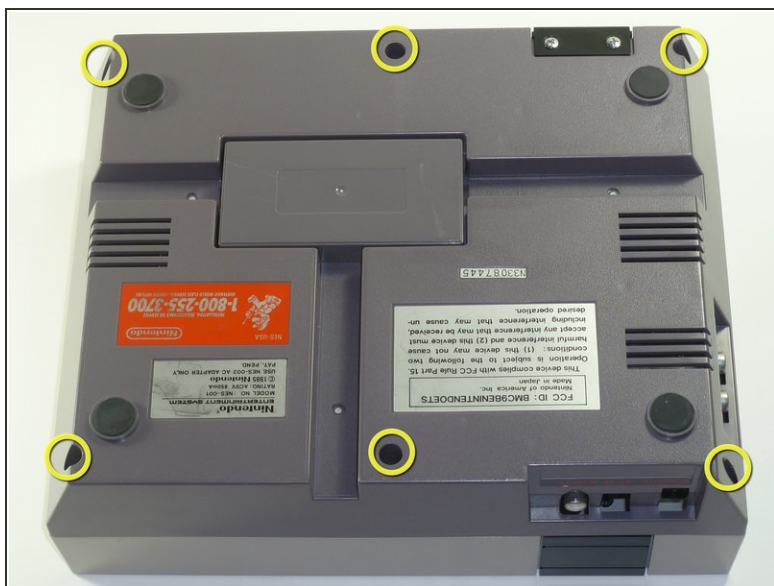
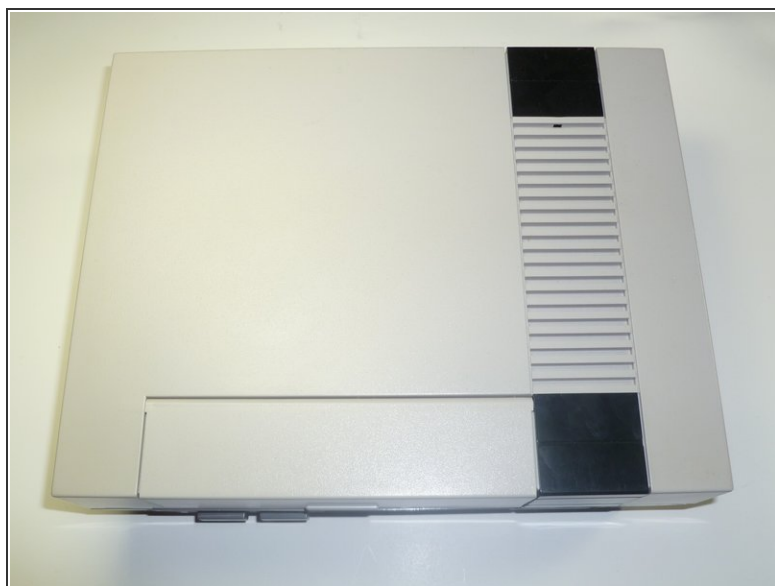
## Step 1 — Game Cartridge Tray

- Remove the six 13.25mm Phillips screws on the bottom of the game console with a #2.5 flathead screwdriver.
- ⓘ The screws are recessed about 40 mm.
- Flip the game console right side up and take off the top by pulling it up and away from the rest of the device with your hands.
