How to Sangean DT 200V radio

If your radio stops working, particularly after dropping it, it is usually an easily fixed break in the battery connection solder.

Written By: db88

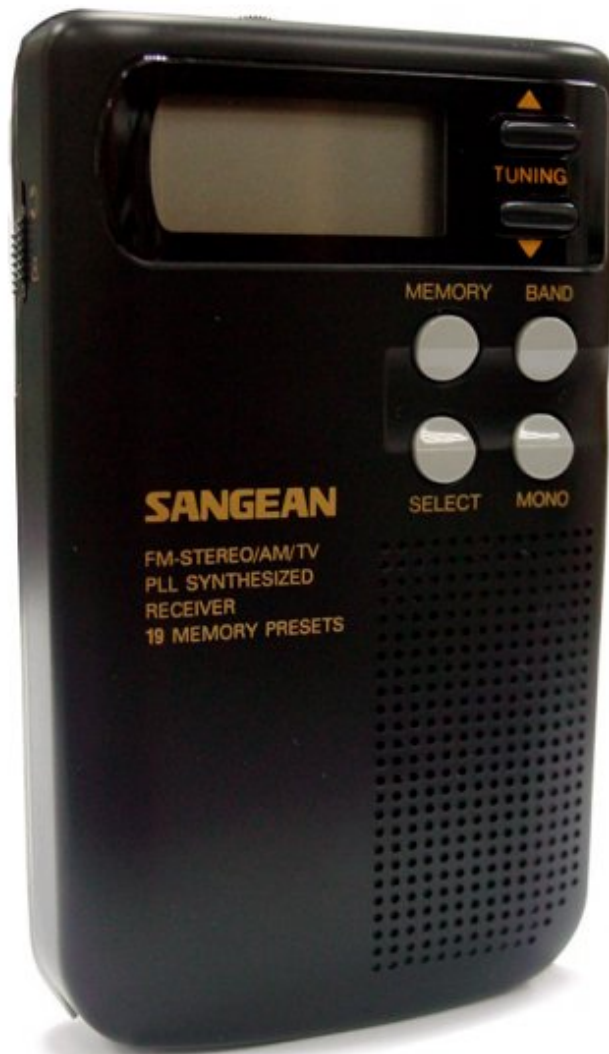
After owning two of these Sangean DT 200V pocket radios, I discovered that they were easily repairable when they failed after being dropped. Apparently this is a common failure to their design and manufacture.

- If your radio has stopped working after dropping it, my experience with two of these radios is that the solder connecting to the battery holder has broken. First, you need to expose the broken connection by unscrewing the screws on the back of the radio, and carefully loosening and removing the back casing.

- The broken connection is at the top right of the battery compartment. You will need a soldering iron, but probably do not need to add any new solder. The soldering iron will need to be hot (follow its instructions), which typically takes a few minutes of heating up.

- Remove the radio batteries. Use the hot iron to carefully melt the existing solder at the outer edge of the radio where the circuit board connects to the batteries. Melting the solder restores the connection to the battery terminals. Be careful not to overheat this area which could damage other parts on the circuit board. It only takes a very brief time to melt the solder with a hot iron.
