Rapoo E6700 Bluetooth Touch Keyboard Teardown

This 'guide' shows that it is NOT possible to repair a damaged USB connector on this device.

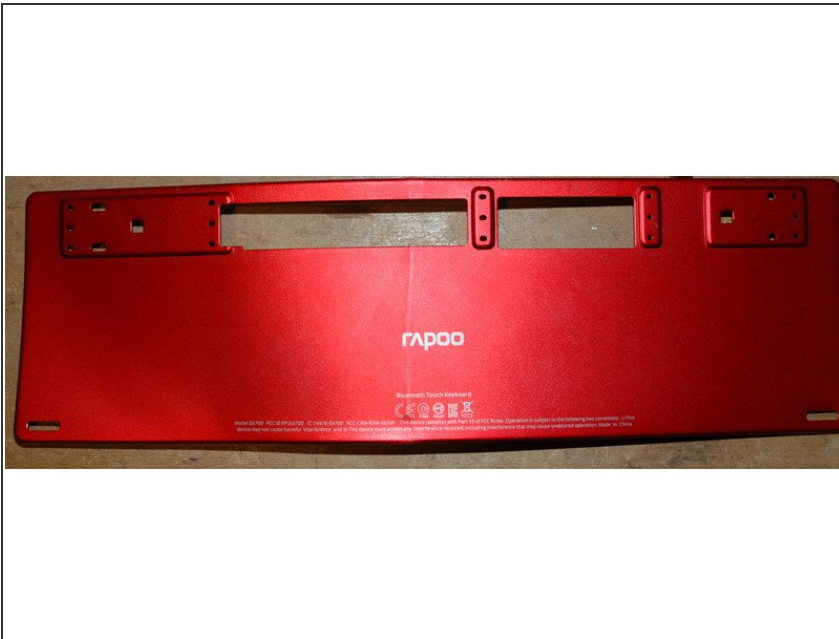
Step 2

- I tried to get access to the damaged USB connector, but the bottom cover that contains the main PCB is held in place by screws not from the outside but the inside.
- So I broke off the bottom cover to repair the connector, but then you cannot connect back the flex connectors to the keyboard.
- Maby we can separate the keyboard from the aluminium housing ?

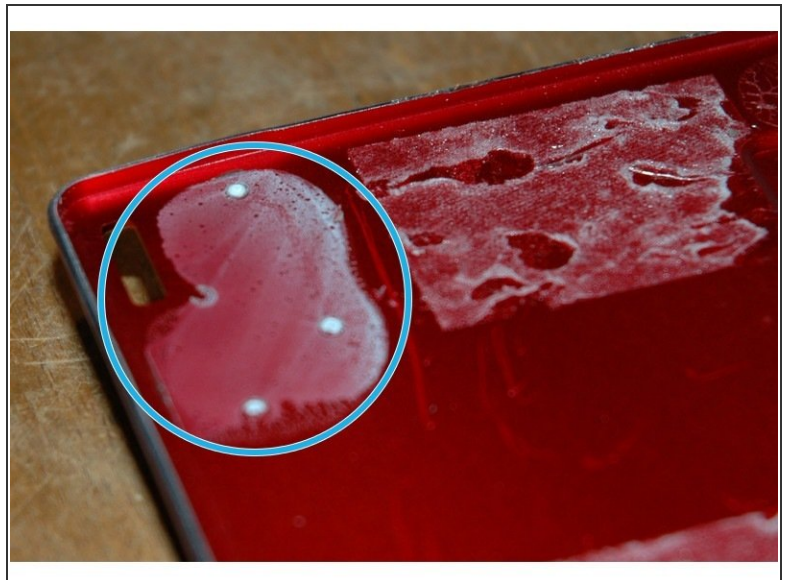
Step 3

- Well for those who try to get the keyboard off, someone has developed superglue.
- Yes you heard it, not just sticky double sided tape, also superglue applied in the marked areas.

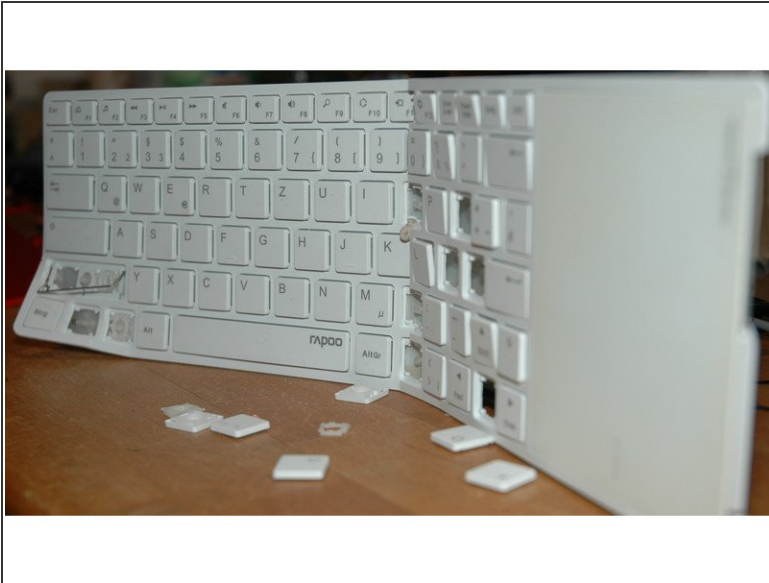
Step 4

- Here's the keyboard after 1 hour trying to separate the parts.
- And another view of the superglue residuals on the keyboard side.
