# Sony Laptop VGN-FE31Z LCD Repair

Written By: Djair Guilherme

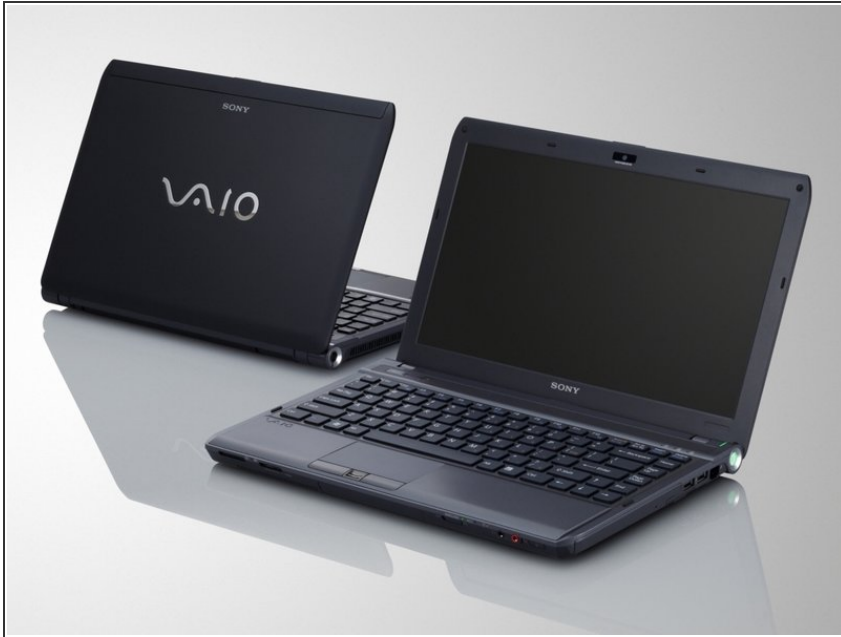
## Step 1 — Sony Laptop VGN-FE31Z LCD Repair

- The ants have focused on two points: the LVDS and backlight ballast.
- I removed all electrical parts and proceeded to clean all plastic casing of the laptop, with water and detergent. While the coating was dry, I used isopropyl alcohol to clean the traces of soil. I applied a clean contact solution and the other in LVDS connectors.

- This problem has already happened in many electronic devices in my home, almost every year. The solution is simple: to dismantle the machine completely and remove all traces of soil, ants and dirt.

- I mounted the LCD, putting a little poison for ants to prevent future infestations.
