# Sony Laptop VGN-FE31Z LCD Repair

Written By: Djair Guilherme

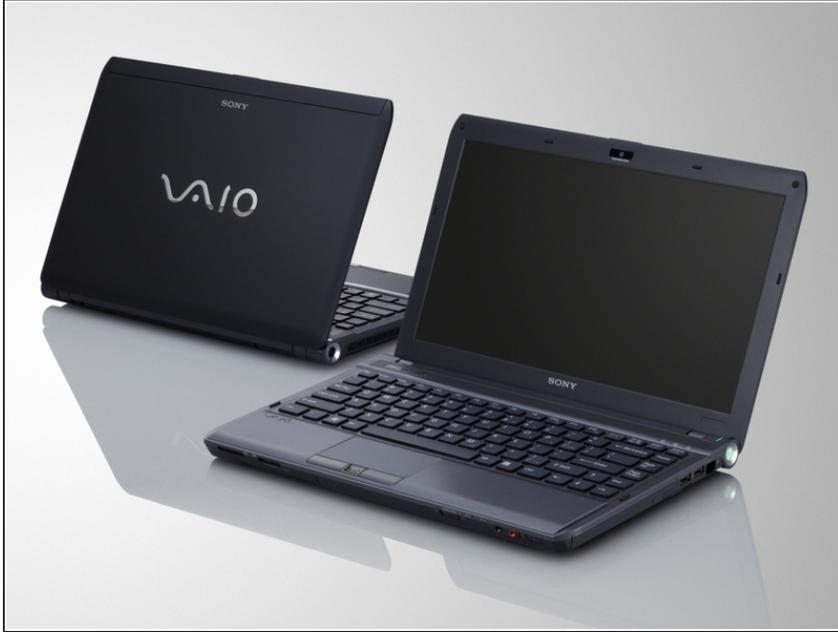
## Step 1 — Sony Laptop VGN-FE31Z LCD Repair

- Researching a little on Google, I found the repair manual of the Sony Vaio VGN FE31Z at this address: <http://www.givemefile.net/smanuals/noteb...>
- Procedures carefully dismantling the equipment until the LCD. While performing this procedure, I noticed that the ants began to move from side to side, Laptop Keyboard leaving and entering the LCD.

- The ants have focused on two points: the LVDS and backlight ballast.
- I removed all electrical parts and proceeded to clean all plastic casing of the laptop, with water and detergent. While the coating was dry, I used isopropyl alcohol to clean the traces of soil. I applied a clean contact solution and the other in LVDS connectors.

- This problem has already happened in many electronic devices in my home, almost every year. The solution is simple: to dismantle the machine completely and remove all traces of soil, ants and dirt.

- I mounted the LCD, putting a little poison for ants to prevent future infestations.
