Sony Laptop VGN-FE31Z LCD Repair

Written By: Djair Guilherme

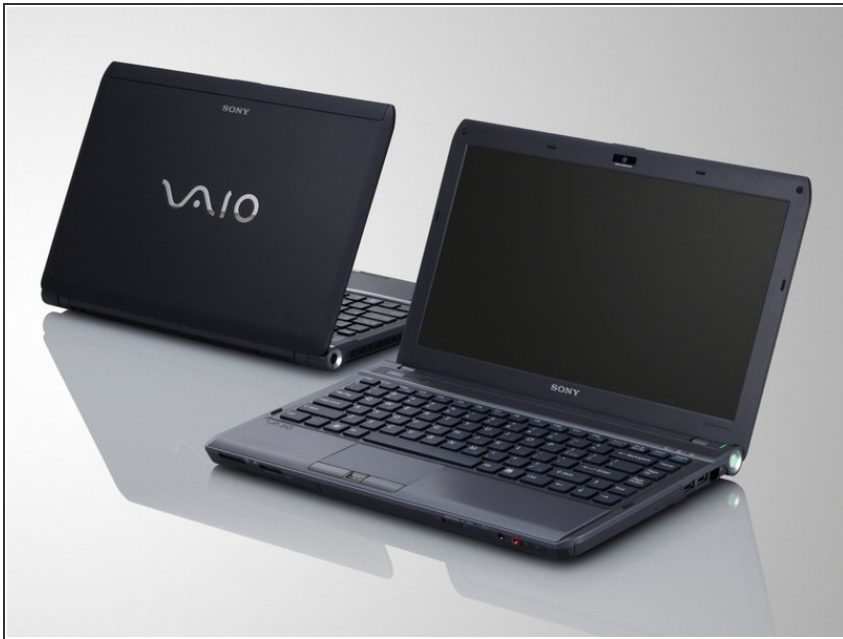
Step 1 — Sony Laptop VGN-FE31Z LCD Repair

- This problem has already happened in many electronic devices in my home, almost every year. The solution is simple: to dismantle the machine completely and remove all traces of soil, ants and dirt.

- Researching a little on Google, I found the repair manual of the Sony Vaio VGN FE31Z at this address: <http://www.givemefile.net/smanuals/noteb...>
- Procedures carefully dismantling the equipment until the LCD. While performing this procedure, I noticed that the ants began to move from side to side, Laptop Keyboard leaving and entering the LCD.

- The ants have focused on two points: the LVDS and backlight ballast.
- I removed all electrical parts and proceeded to clean all plastic casing of the laptop, with water and detergent. While the coating was dry, I used isopropyl alcohol to clean the traces of soil. I applied a clean contact solution and the other in LVDS connectors.

- I mounted the LCD, putting a little poison for ants to prevent future infestations.
