# Microsoft Lumia 535 Back Cover / Rear Case Replacement

Microsoft Lumia 535

RM-1090 / RM-1091 / RM-1089 / RM-1092

How to remove the back cover / bezel.

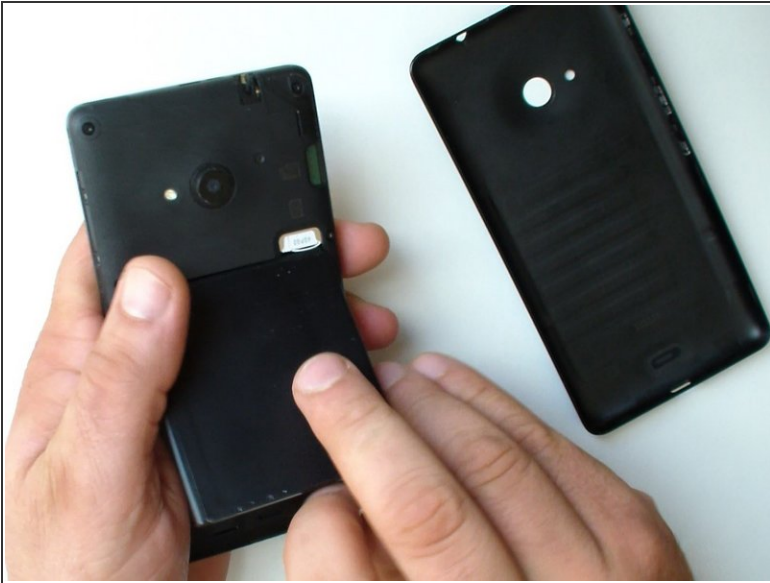
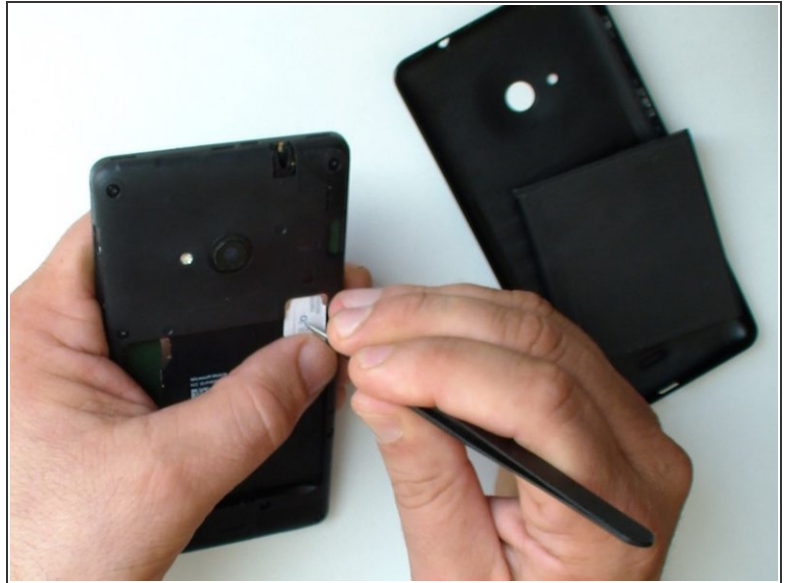
## Step 1 — Back Cover / Rear Case

- Turn off the phone.
- Remove the battery and any SIM and memory cards.

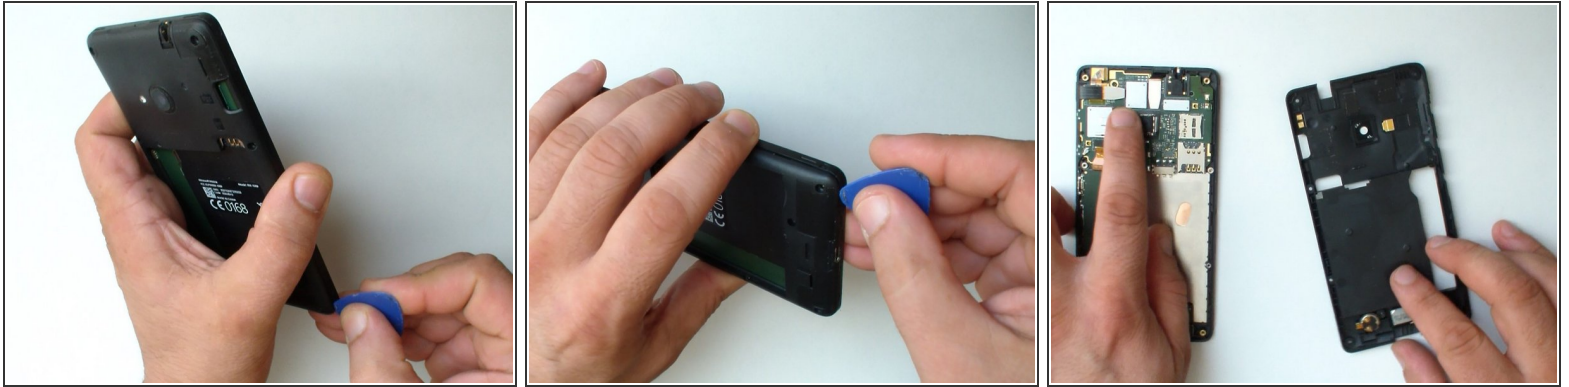
### Step 3

- With a plastic opening tool separate the back cover from the middle frame.

To reassemble your device, follow these instructions in reverse order.
