# Fujifilm Instax Mini 8 Infrared Blaster Replacement

This guide helps you recognize the steps to fix your IR blaster on an Instax Mini 8.

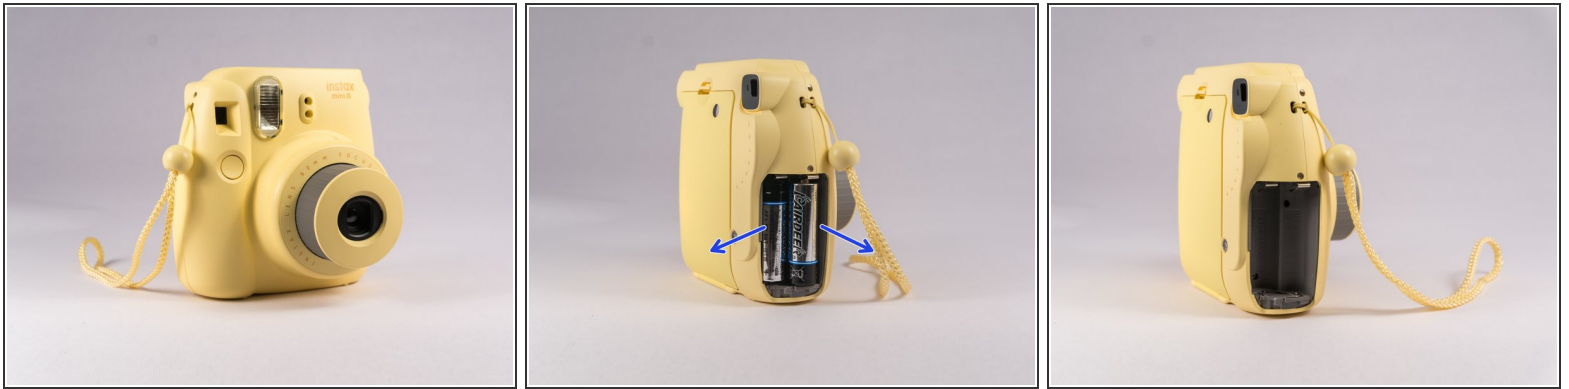
## Step 1 — Infrared Blaster

- First, push in the lens and remove the two AA batteries.

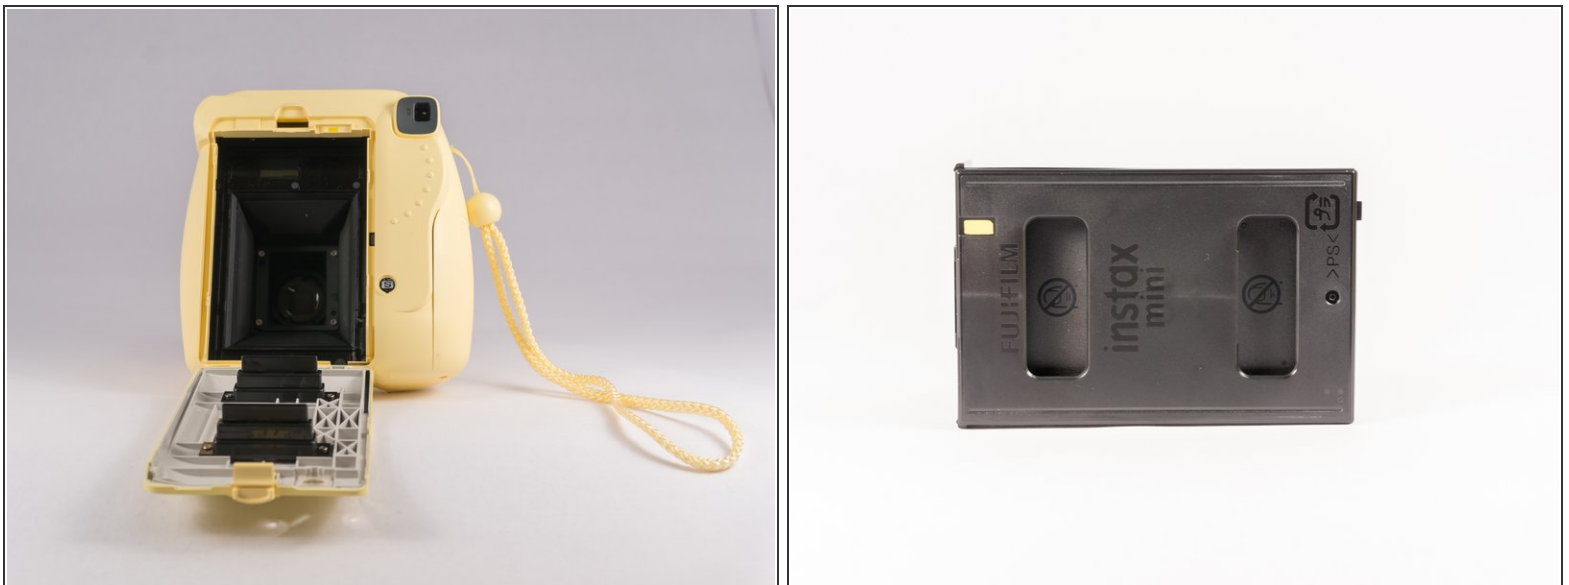
## Step 2

- Open the rear compartment and remove the film cartridge.

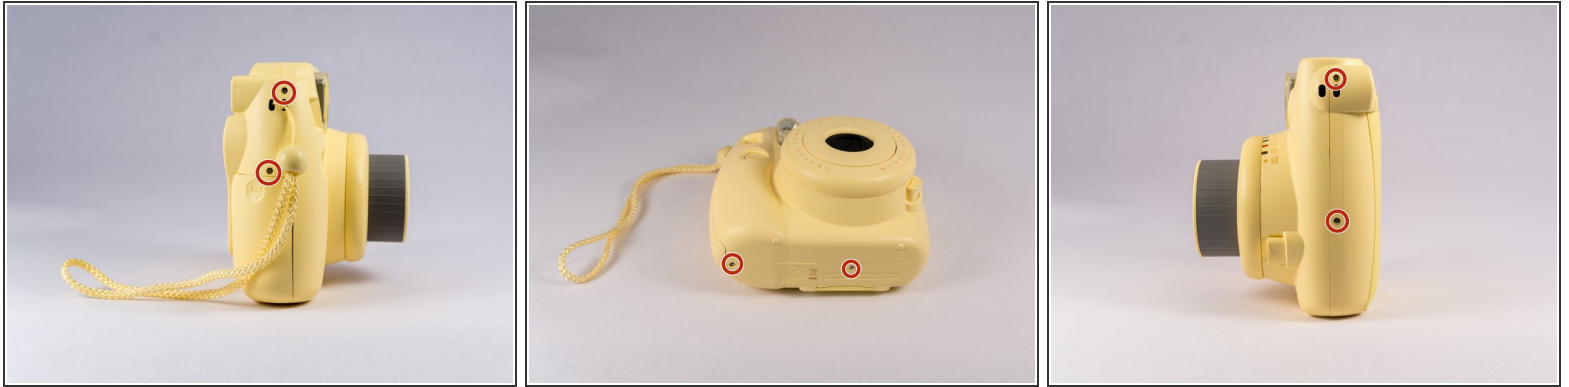
### Step 3

- Remove screws from bottom of camera with a small #00 Phillips Screwdriver. Then remove screws around the camera. Additionally, there are two screws in the battery compartment which also need to be removed.

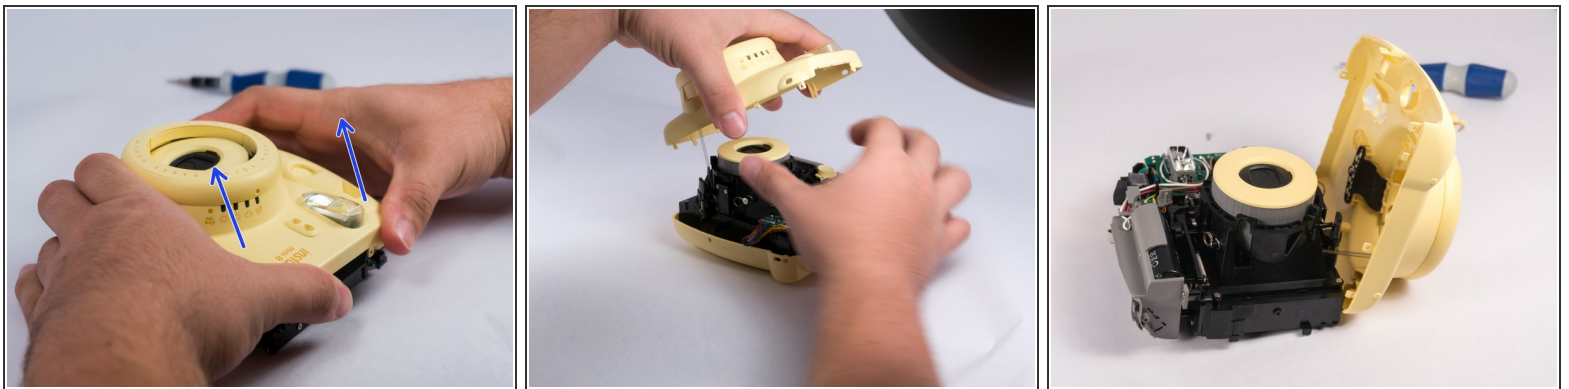
### Step 4

- Once all screws are removed, gently pry open the front casing with your hands or plastic opening tools carefully. Do note that there will be a spring that attaches the front casing and the main circuit board, so refrain from allowing excess tension on the spring.

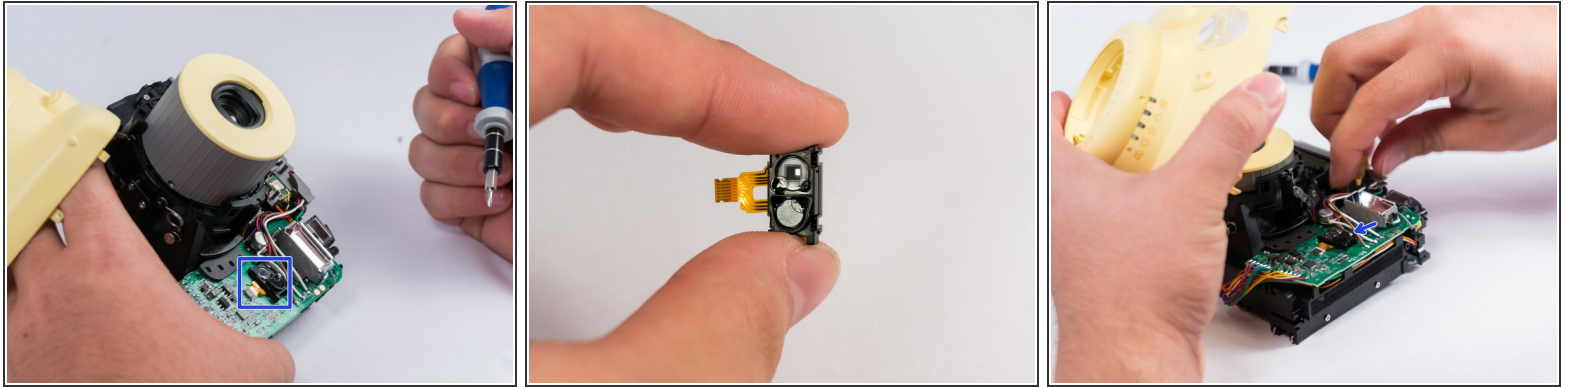
## Step 5

- Locate the IR blaster, remove the connecting wire ribbon by prying the connector latch open on the motherboard, then sliding it out. Once the wire ribbon is disconnected, the IR blaster can be lifted away from the motherboard.

To reassemble your device, follow these instructions in reverse order.
