Ubiquiti UniFi AP AC Lite TVS Diode Replacement

Repair an Ubiquiti UniFi AP AC Lite which is exhibiting a power fault problem: AP does not power on, and PoE Injector is blinking white.

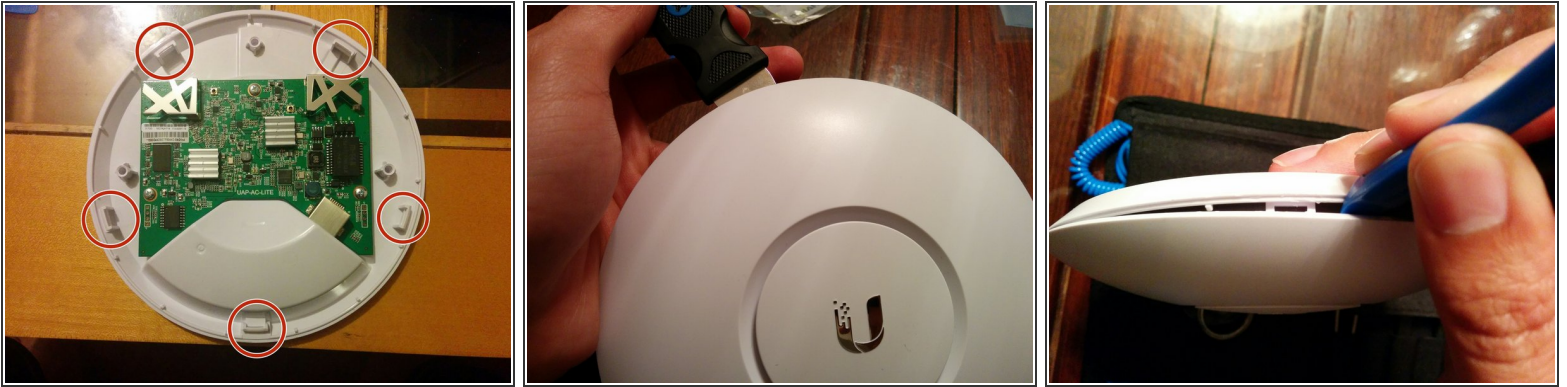
Step 1 — Open the UAP-AC-LITE

- The front cover is secured by 5 tabs.
 - Work the Jimmy into the space near a clip, and create a big enough gap to insert a prying tool. Moderate pressure from a prying tool should force the clips open.
 - There are a number of alignment tabs that can get in the way. It is best to try and work the Jimmy towards the center of the front cover, hugging its inside surface.
- The PCB is held down by 3 screws. It is not necessary to remove the board for this repair.

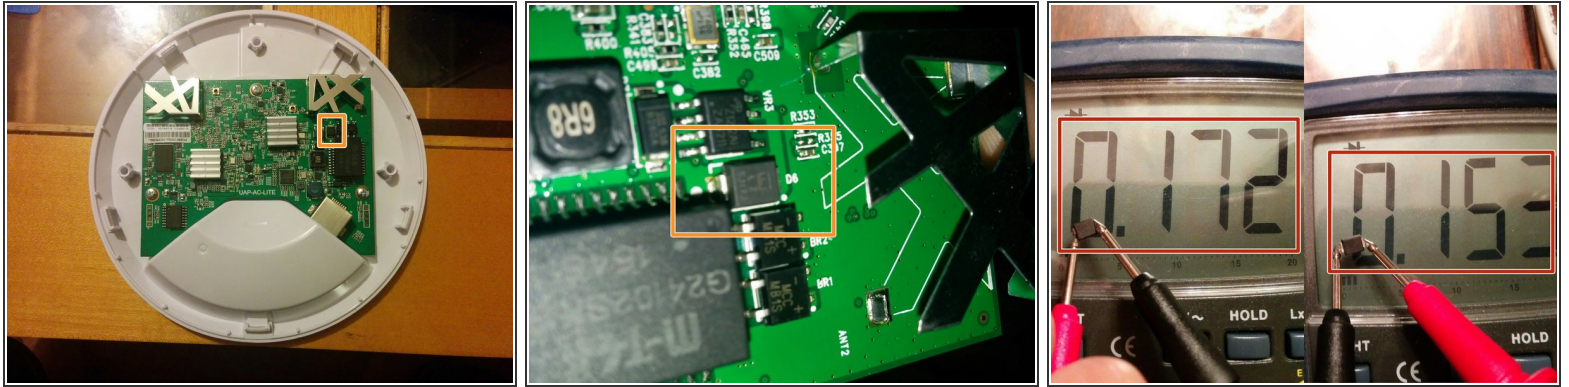
Step 2 — Test the TVS diode

- The TVS diode is located between the antenna and a large IC on the RJ45 port side of the board. It's PCB marking is **D6**.
 - It is a LittleFuse 24V uni-directional TVS diode, with J leads (SMBJ24A). Note the location of the white bar on the diode, which marks its orientation.
- Use a multimeter or ohmmeter to test that the diode has indeed shorted. A shorted diode will read less than 1 Ohm in both directions. A working diode will read significantly higher resistance in one direction relative to the other.
- ⓘ If the diode is not shorted, then something else is wrong, and proceeding further may or may not help fix your access point.
