Amazon Kindle Paperwhite 7th Generation Repairability Assessment

Amazon Kindle Paperwhite repairability assessment performed on January 5, 2017.

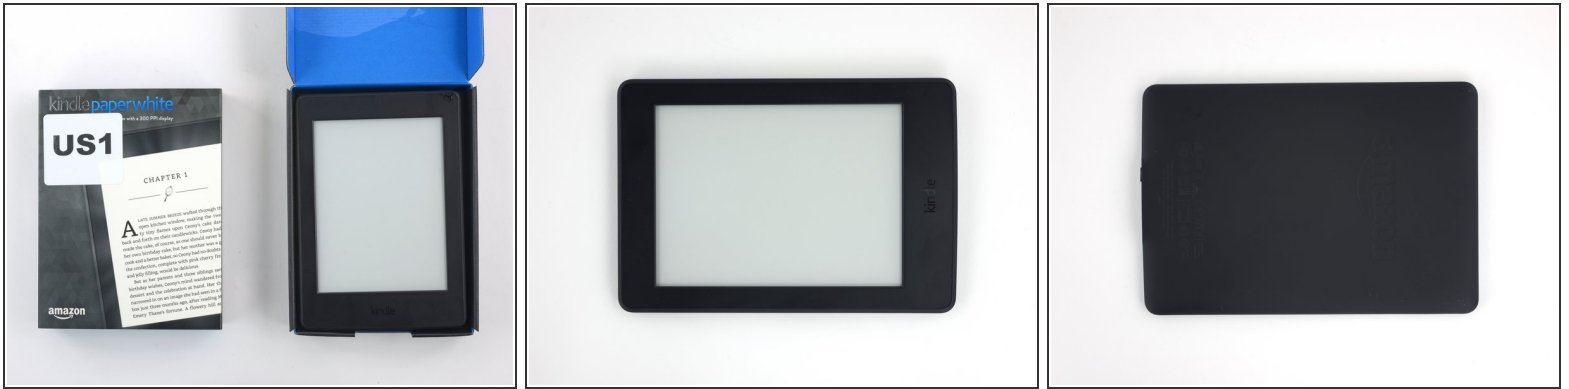
Step 1 — Amazon Kindle Paperwhite 7th Generation Repairability Assessment

- Front and rear reference shot.

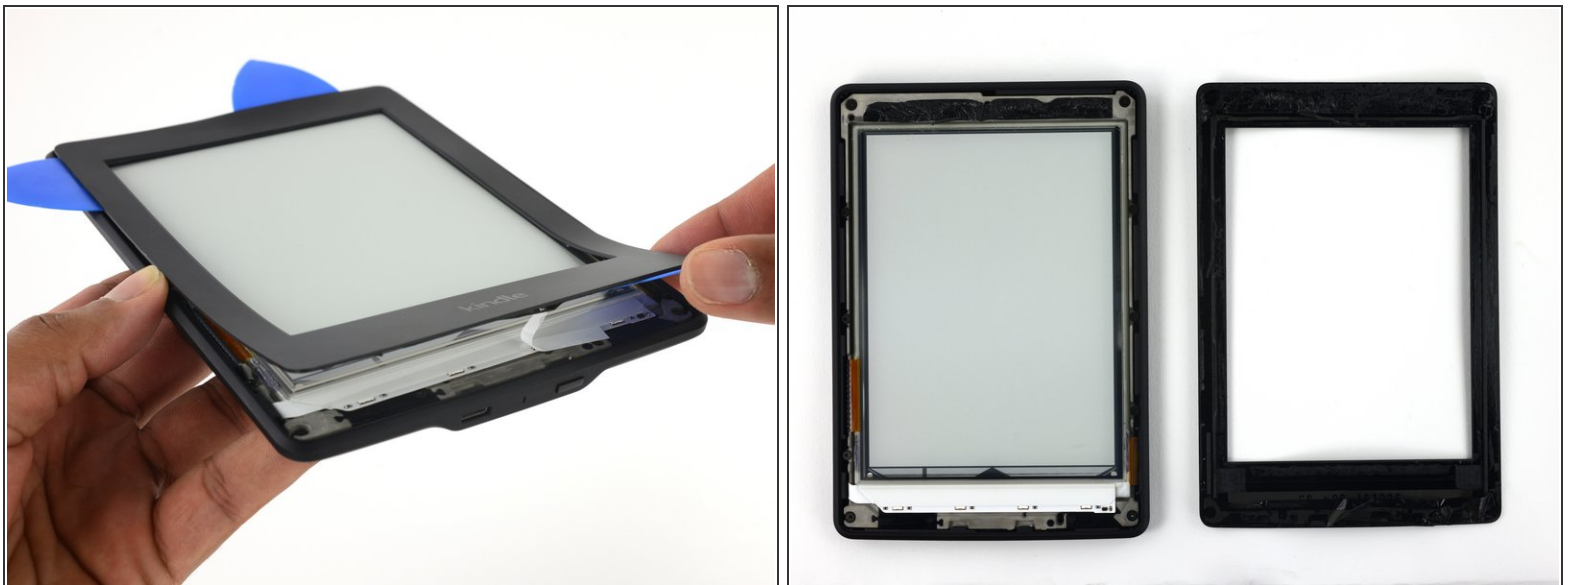
Step 2

- Adhesive is holding the bezel in place.
- An opening pick and an iFixit opening tool were the only tools needed to remove the bezel.
- No heat was needed, yielding a moderately difficult opening procedure.

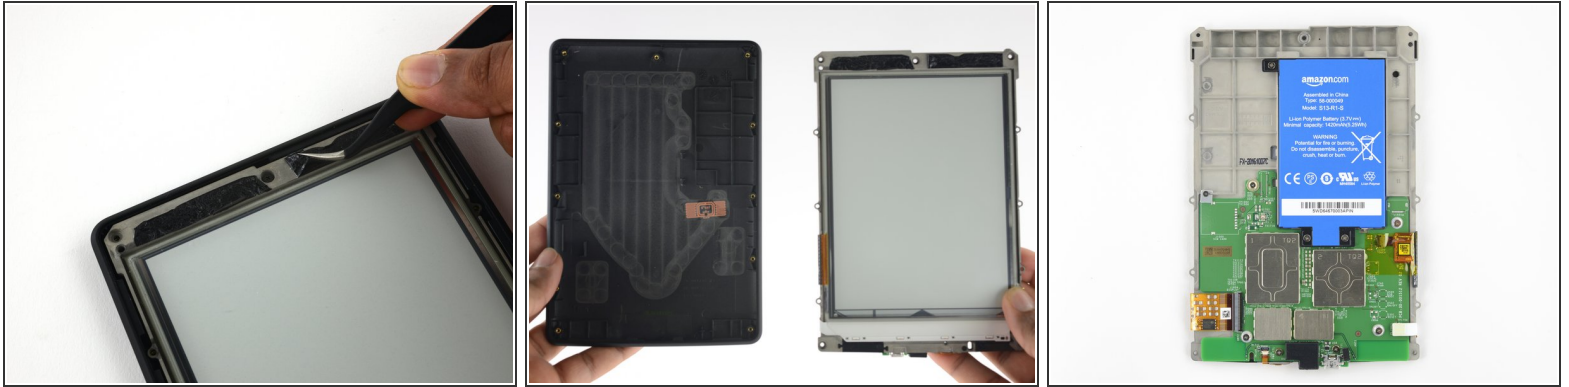
Step 3

- There are 11 Phillips screws holding the midframe to the rear case. One of those screws is hidden underneath tape.
- Once the screws are out the midframe easily separates from the rear case.
- The battery and motherboard are connected to the rear case.

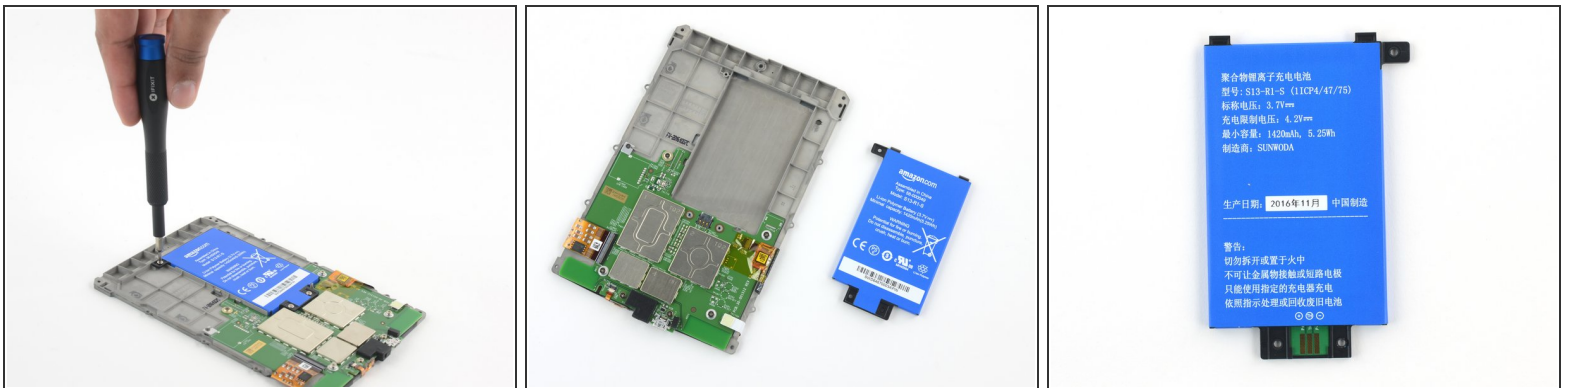
Step 4

- Battery is held in place by three Phillips screws.
- Once the screws are removed, the battery can be removed by lifting from the bottom.

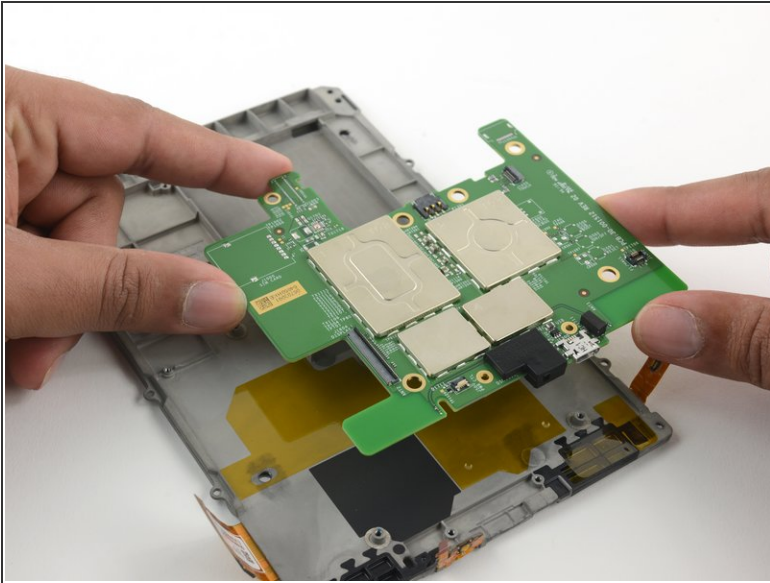
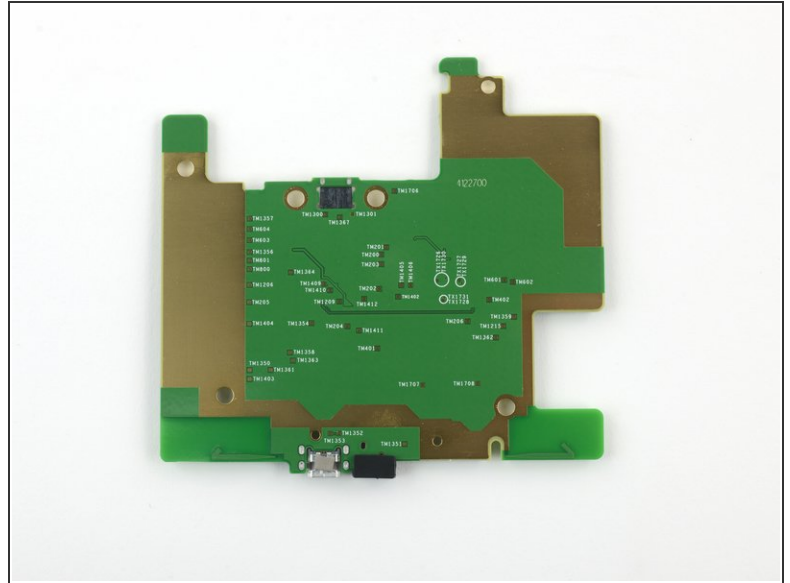
Step 5

- The motherboard is held in by 5 Phillips screws.
- There are 3 ZIF connectors and 1 press connector that must be disconnected before removing the motherboard.

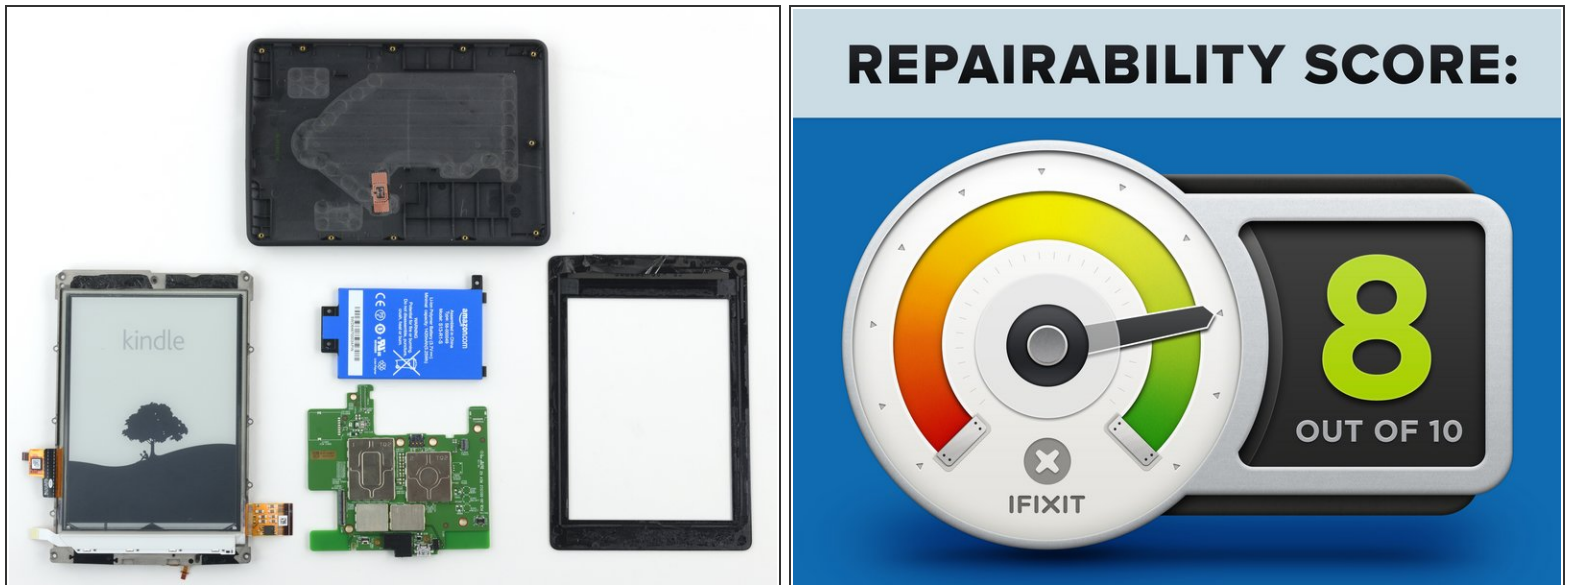
Step 6

- The Amazon Kindle Paperwhite earns an **8 out of 10** on our repairability scale (10 is the easiest to repair):
 - The battery was very easy to remove.
 - All screws were Phillips #00 screws.
 - All components likely needing replacement were modular, except for the USB port.
 - Thin layer of adhesive that needed to be broken in order to remove the bezel and access the internal components.
 - Manufacturer does not provide user-accessible repair documentation.
