# Xbox One Elite Controller (Model 1698) Daughterboard Replacement

Written By: EasyAsABC123

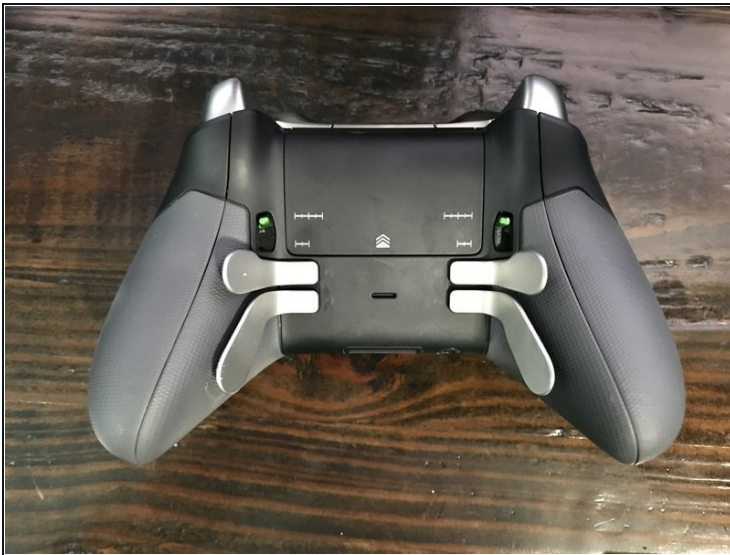
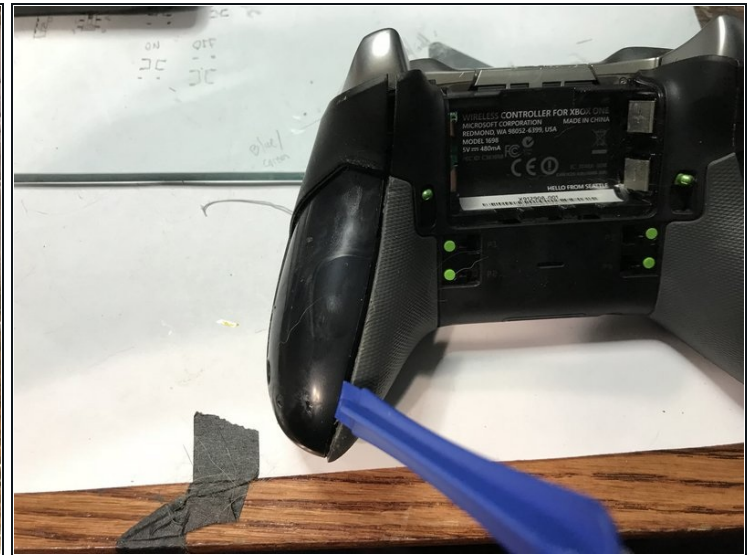
### Step 1 — Show me the Screws!

- You can remove the side panels with a pry tool.
- ① **You don't need to remove the rubber. The rubber on this controller was already bad.**

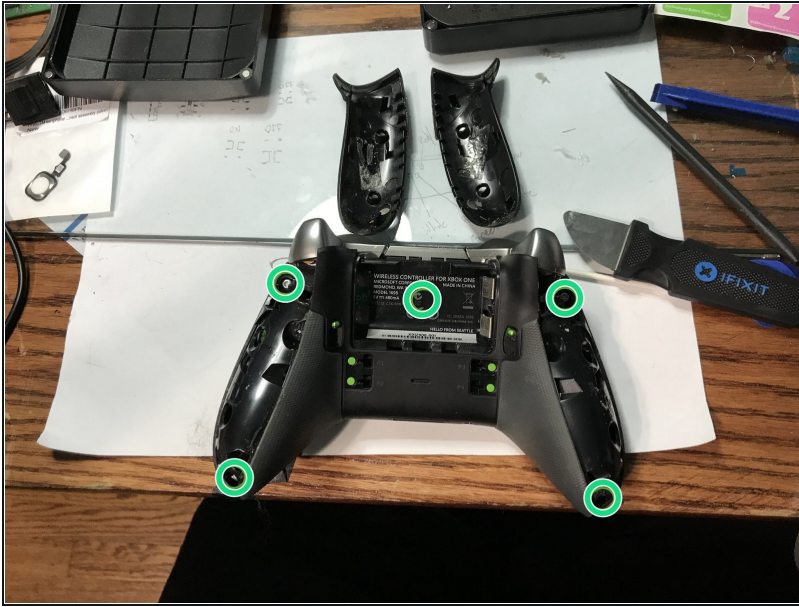
## Step 2 — Removing the back panel screws

- Remove the 5 Torx Security Bit (TR9) screws.

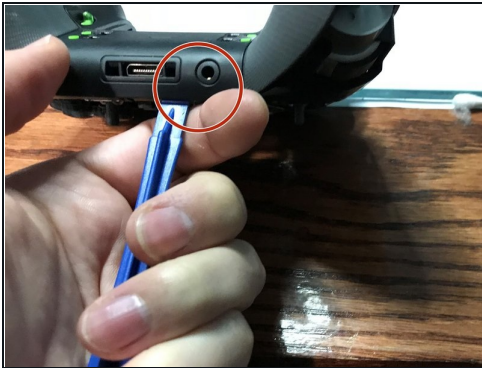
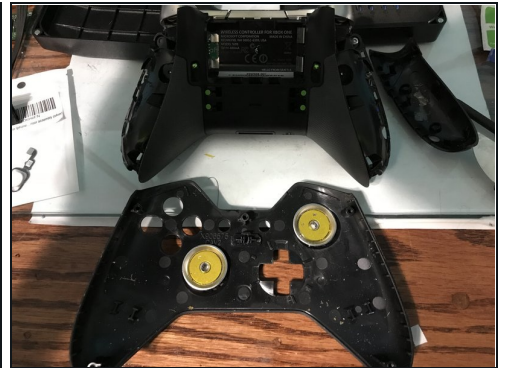
## Step 3 — Popping that back panel off

- Pry the panel next to the 3.5mm port.

⚠ Be careful to not rip the ribbon shown in the next step.

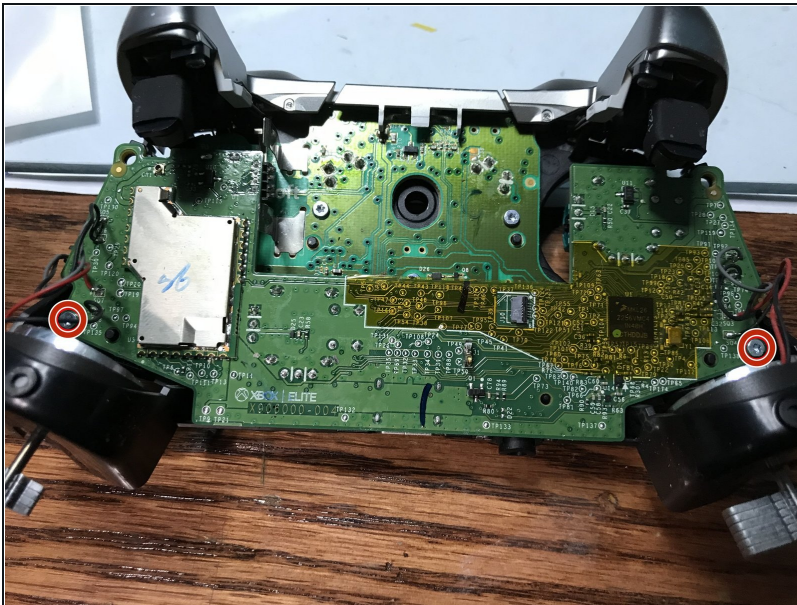
## Step 5 — Screws on controller motherboard

- Remove the 2 Torx (T6) screws.

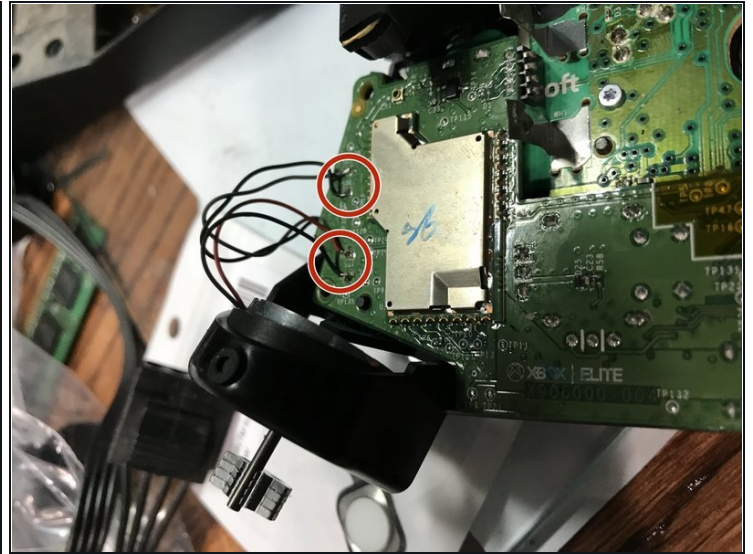
## Step 6 — Desolder wires from motherboard

- Desolder the 4 wires on each side, these control the vibrations and the RT LT.

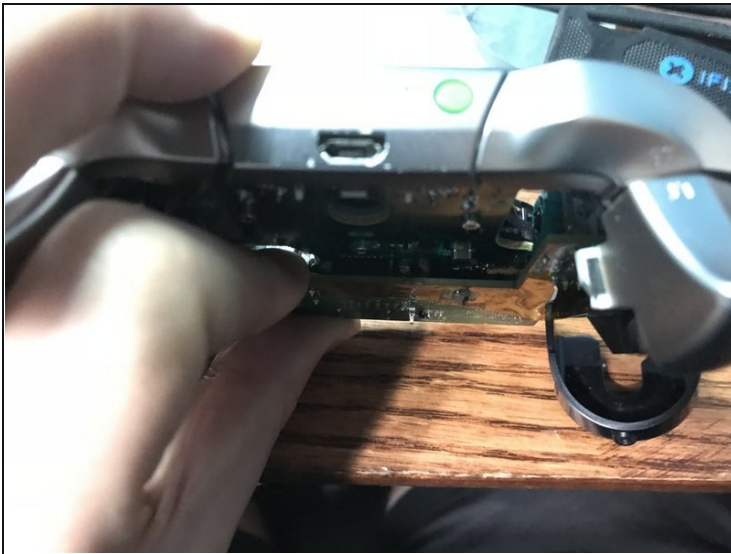
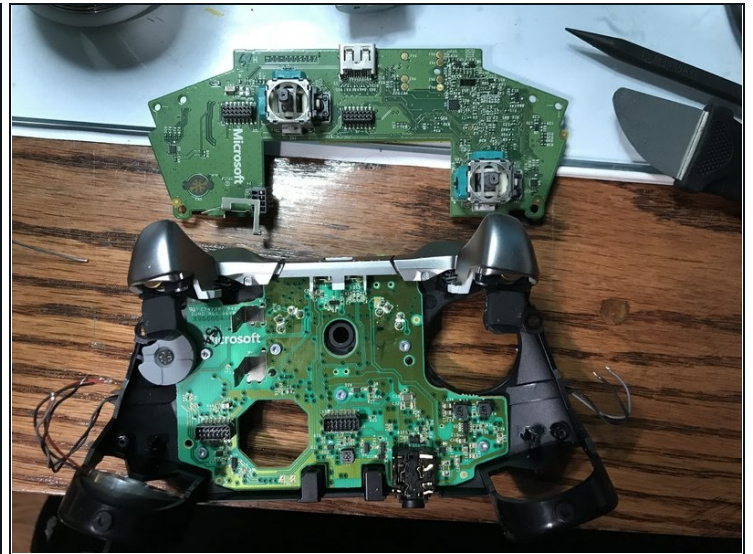
## Step 7 — Remove the motherboard

- Pull up from the "top" side of the controller on the daughterboard.

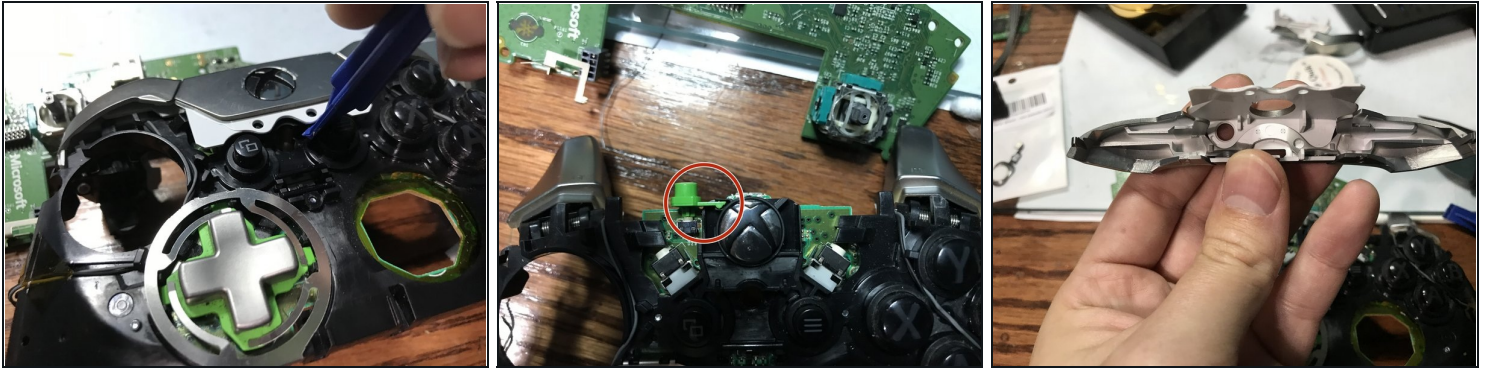
## Step 8 — Remove the Home Button Cover

**⚠ Be Careful to not lose the sync button.**

- Pry the middle section up from the home button side.
- ① This will also remove the LB and RB which is a single part.

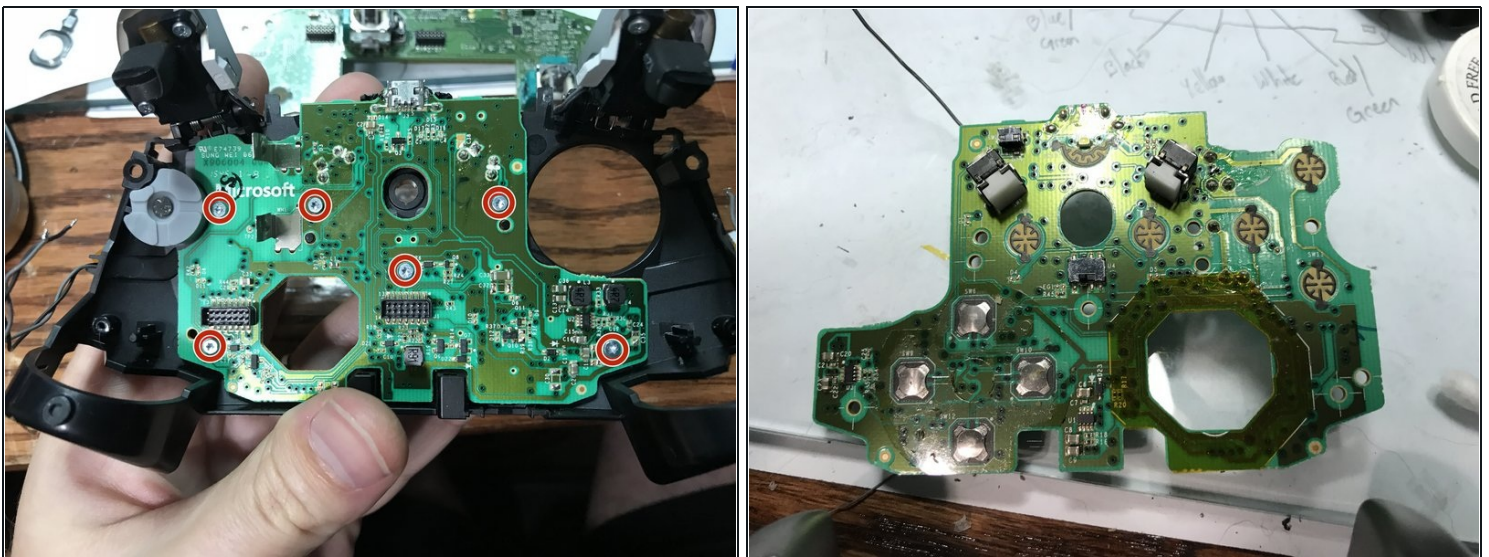
## Step 9 — Remove the controller daughterboard

- Unscrew the 6 Torx (T6) screws.
