Lenovo ThinkCentre A70z Backlight Cable Replacement

The ThinkCentre A70z Monitor lamp turns off so can't see display without a light to verify LCD screen is working.

Written By: James Finch

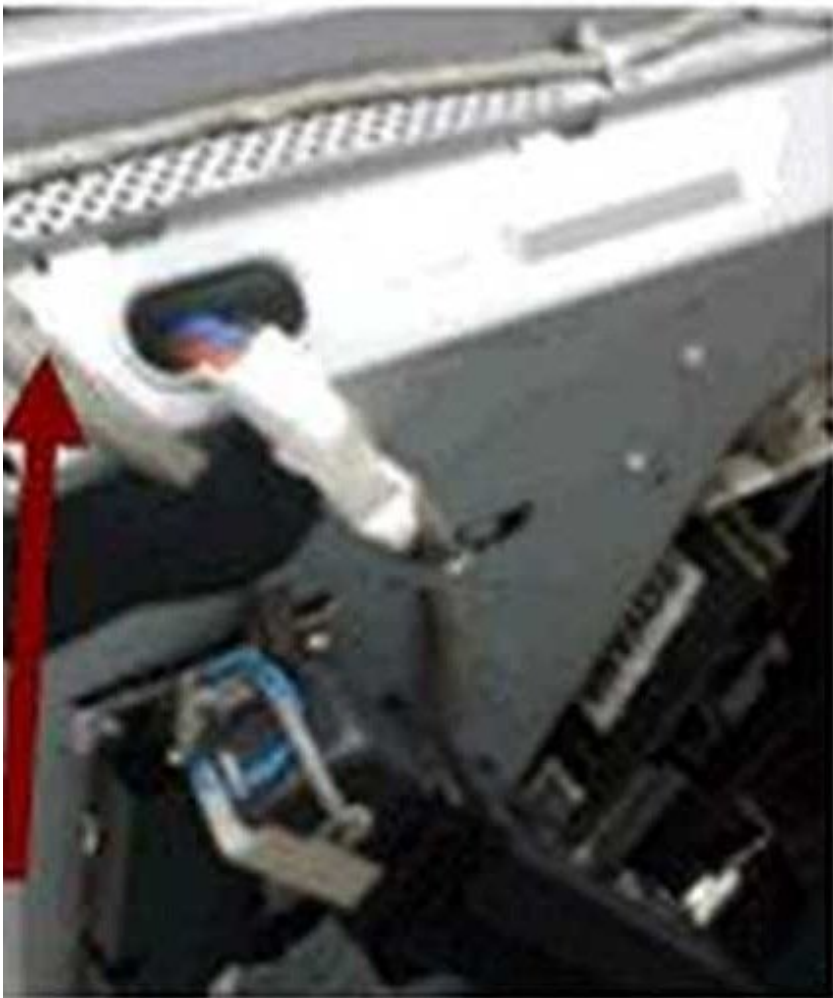
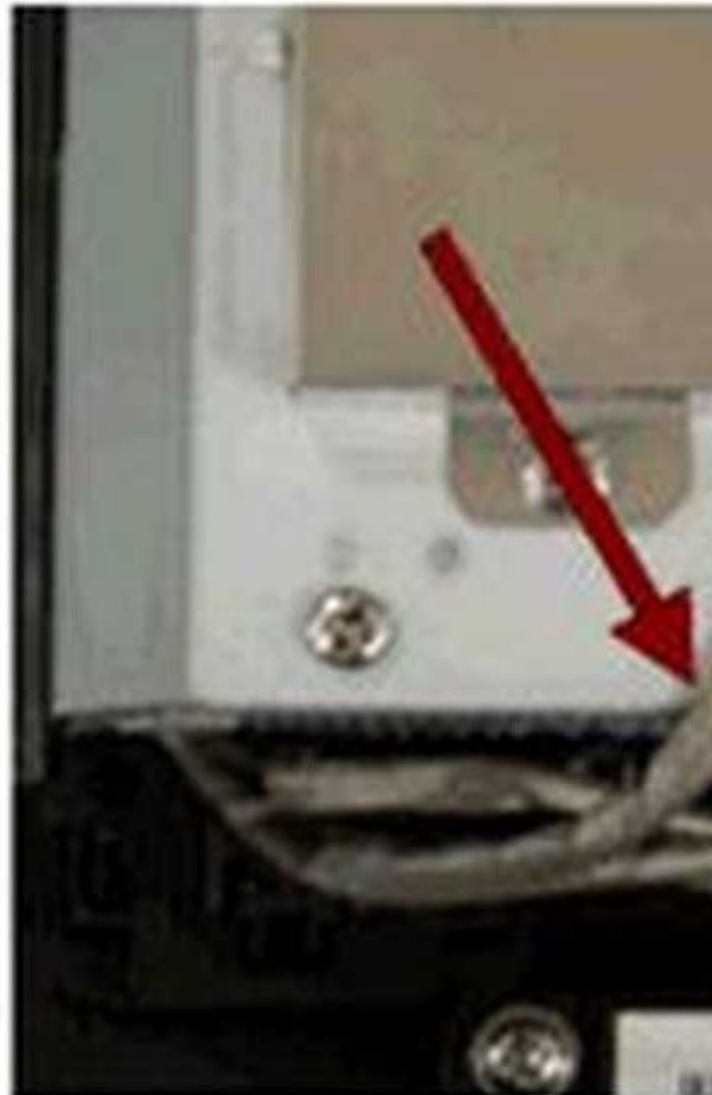
The issue is caused by the conductive tape wrapped around the backlight cable as seen below.

The issue has a low failure rate with the woven type of conductive tape. However, has a high failure rate with an aluminum foil type of conductive tape.

LG panel mentioned, "do not attach a conducting tape to lamp connecting wire directly. If the lamp connecting wire attach to a conducting tape. LCD module will have a risk for low luminance.

I removed the conductive tape wrapped around the backlight as noted and now the computer is working great again other than a login issue that will be corrected with a Windows 10 reset or I'm thinking a fresh install of a Linux OS for a multiboot system.

- Remove conductive tape wrapped around the backlight cable as below seen below.
- The issue has a low failure rate with the woven type of conductive tape. However, has a high failure rate with an aluminum foil type of conductive tape.

- Order special tape that has sponge as noted: 03T9708 34.3BE7.001
FRU_EMI_GASKET_MB_SHEILDING_TOYAMA
- Replace previous conductive tape with new tape 03T9708 after Removing original tapes.
