# Philips Wake-Up HF3520 Power supply repair

Flashing or flickering light when using radio can be caused by a malfunctioning switchmode power supply IC.

Written By: Thomas Widmaier

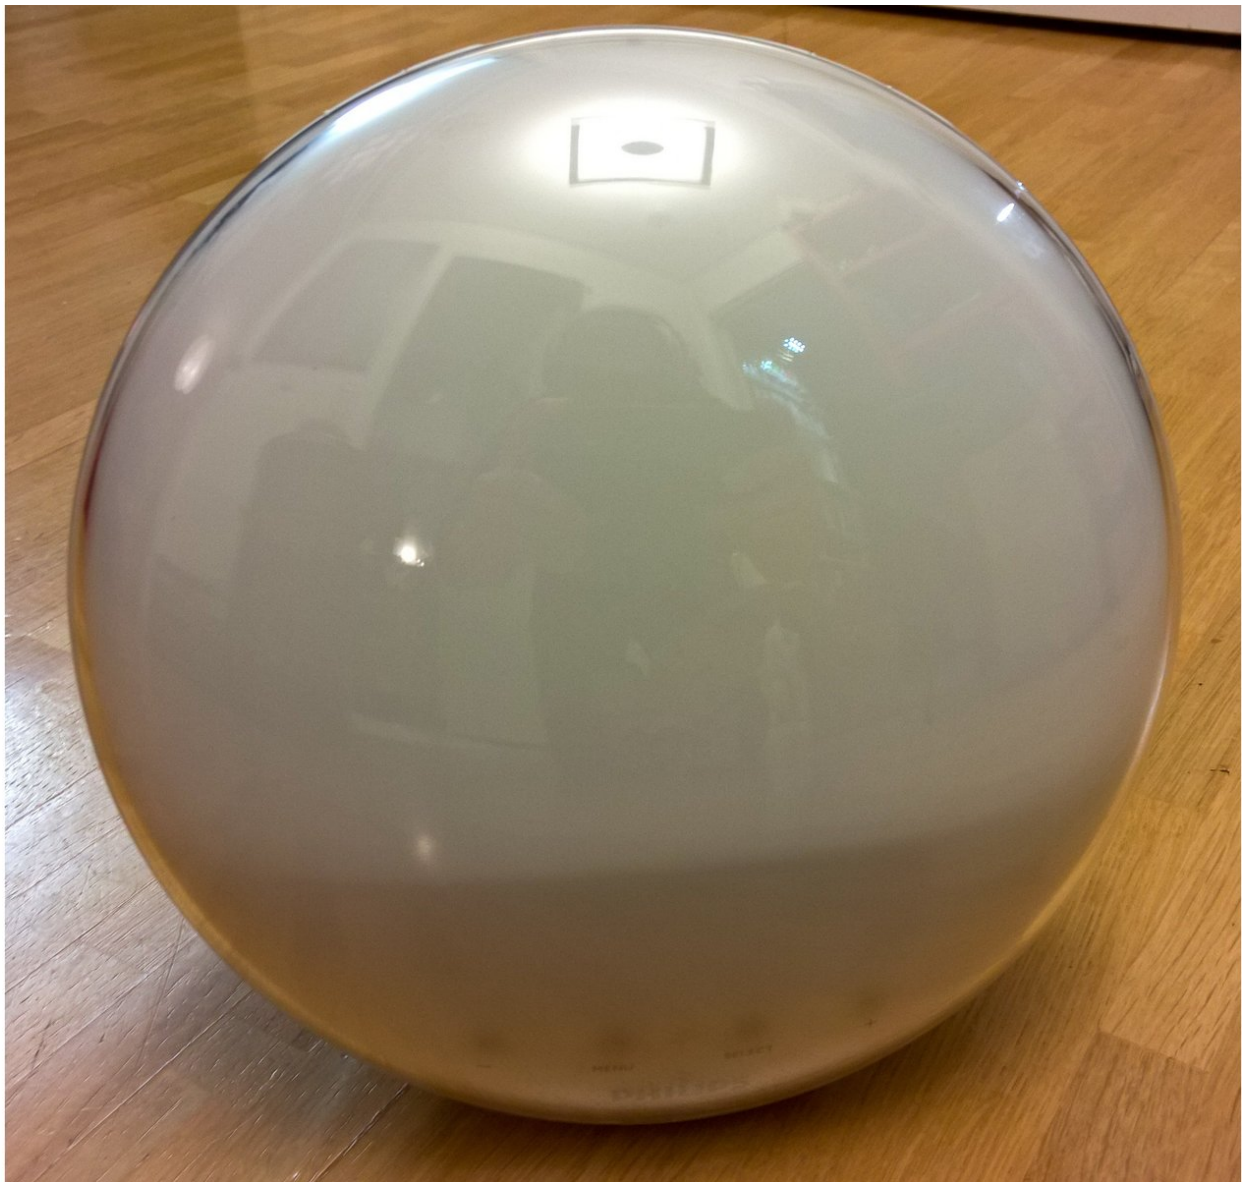
The IC (chip) inside the lamp seems to die slowly resulting in flickering/flashng lamp operation when using the radio. Also the buttons may become unresponsive.

The problem occurs specifically when the device is cold and/or humid. Heating up the IC makes it work again.
