# Insignia NS-VCS14SL7 Brush Head Replacement

Use this guide to troubleshoot and replace the Insignia NS-VCS14SL7 vacuum head brush.

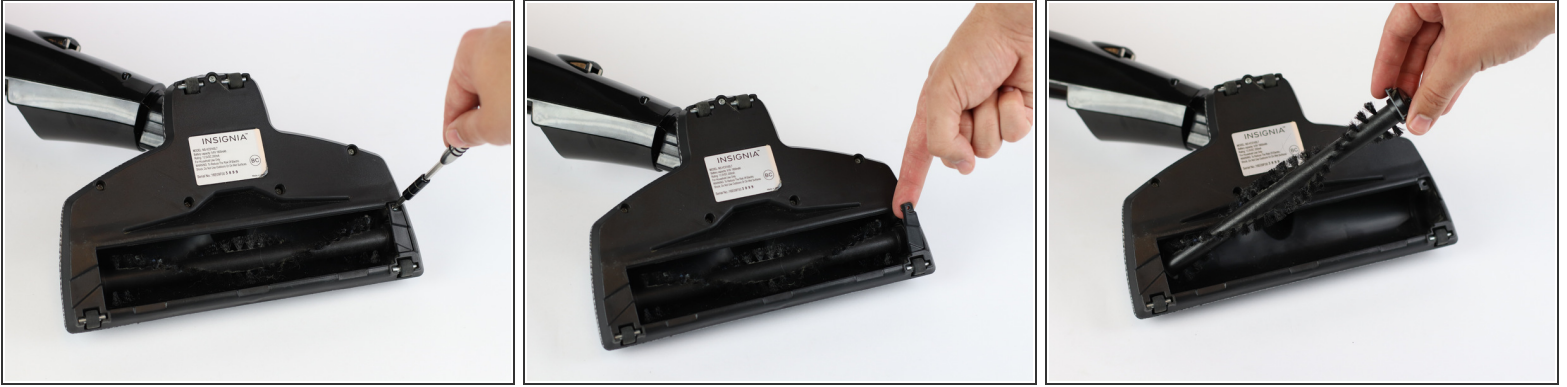
## Step 1 — Brush Head

- Unscrew the single 12.0 mm Phillips #2 screw on the right side of the bottom of the vacuum head.
- Lift and pull up on the brush retention clip.
- Pull brush up and out to remove.

To reassemble your device, follow these instructions in reverse order.
