LG Tribute HD Rear Camera Replacement

A guide for replacing the rear camera of a LG Tribute HD LS676 due to damaged rear camera causing blurry photos, error messages or not able to take photos

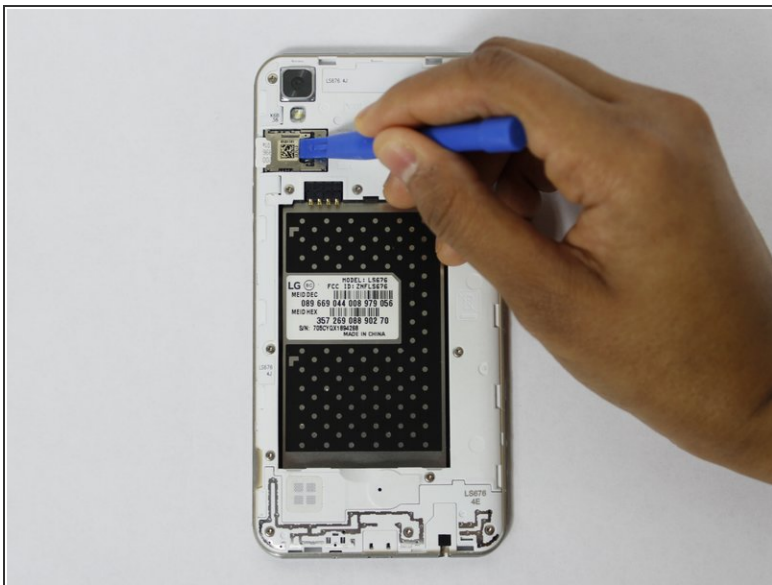
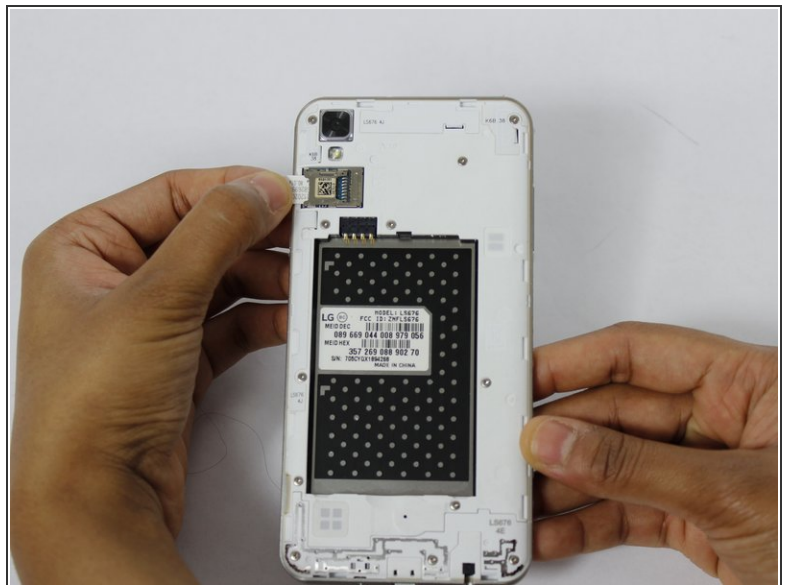
Step 2

- Pull the battery out of the phone.
- Remove the SD Card by sliding the card out as shown.

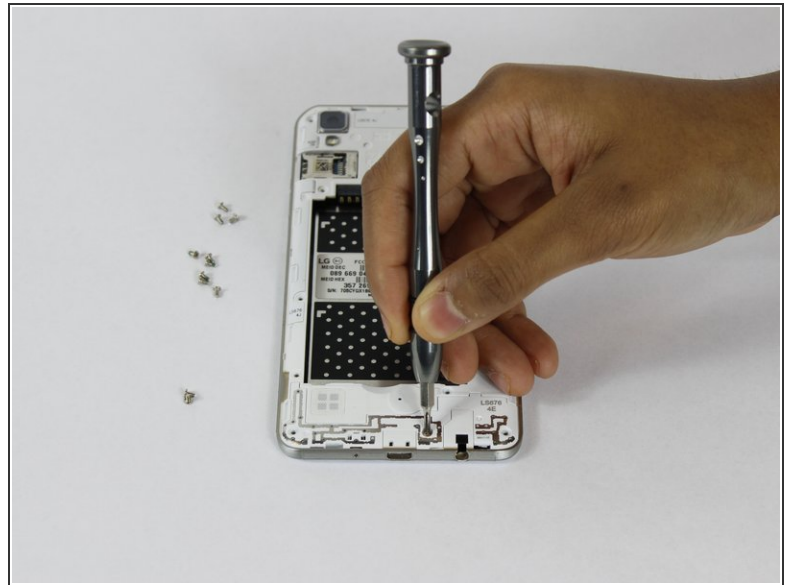
Step 3 — Rear Camera

- Remove the twelve 2mm JIS #00 screws from the mid-frame.

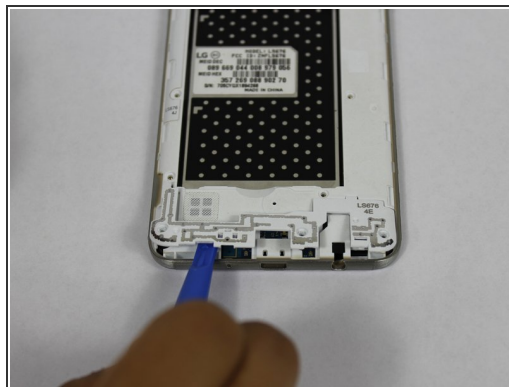
Step 4

- Using a plastic opening tool, remove the antenna extender from the mid-frame.

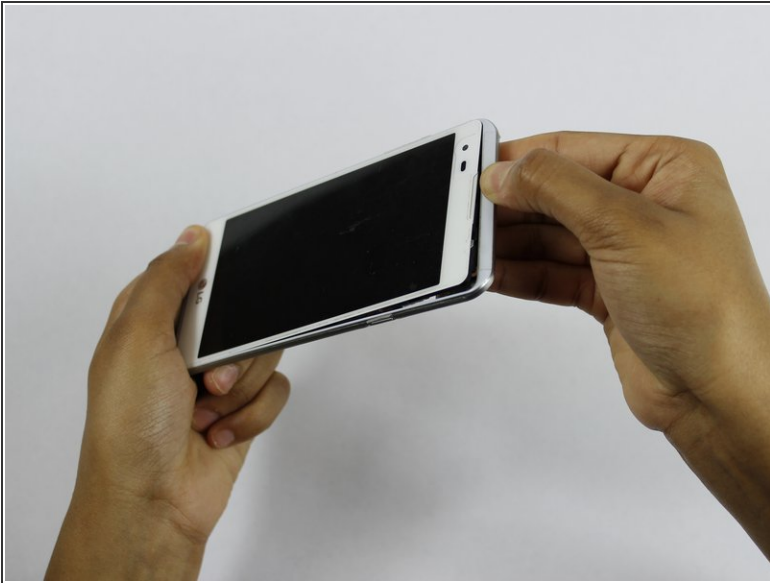
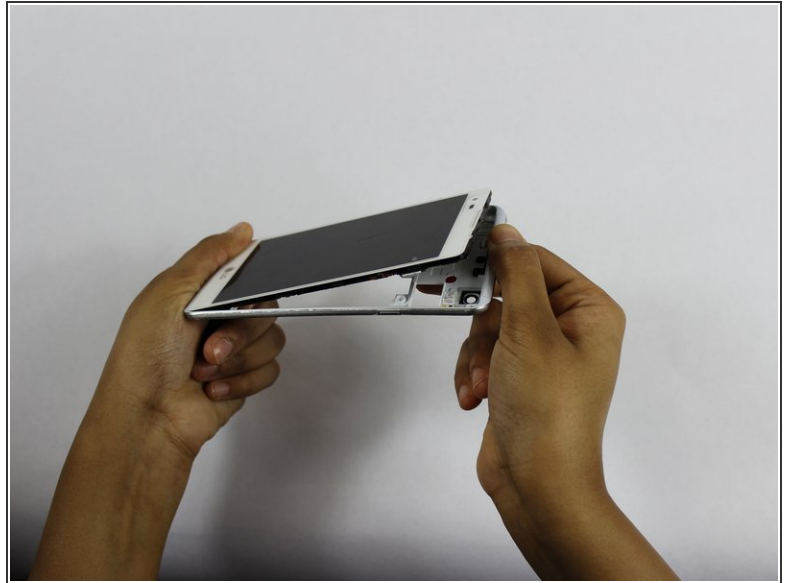
Step 5

- Using your fingers, remove the mid-frame.

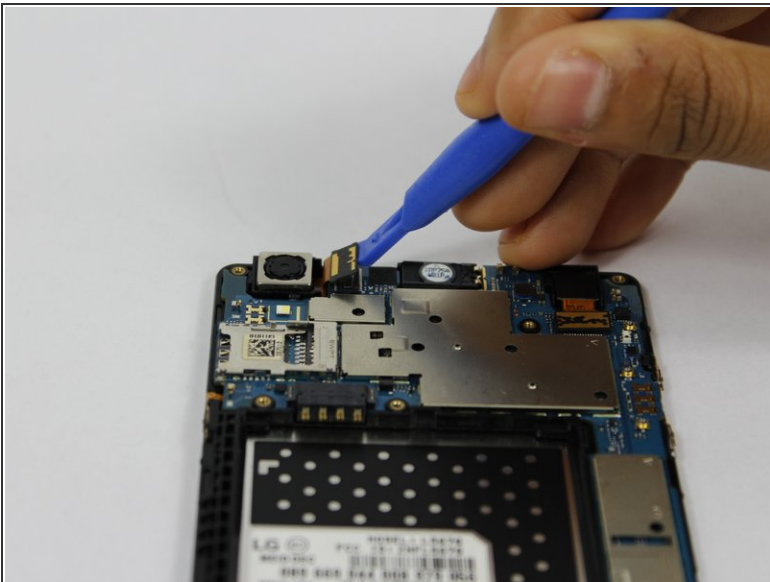
Step 6

- Use a plastic opening tool to disconnect the rear camera and pull from the phone.

To reassemble your device, follow these instructions in reverse order.
