HP Pavilion 15-ab243cl CD Drive Replacement

Replacement of the CD ROM/CD Drive.

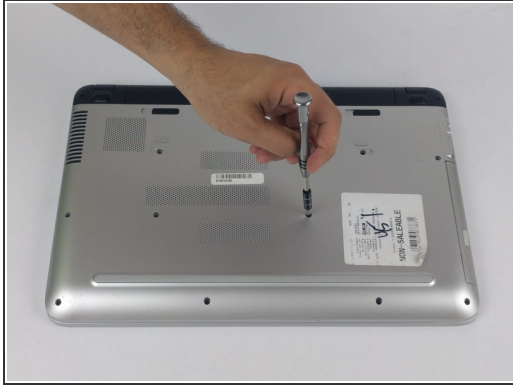
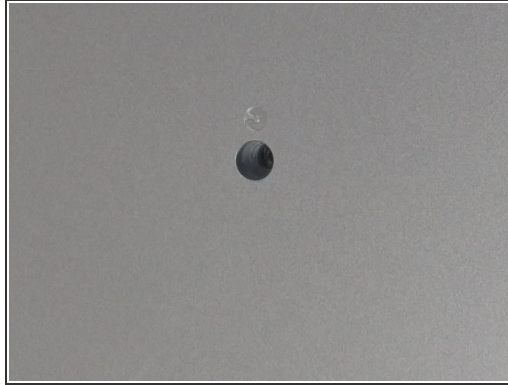
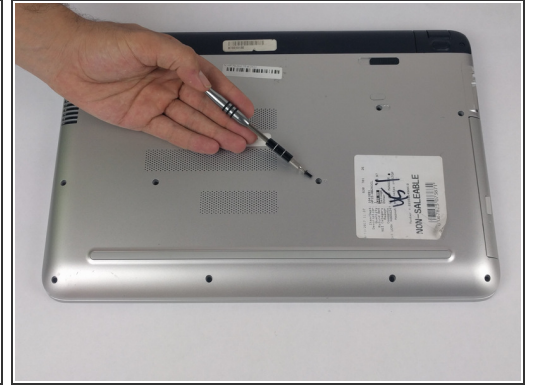
Step 1 — CD Drive

- Locate the screw, will have a CD symbol next to it, and remove this 3.5 mm screw with a PH0 screw driver.

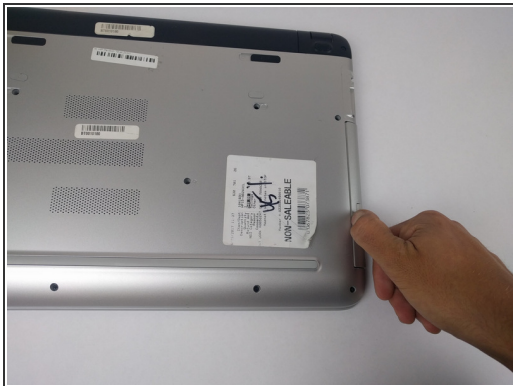
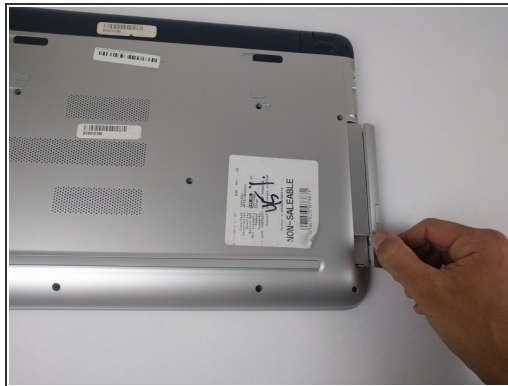
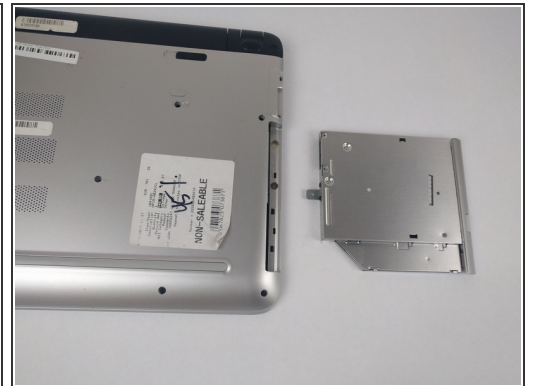
Step 2

- Using your finger nail or a plastic opening tool, pull out the drive.

To reassemble your device, follow these instructions in reverse order.
