Pioneer FH-X730BS Deck Buttons Replacement

How to replace the Pioneer FH-X730BS buttons.

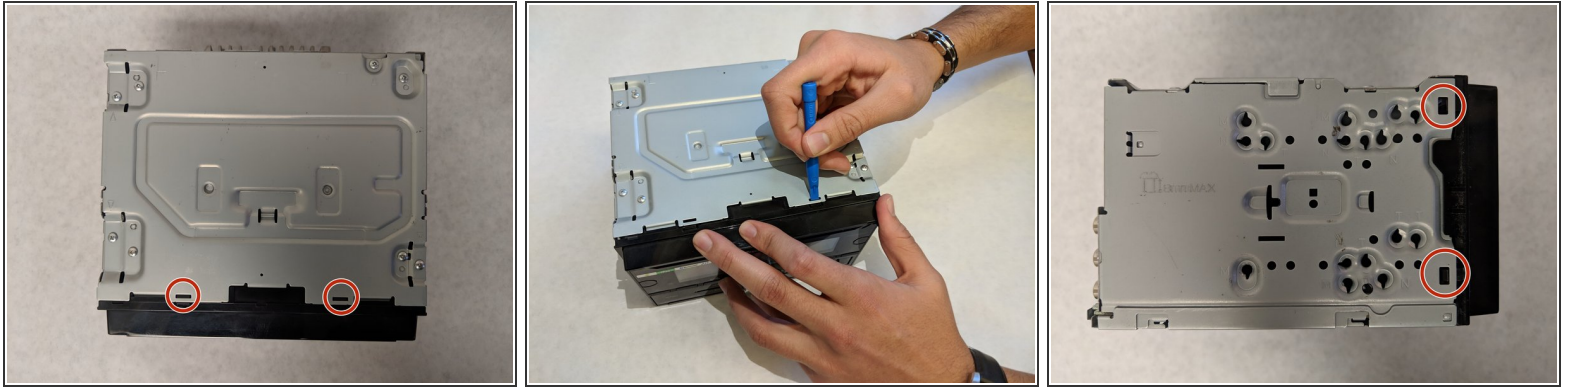
Step 1 — Deck Buttons

- Apply pressure to the tabs on each side using the plastic opening tool.
- You will need to pull the face away from the frame while unhooking the tabs.

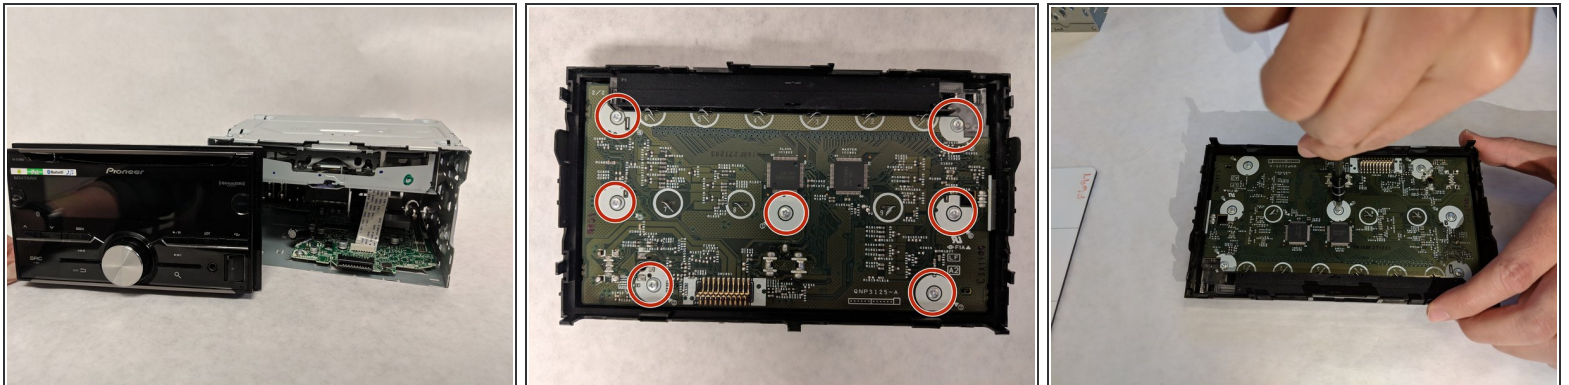
Step 2

- After removing the stereo face from the frame it should look similar to this.
- Remove the seven 11.2mm Phillips #1 screws on the rear side of the stereo face.

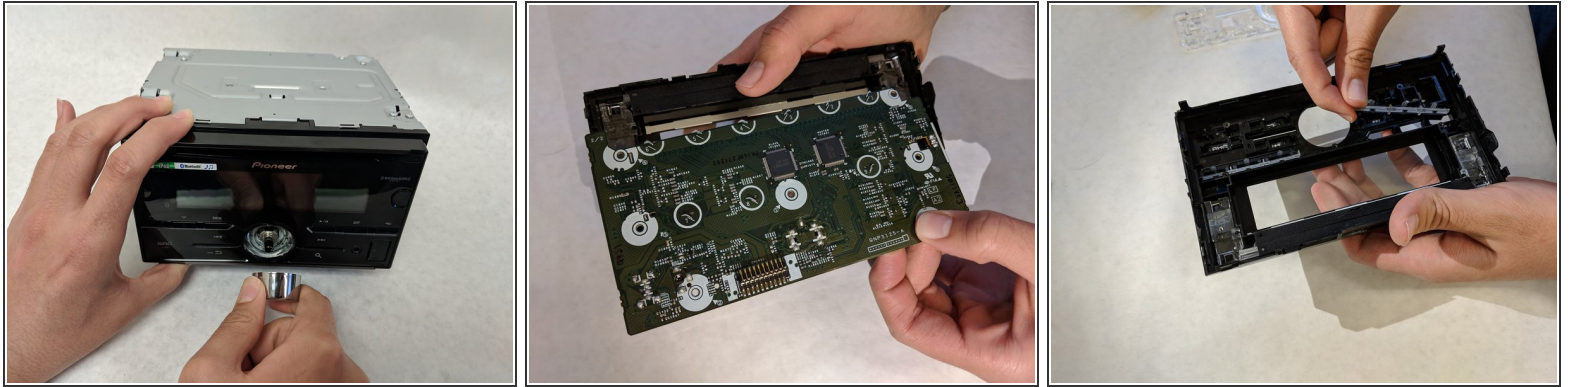
Step 3

- Remove the volume knob by pulling it towards you and pull the motherboard out of the face.
- The audio buttons can now be taken out. You can flip the face downwards and tap the audio buttons.
- You can now insert the replacement audio buttons into the face.
