Samsung Galaxy Note 10.1 3.5 mm Headphone Jack Replacement

This guide will help you replace the 3.5 mm headphone jack on the Samsung Galaxy Note 10.1.

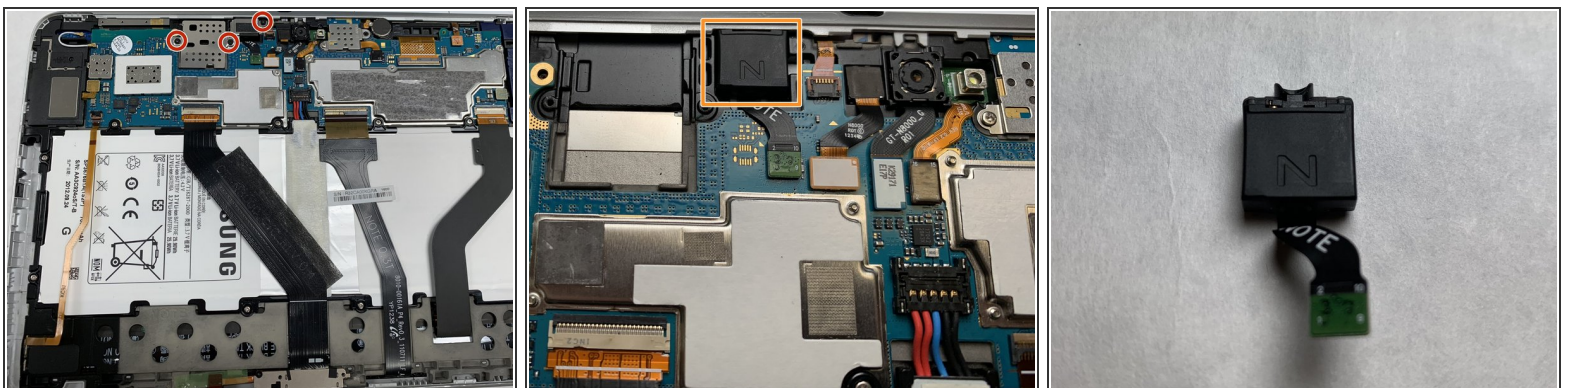
Step 3

- Remove the three 2 mm screws indicated by the red circles with the Phillips #00 screwdriver.
- Starting with the black motherboard connector, remove the module indicated by the orange box in the second picture.
- Replace the 3.5 mm auxiliary port with a similar model.

To reassemble your device, follow these instructions in reverse order.
