Samsung Galaxy Note 10.1 3.5 mm Headphone Jack Replacement

This guide will help you replace the 3.5 mm headphone jack on the Samsung Galaxy Note 10.1.

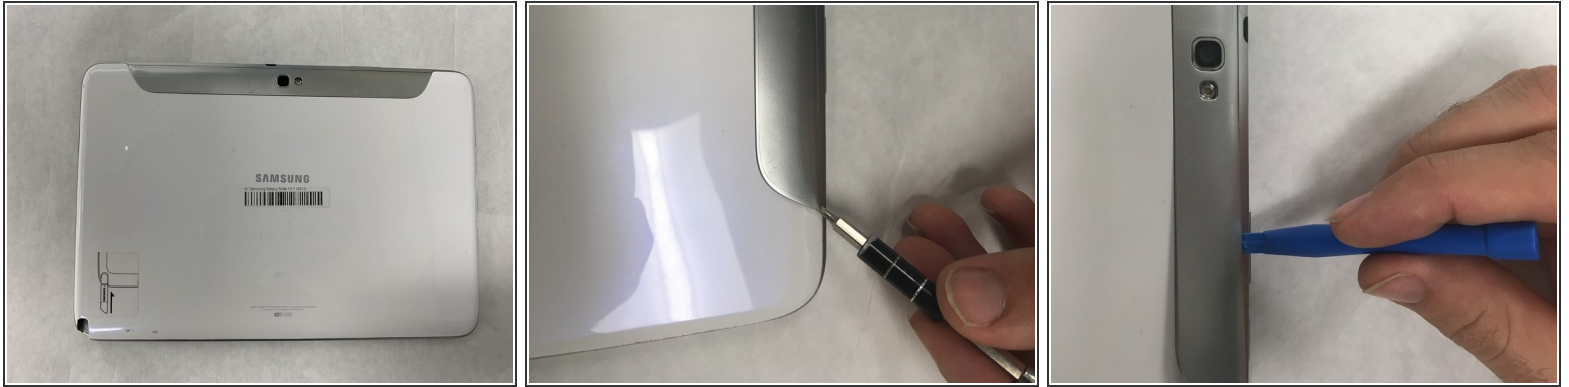
Step 1 — 3.5 mm Headphone Jack

- This is the back of the device and where you will begin to take it apart.
- It is necessary to remove the silver piece covering the camera first before removing the bigger back piece.
- Use a metal spudger to pop up the corner of the silver piece.
- Use the plastic opening tools to pry along the edges of the silver piece.
- Lift up the silver piece to reveal the rest of the back cover.

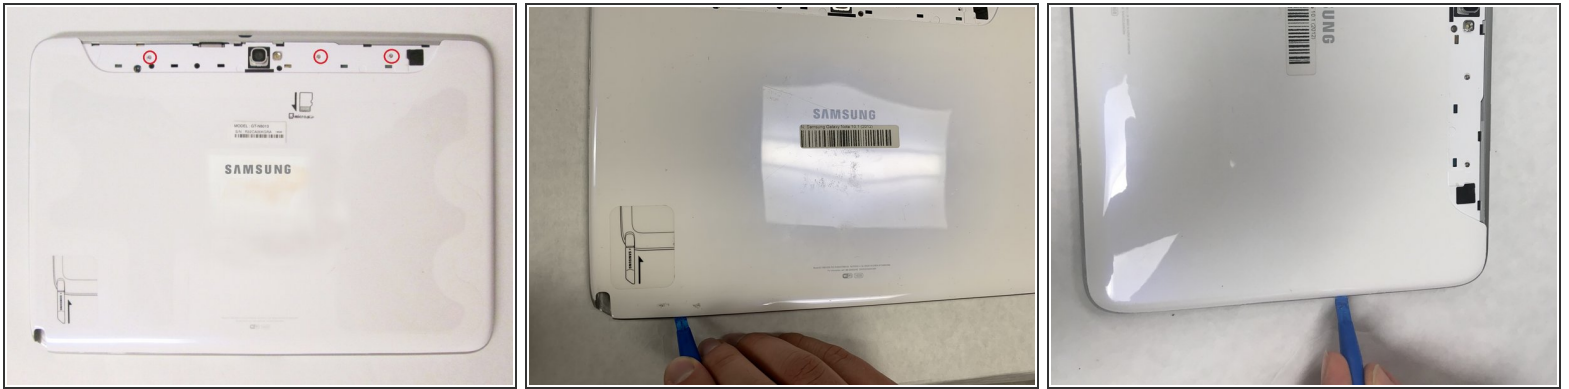
Step 2

- Remove the three 5mm screws indicated by the red circles with the Phillips #00 screwdriver.
- Using the plastic opening tools pry along the bottom of the device, moving to the sides of the cover to the top.
- Remove the back cover.

⚠ At this point use anti-static gloves or do NOT take it apart on carpet.

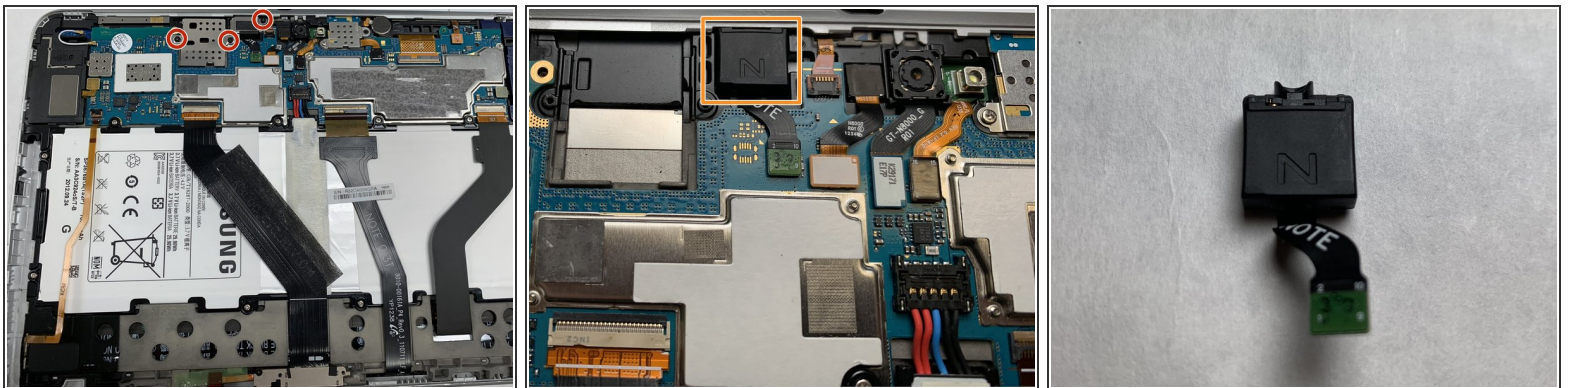
Step 3

- Remove the three 2 mm screws indicated by the red circles with the Phillips #00 screwdriver.
- Starting with the black motherboard connector, remove the module indicated by the orange box in the second picture.
- Replace the 3.5 mm auxiliary port with a similar model.

To reassemble your device, follow these instructions in reverse order.
