# Sharp Aquos Serie mini SHV31 Volume Rocker Replacement

How to replace a Sharp Aquos Serie mini SHV31 volume rocker.

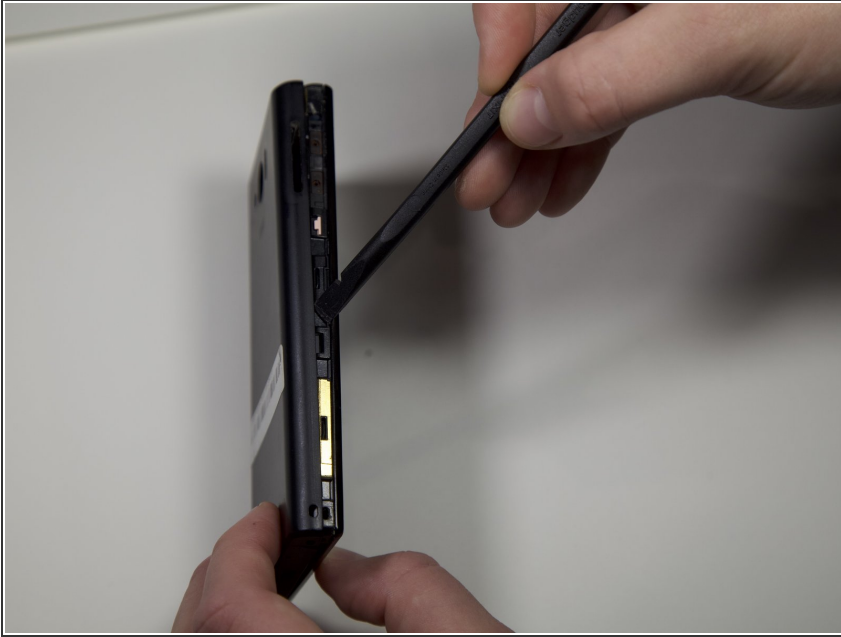
## Step 1 — Volume Rocker

- Begin by using the nylon spudger to pry off the back case.

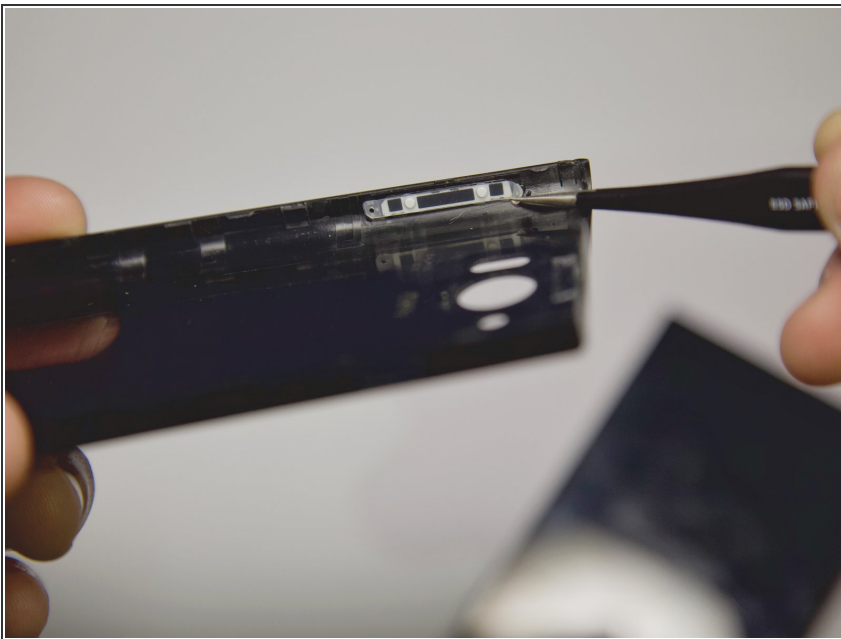
## Step 2

- Use the tweezers to pull the volume rocker from the clips.

To reassemble your device, follow these instructions in reverse order.
