# iPhone 11 Pro Back Glass Replacement

Written By: Phryne

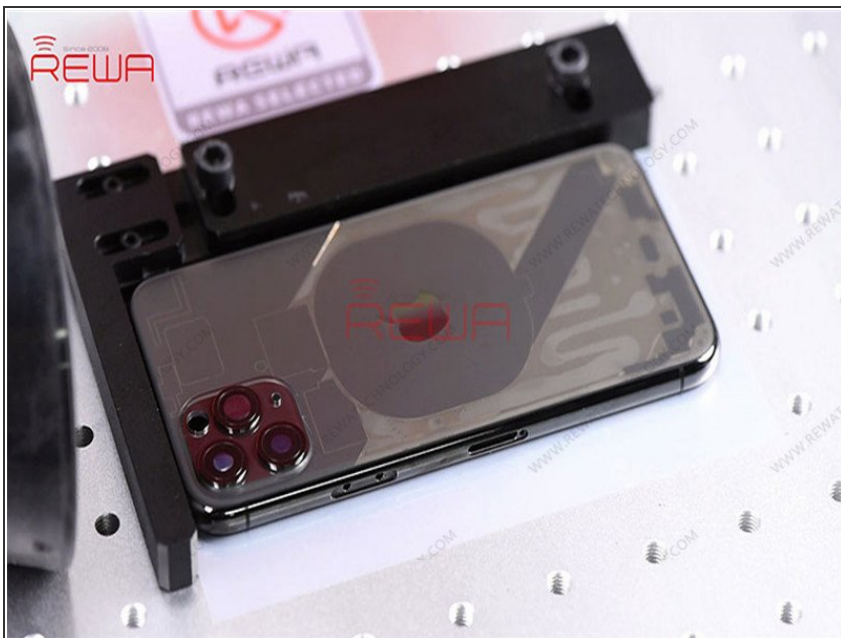
## Step 2 — Scan The Back Glass With Laser

- Adjust the laser light scanning area on the back glass.
- Once finished, get the parameter set and click 'Mark' to scan the back glass with the laser light.

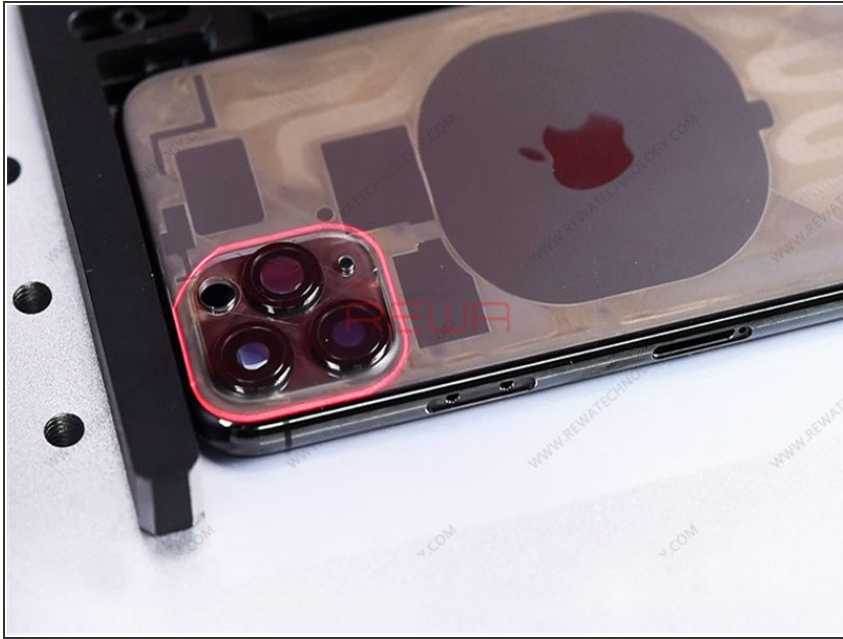
### Step 3 — Scan The Glass Around The Triple-lens Camera With Laser

- The laser light scanning didn't work well with the triple-lens camera area here.
- After several attempts and experiments, [REWA LAB](#) successfully completed a specialized drawing for the triple-lens camera area.
- Scan the triple-lens camera area again with the laser with the help of the drawing.

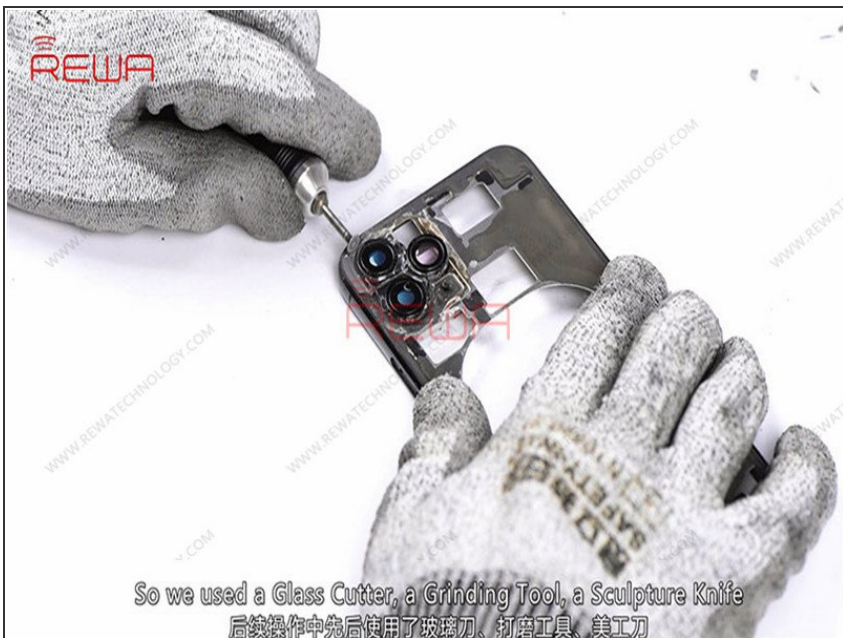
### Step 4 — Separate The Back Glass From The Mid-frame

- The scanned back glass can be separated easily. However, the glass around the triple-lens camera needs further operation.
- Our commonly used tools failed to remove the glass here, so we used a glass cutter, a grinding tool, a Sculpture Knife and a Cutting Nipper to remove the glass around the triple-lens camera.
- Once completed, remove residual black adhesive with the Laser Machine.

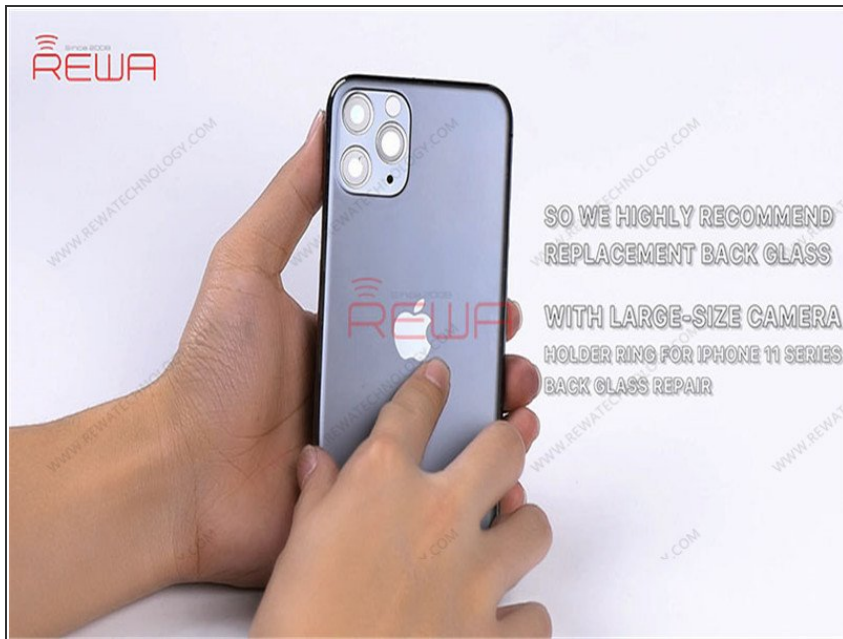
## Step 5 — Big Hole Back Glass

- The camera holder ring of iPhone 11 series is harder and comes with thick inside walls, adding to the difficulty of polishing. Meanwhile, the camera lens can also be easily damaged during polishing.
- So we highly recommend replacement back glass with a big camera hole for iPhone 11 series back glass repair.
- **Credit:** [REWA Academy](#)
