# How to Fix iPhone X Face ID Not Working After Screen Replacement

Written By: Phryne

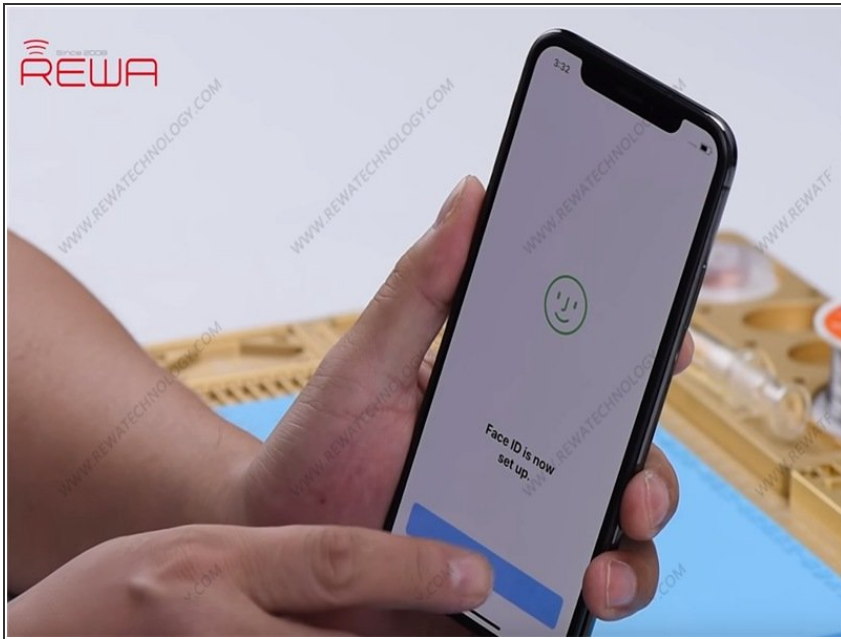
## Step 6 — Test

- Go to Settings > Face ID & Passcode > Reset Face ID. Face ID can be setup successfully
