How To Restore True Tone After Screen Replacement On iPhone XS

How to Fix iPhone XS True Tone Missing After Screen Replacement

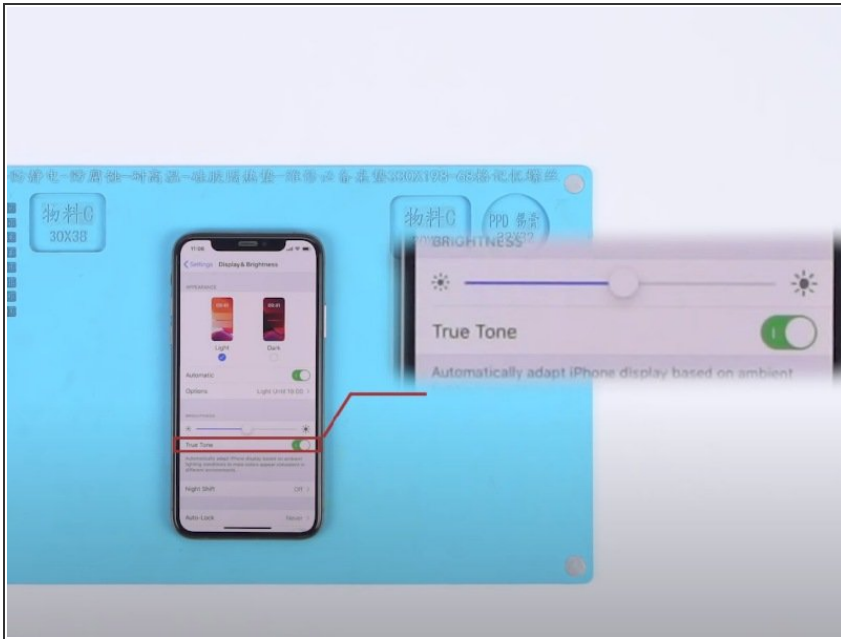
Step 1 — iPhone XS Aftermarket Screen True Tone Restoration With Original Screen

- Go to Settings>General>About and check the software version of the phone – iOS 13.2. Tap Display & Brightness. We can see that the True Tone has been turned on with the switch being green.
- Replace with a new aftermarket screen.
- Tap Display & Brightness. We can see that the true tone option has vanished.

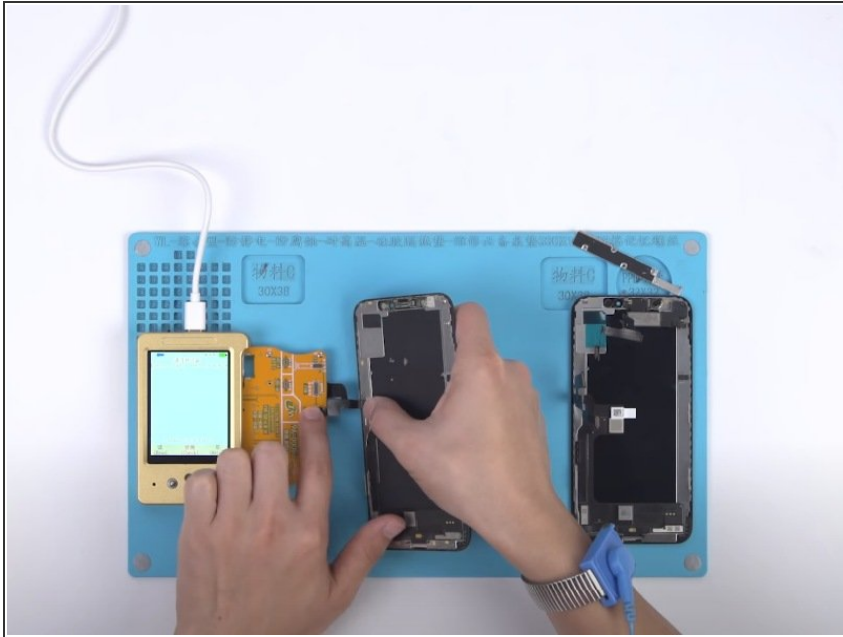
Step 2

- Now, let's restore the true tone with the multi-functional programmer.
- First, connect the display extended module with the programmer. Next, connect the original screen with the display extended module.
- Then we need to use the programmer to read data on the original screen.
- Once finished, disconnect the original screen and connect the aftermarket screen with the display extended module.
- This time we use the programmer to write the data to the aftermarket screen. Once finished, disconnect the aftermarket screen.

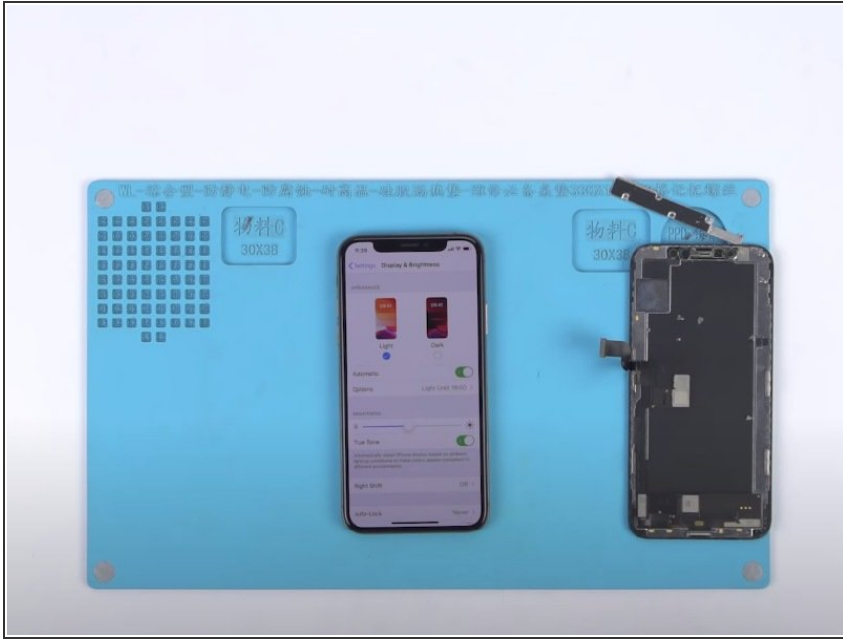
Step 3

- Now we can assemble the phone and test.
- Tap Display & Brightness. We can see this time that the True Tone has been turned on with the switch being green. The True Tone has been restored back.

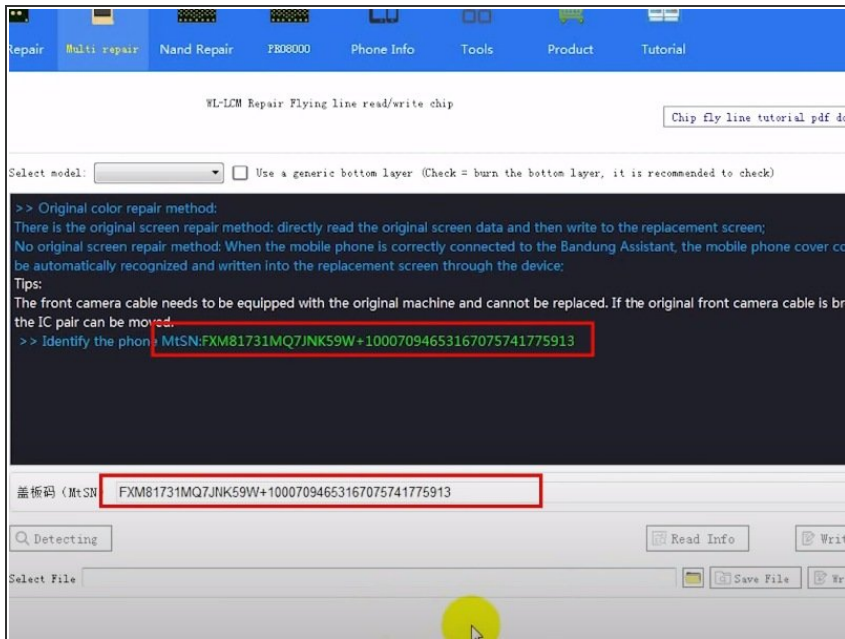
Step 4 — iPhone XS Aftermarket Screen True Tone Restoration Without Original Screen

- Go to Settings>General>About and check the software version of the phone – iOS 13.2. Continue to tap Display & Brightness. We can see that there is no true tone option.
- Connect the phone to the computer and open the WL assistance software. The cover board number of the phone has been read automatically.
- Continue to power off and disconnect the phone from the computer. Remove the aftermarket screen afterwards.

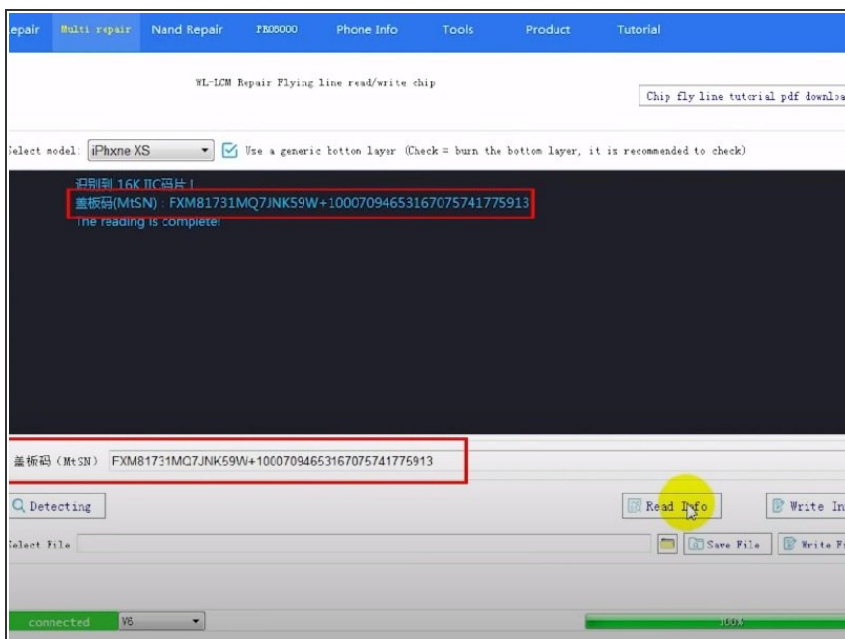
Step 5

- Now, let's restore the true tone without the original screen.
- Connect the aftermarket screen with the display extended module and connect the multi-functional true tone programmer to the computer.
- To restore true tone without the original screen, we need to write the previously read cover board number to the aftermarket screen with the help of the software.

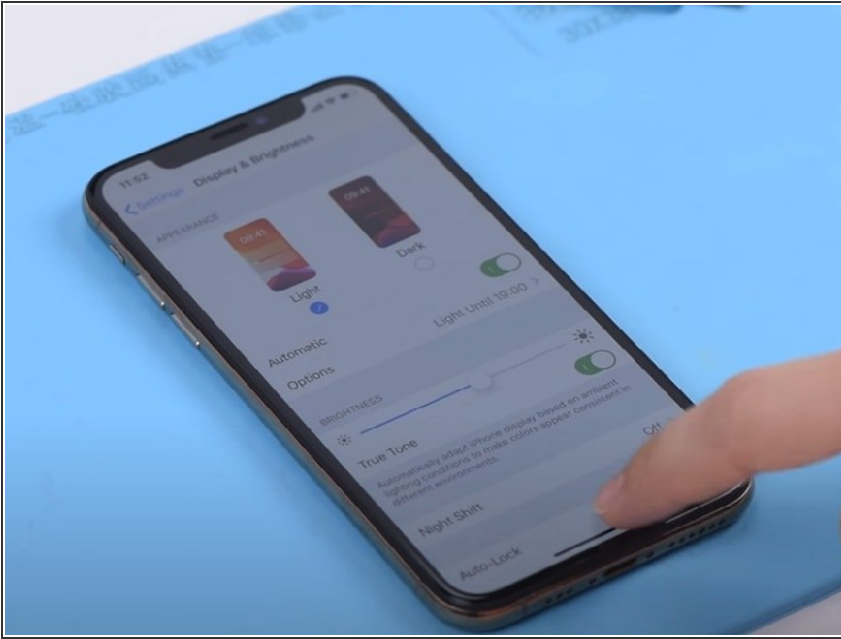
Step 6

- Now we can assemble the phone and test. Get the aftermarket screen installed and connect the battery. Press the power button to turn on the phone.
- Continue to tap Display & Brightness. We can see that the True Tone has been turned on with the switch being green. The True Tone has been restored back.
