# iPhone X Water Damage Repair

iPhone X/XS/XS Max Water Damage Repair

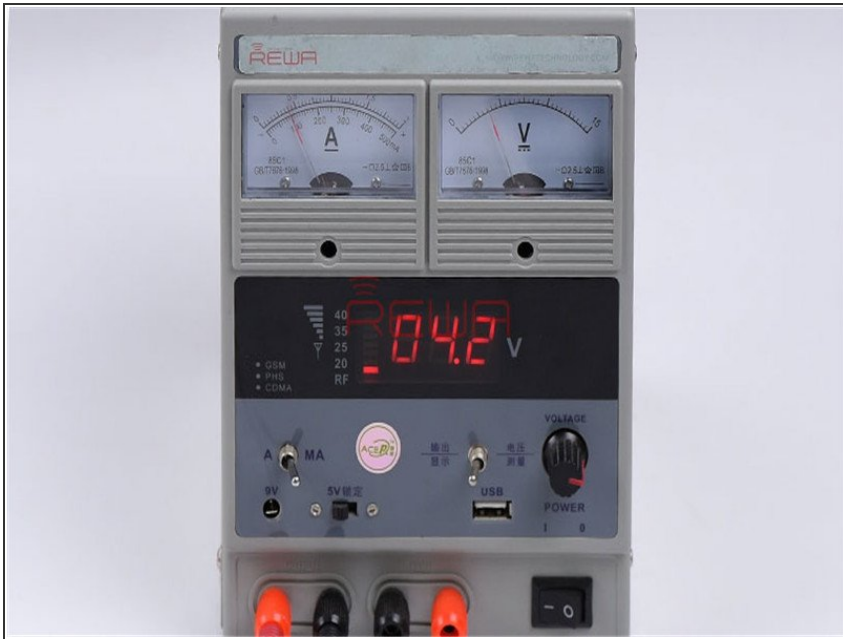
## Step 1 — Problem

- Press the power button to turn on the phone. There is no response at all.
- Let's take apart the phone and remove the display assembly first.
- Connect the battery connector with the DC Power Supply. Current reading on the ammeter jumps to 100mA and then stays still, which is abnormal.

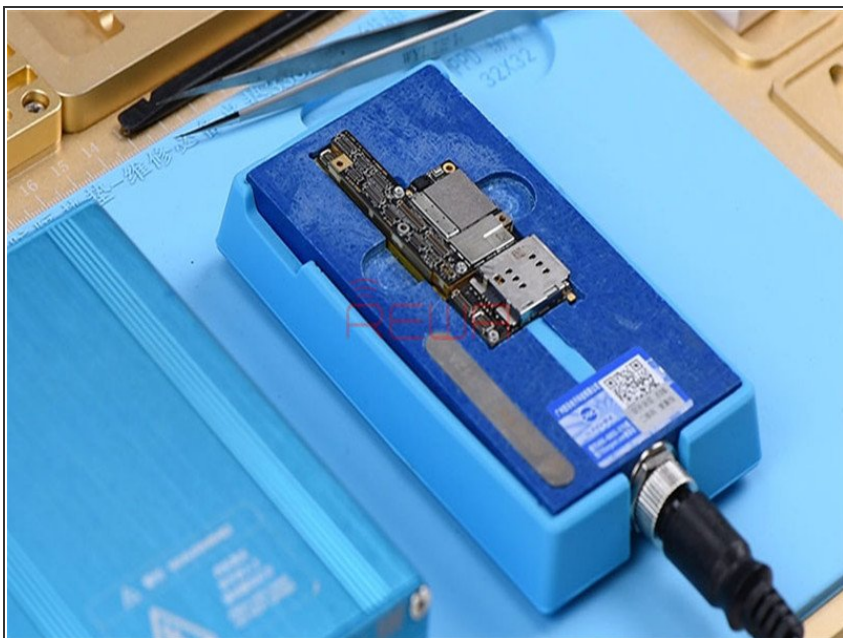
## Step 2 — Motherboard Separating

- The first thing we do is to separate the upper layer from the lower layer with the help of the specialized Heating Platform.
