# iPad Pro 12.9" 4th Gen Teardown

A video teardown of the 4th-gen iPad Pro, announced and released in March 2020.

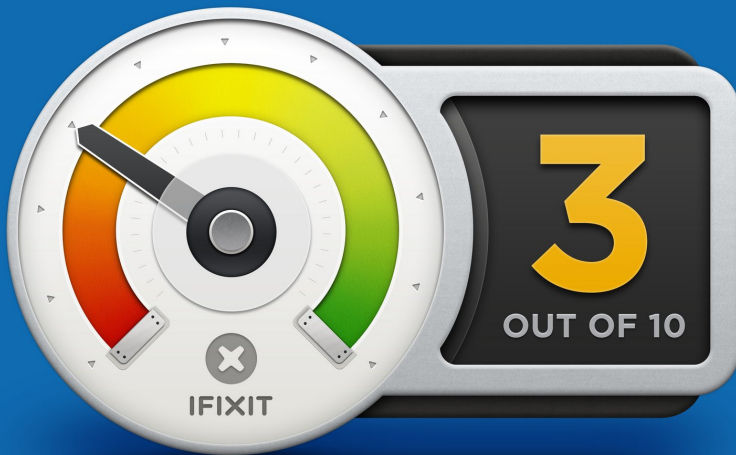
### REPAIRABILITY SCORE:

- The iPad Pro 12.9" 4th Gen "earns a **3 out of 10** on our repairability scale (10 is the easiest to repair):
  - The USB-C port is modular and can be independently replaced.
  - The lack of a physical home button eliminates a common failure point and may simplify repairs.
  - The battery is secured with both easier-to-remove stretch-release tabs *and* conventional, non-removable adhesive.
  - The LCD and front panel glass are fused together—simplifying the opening procedure, but increasing the cost of repair.
  - Gobs of adhesive hold most everything in place, making all repairs more difficult.
