# How To Fix iPhone 11 Pro Max Face ID Not Available - Motherboard Repair

Written By: Phryne

As we all know, iPhone X and later models can easily come with Face ID failure after being dropped or water damaged. However, it should also be noted that improper operation during daily repair might also bring damage to Face ID relevant components and therefore result in Face ID failure.

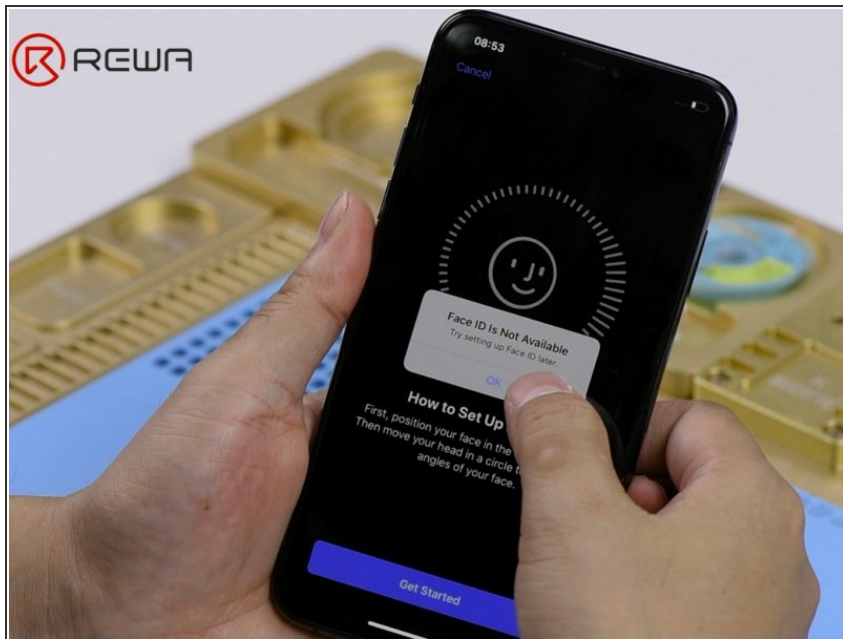
## Step 1 — How To Fix iPhone 11 Pro Max Face ID Not Available - Motherboard Repair

- Go to Settings > Face ID & Passcode > Reset Face ID. When trying to setup Face ID on the iPhone, we get the message 'Face ID is Not Available, try setting up Face ID later.'
- Start the Camera app and select Portrait in the bottom bar. Switch to the front camera. When the camera detects a person's face, the name of the lighting effect 'Natural Light' stays the same. And there is also no flashing red light from the Dot Projector.
- Normally, when Portrait mode is ready, the name of the lighting effect 'Natural Light' should turn yellow. And there is also flashing red light from the Dot Projector.

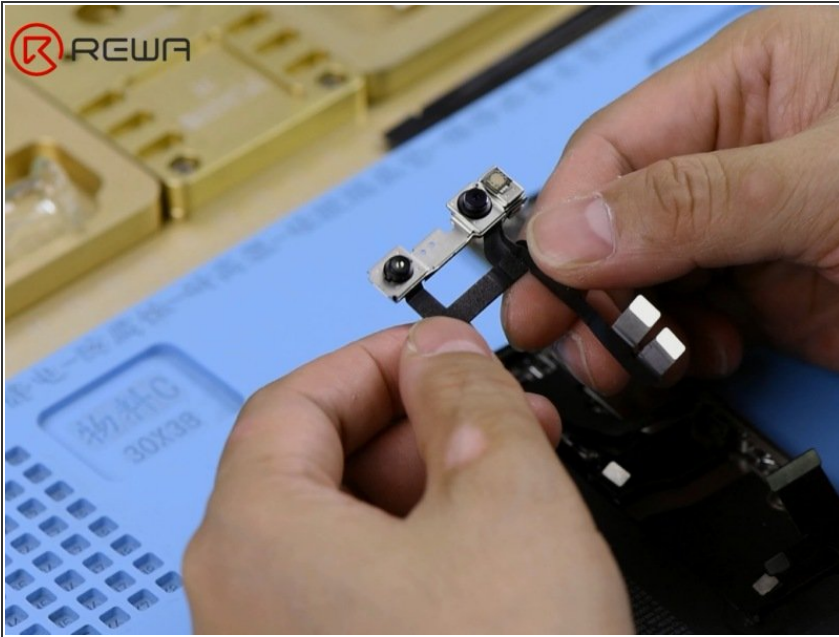
## Step 2

- Let's check Face ID parts first. Take apart the phone and take out the motherboard.
- Check the earpiece speaker and sensor flex cable. Nothing goes wrong. The dot projector flex cable, the infrared camera flex cable and the front camera flex cable also haven't been damaged.
