Insignia NS-B2110 Antenna Replacement

This guide will show you how to replace the antenna of the Insignia NS-B2110.

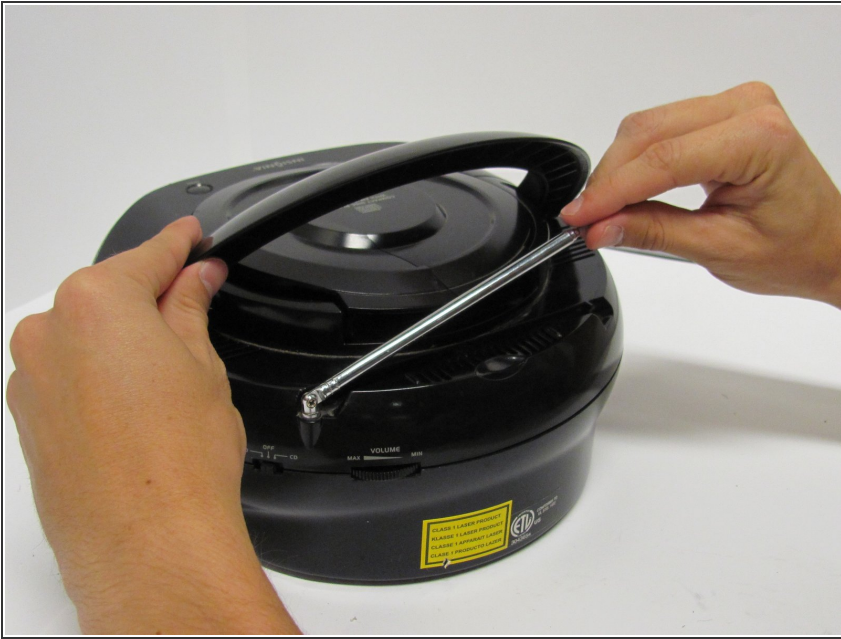
Step 1 — Antenna

- On the backside of the device, lift the plastic handle up with your hands to reveal the antenna.
- Lift the antenna to its upright position.

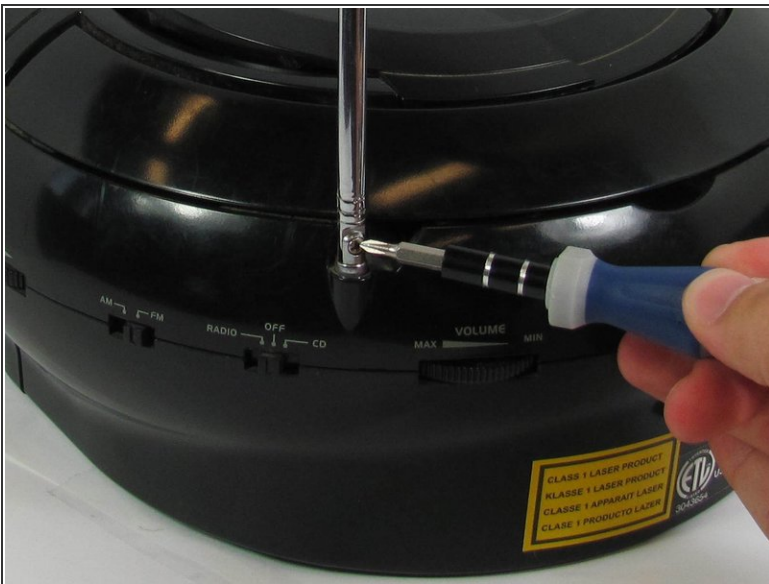
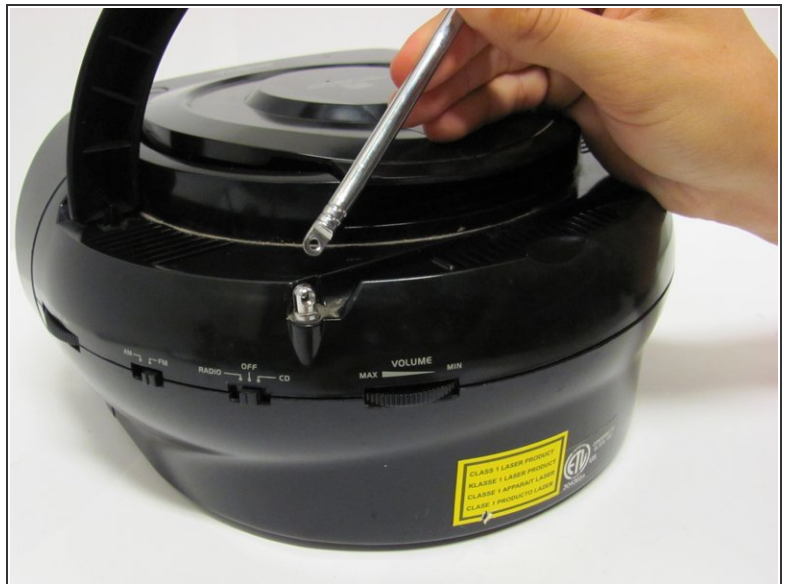
Step 2

- Remove one 6.0 mm Phillips #00 screw from the base of the antenna.
- Remove the antenna from the metal bracket.

To reassemble your device, follow these instructions in reverse order.
