# Samsung Galaxy Tab 3 8.0 Charging Port Replacement

If the device will not charge despite a power cable and battery replacement, replacing this component is the likely solution.

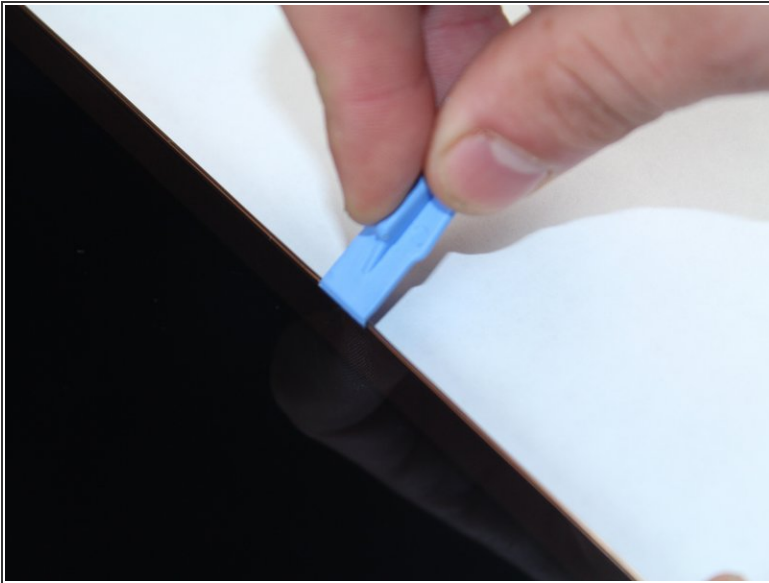
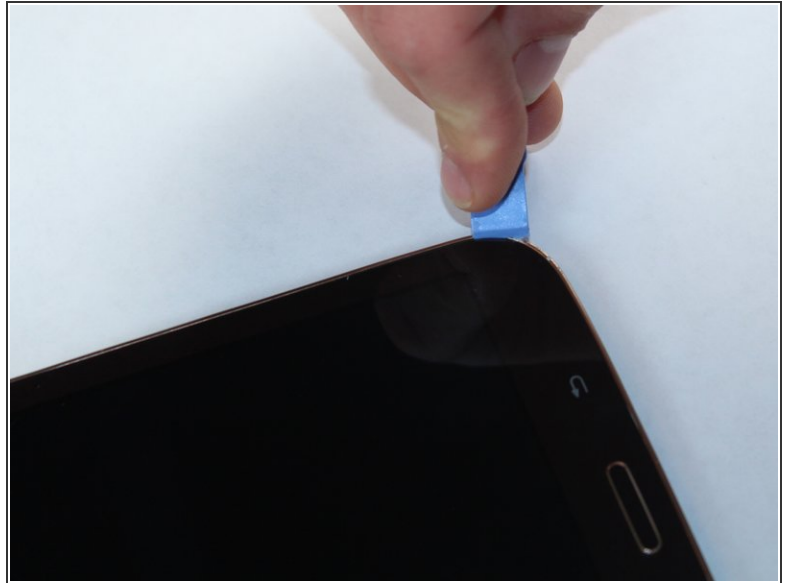
## Step 1 — Battery - Open up the tablet

- Start out by separating the screen from the back cover using the larger plastic opening tool to pry them apart.

Be careful when removing the screen as negligence can cause damage.

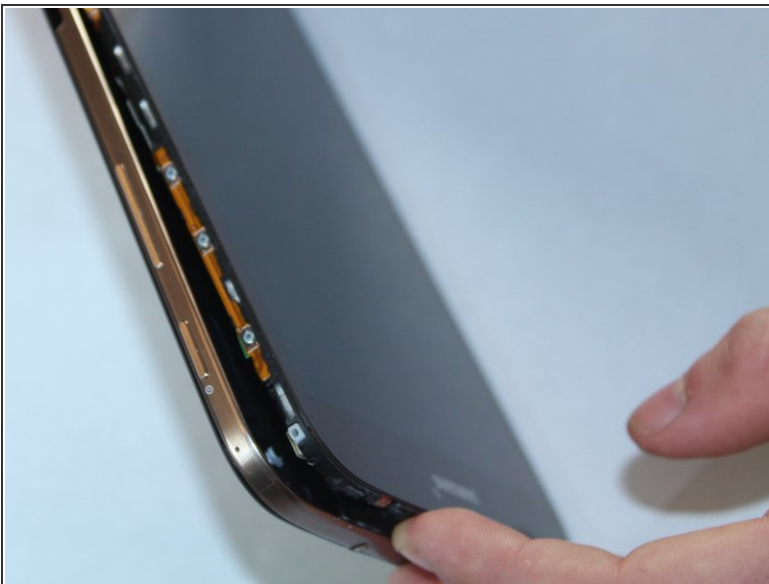
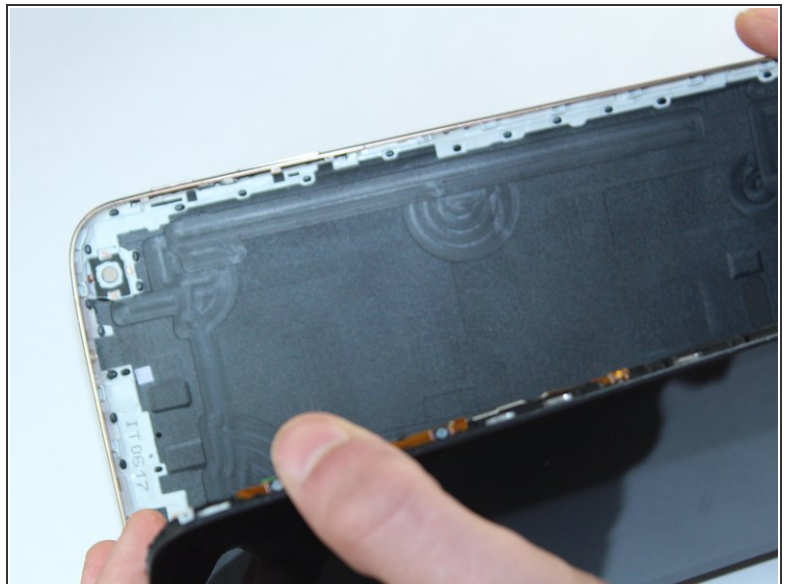
## Step 2 — Remove Back Cover

- Once every part of the screen is separated from the back cover, you should be able to fully remove it with your hands.

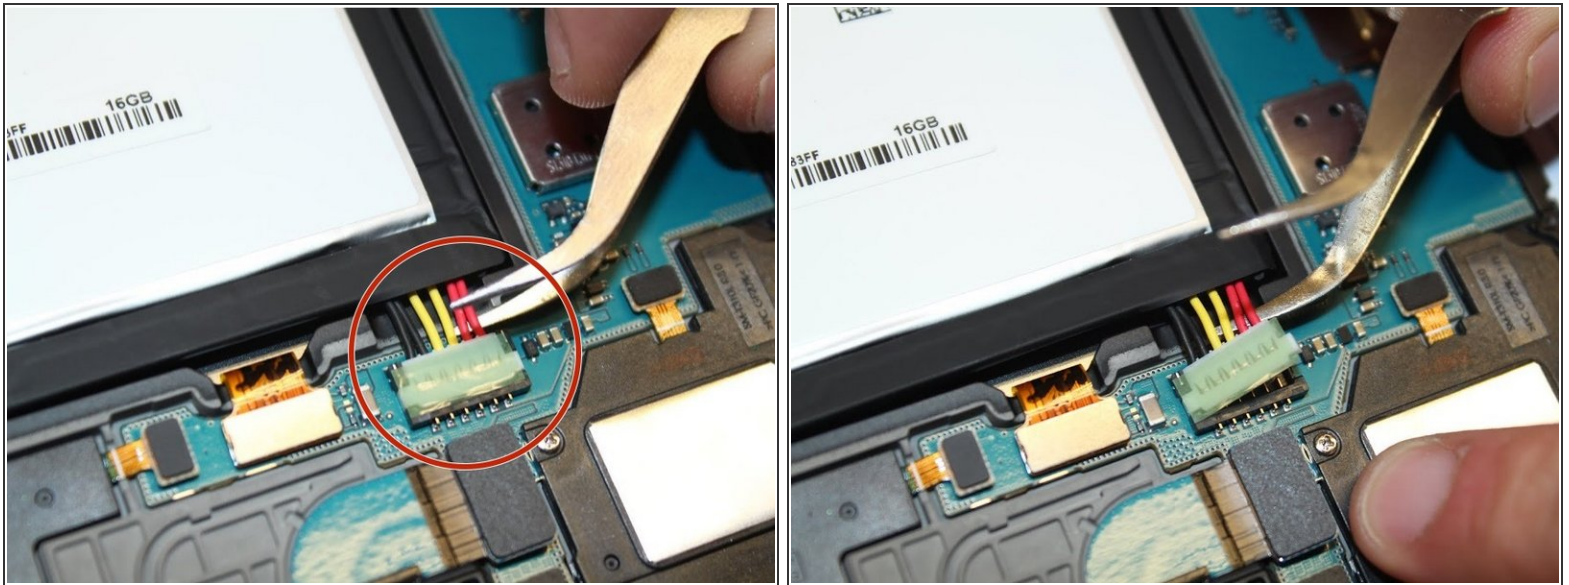
### Step 3 — Disconnect Battery

- To remove the battery you must use something small, such as tweezers, to disconnect the battery from its port.

**i** Note: the connection lifts up to remove.

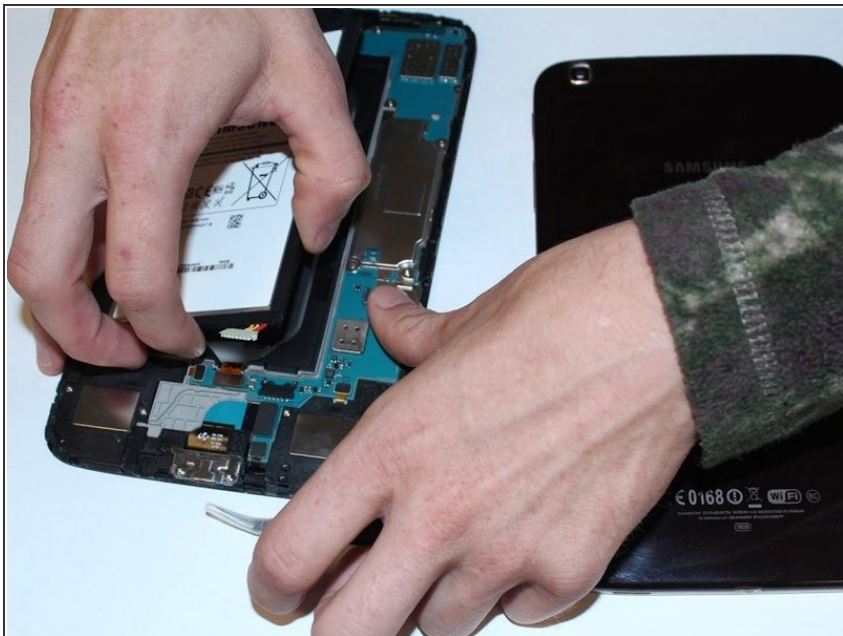
### Step 4 — Remove Battery

- After the battery is disconnected, use the pulling tab to safely remove the battery.

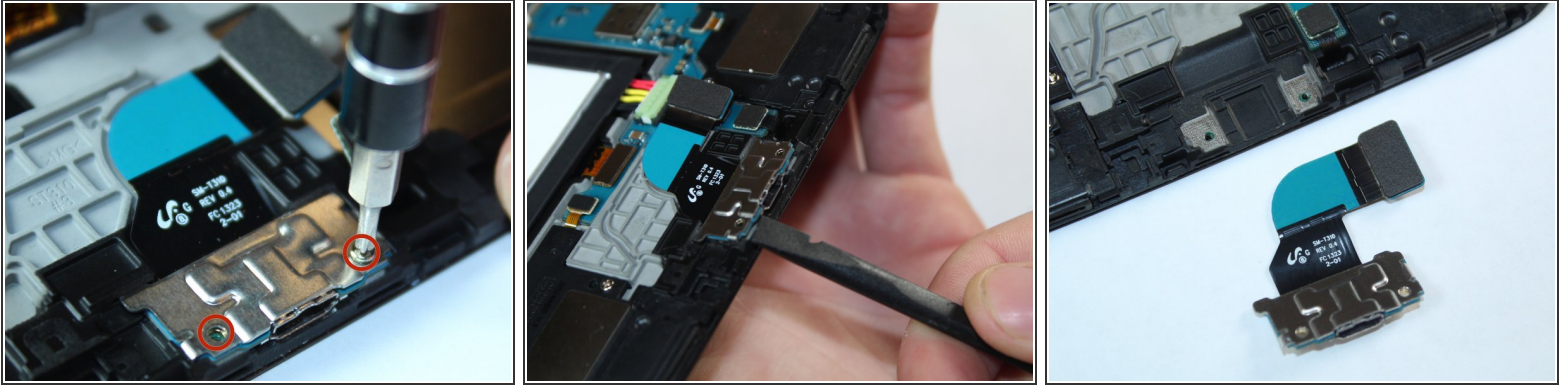
## Step 5 — Unscrew Charging Port

- Unscrew the 2.9mm screws from the charging port with Phillips Head #000 and use the spudger to pry it up from under the port to remove component from the device.

To reassemble your device, follow these instructions in reverse order.
