Xbox 360 Top Vent Replacement

Top vent replacement.

Use this guide to remove the gray plastic top vent from your Xbox 360.

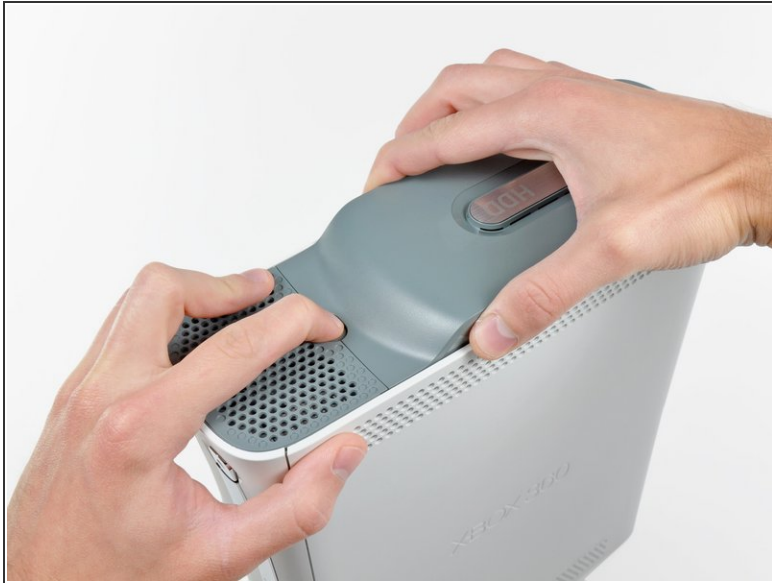
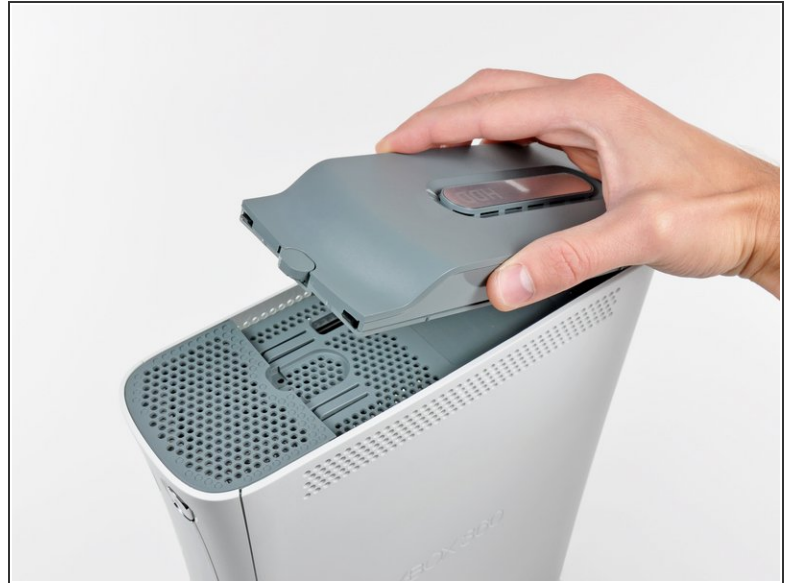
Step 1 — Hard Drive

- Grasp the hard drive assembly and press the release button while lifting its front edge.
- Remove the hard drive assembly from the top vent.

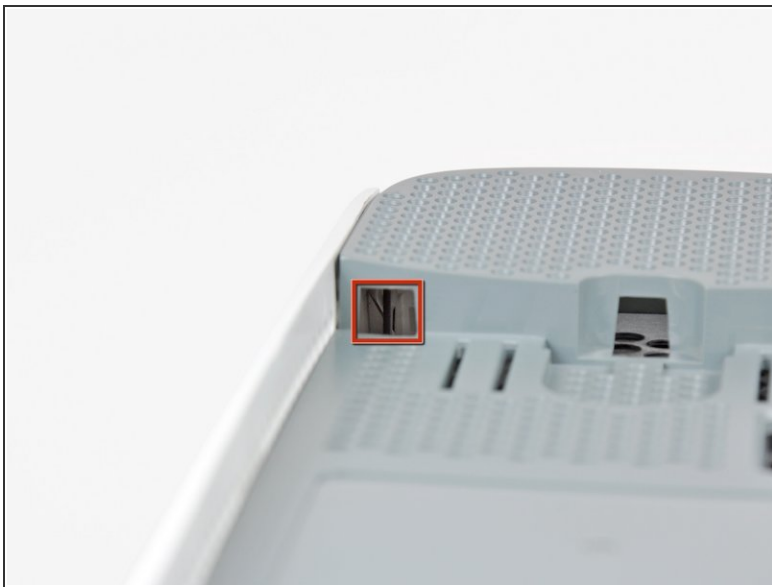
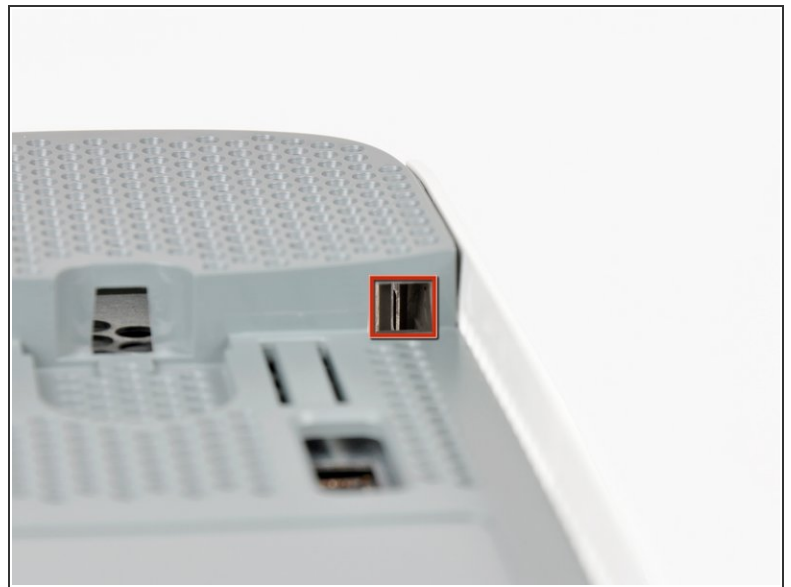
Step 2 — Top Vent

- ☑ Stand the console vertically with the top edge facing up.
- The top vent is secured to the console via clips. The first two clips are located underneath the top vent closest to the faceplate, as shown in the pictures.

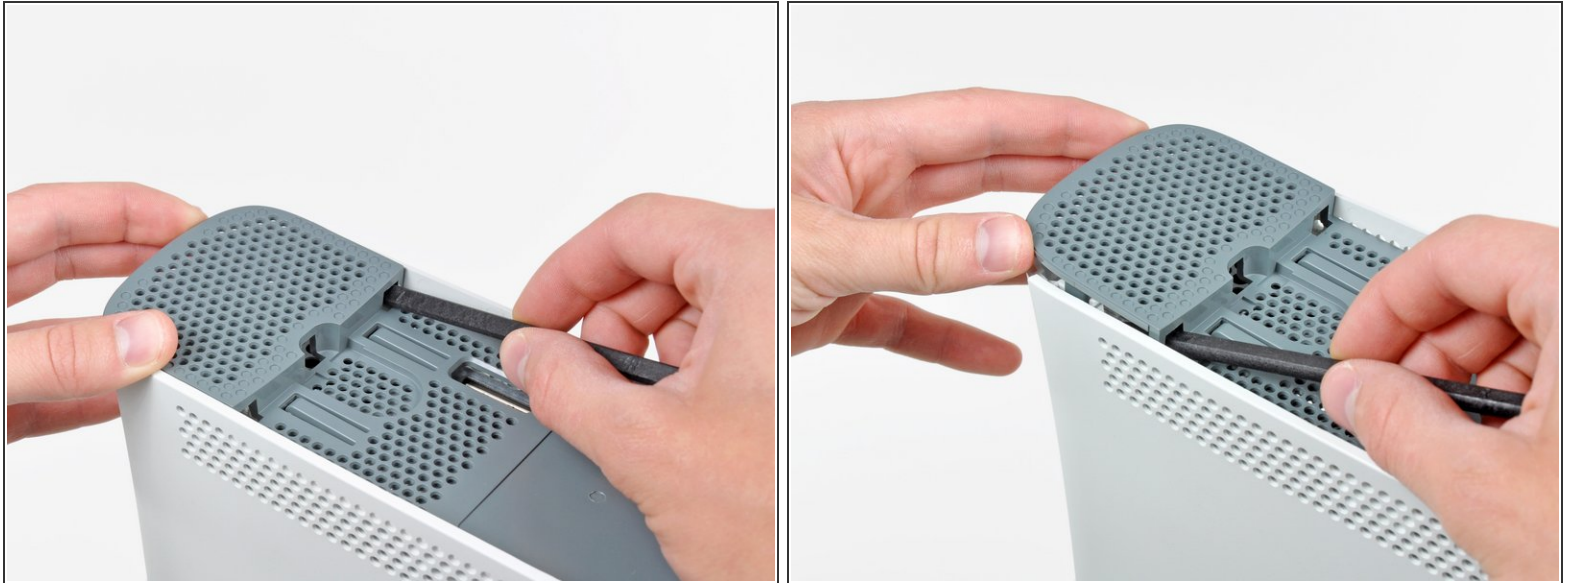
Step 3

- Insert the flat end of a spudger into the small gaps previously mentioned to release the clips.
- ⓘ You may also use the long finger of an Xbox 360 opening tool to accomplish this task.

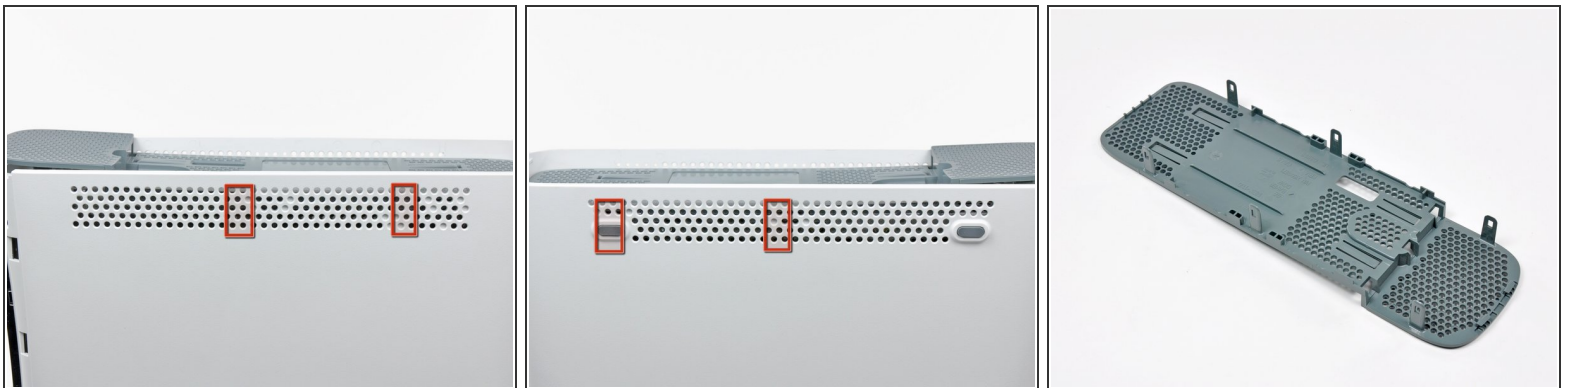
Step 4

- ⓘ In the next few steps, you will use the tip of a spudger or the finger of an Xbox 360 opening tool to release the clips along the left and right sides of the top vent. Their locations are highlighted in red.

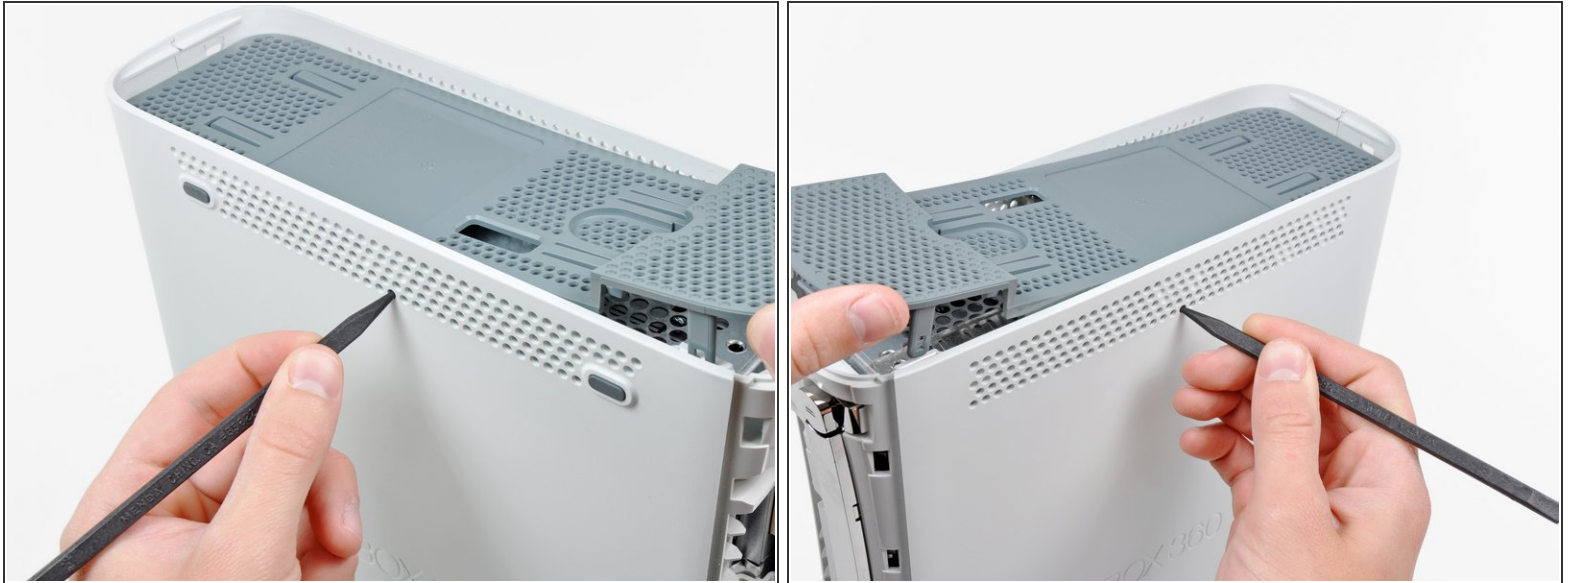
Step 5

- To release the clips, work from the middle of the top vent.
- While slightly lifting the front edge of the top vent, use the tip of a spudger to push the clips closest to the center of the top vent towards the inside of the console.

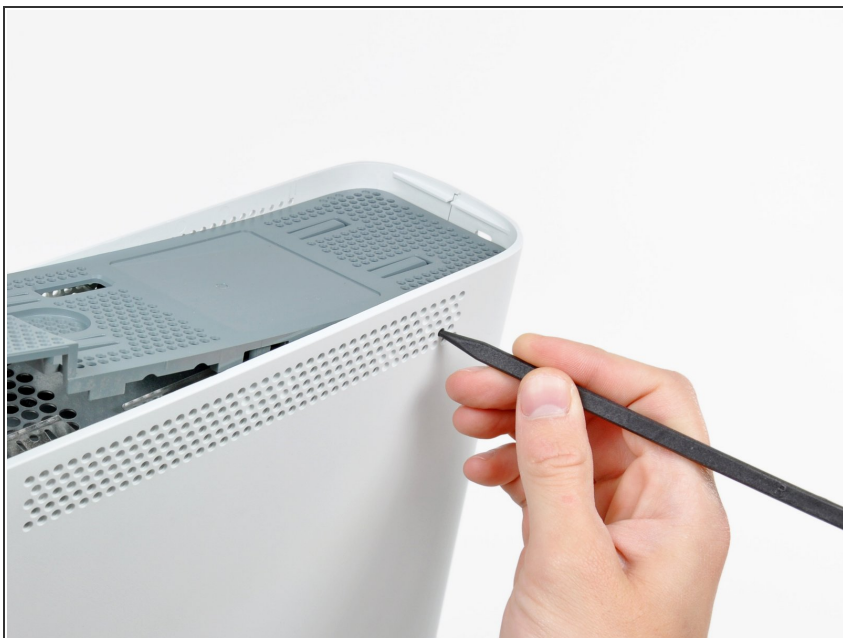
Step 6

- Use the tip of your spudger to release the clip on the top vent nearest the back of the Xbox's upper case.

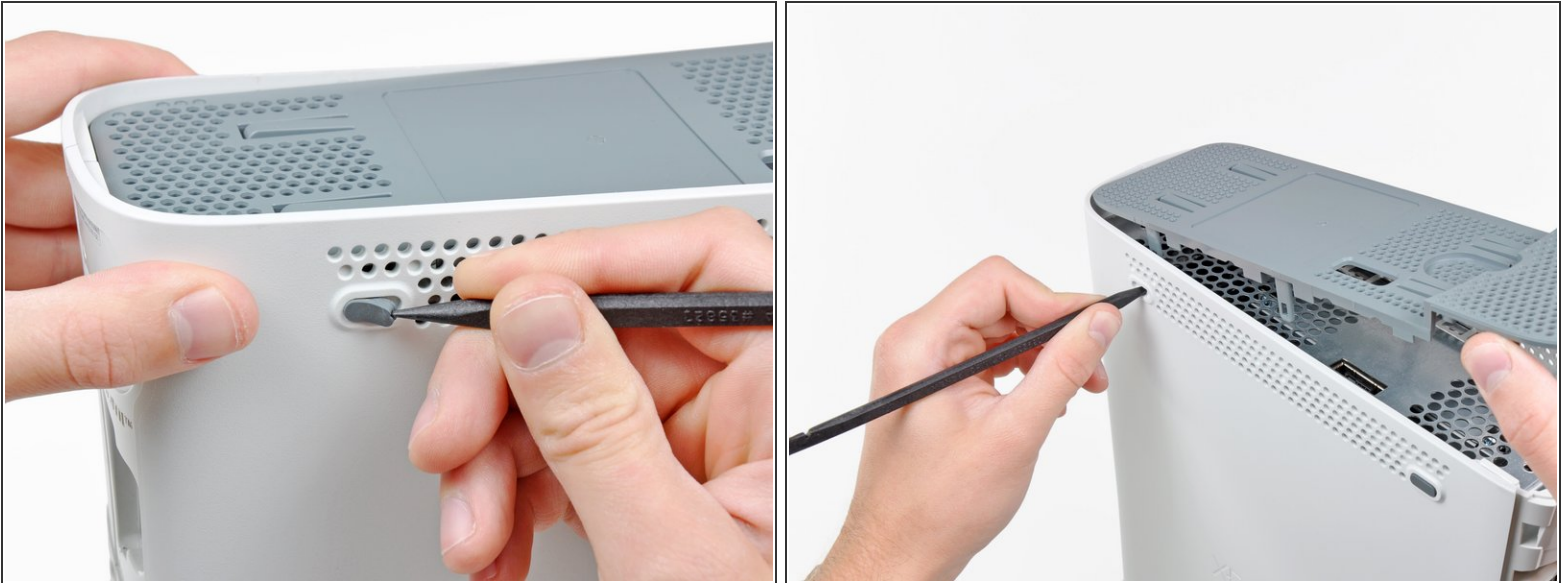
Step 7

- ⓘ The last clip is hidden underneath the rubber foot nearest the back of the console.
- Use the tip of your spudger to release the clip on the top vent nearest the back of the Xbox.
- Remove the top vent from the 360.
